# DAM CATCHMENT RESTORATION

*EROSION PREVENTION AND RESPONSE*

*April 1st, 2019*  
*Taylor Josephy*  
*ER 390*

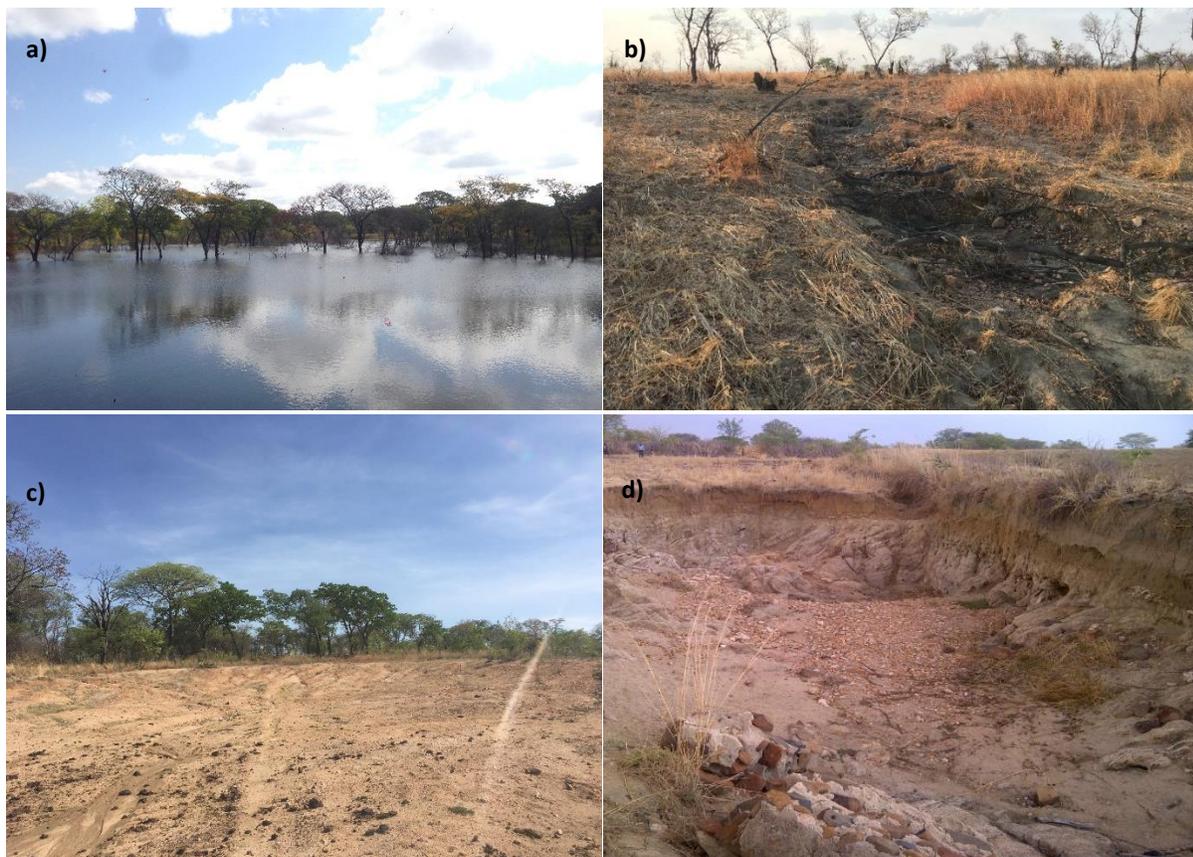
**Figure 2:** a) A portion of the 2.1 ha flooded by the dam reservoir; b) rill erosion occurring on the dam spillway; c) excavated top-soil for embankment construction; d) unchecked gully erosion at nearby dam which cued need for expensive dam rehabilitation

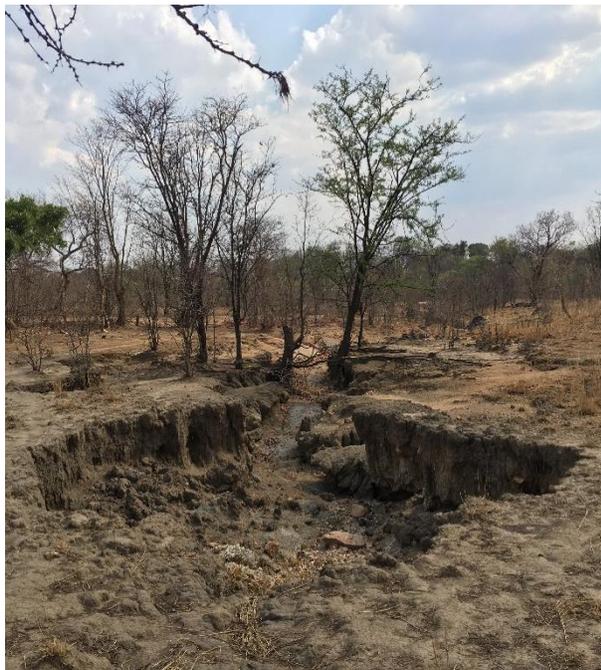
**Figure 3:** Gully erosion occurring at the outlet of the eroding micro-catchment

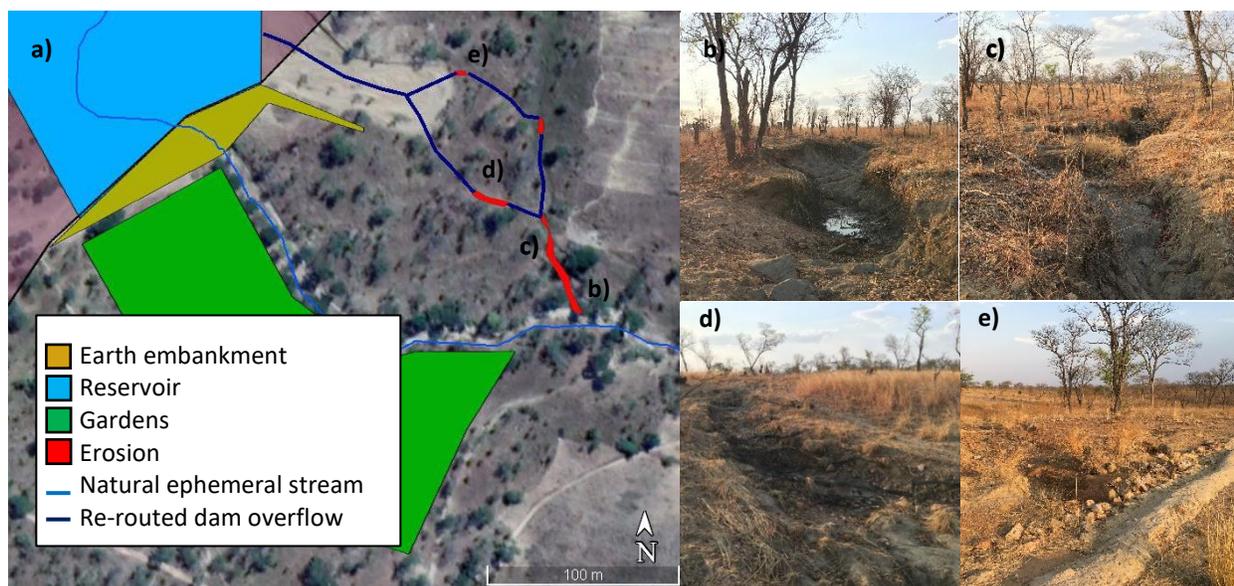
The erosion on the dam spillway is due to the geomorphological disequilibrium introduced by re-routing the ephemeral stream around the dam – a sudden, steep gradient has been introduced to the watercourse and the stream is attempting to readjust itself. This has led to one large ~1m deep, 80m long gully stemming from the intersection with the natural stream (Fig. 5b, 5c). Although this is to be expected, it must be stabilized before the re-adjusted gradient intersects the reservoir, which would result in catastrophic collapse. This gully was plugged with rock prior to the 2018/19 season but grew slightly as the gully head jumped above the rock. The 2018/19 rain season also led to a new ~2m wide, 40m long rill erosion closer to the dam (Fig. 5b).

Figure 5: a) Schematic of dam spillway, water flow routes, and status of erosion at the start of the project; b) gully erosion at the intersection of the re-routed and natural stream; c) mid-way point along the gully erosion shown in 5b; d) rill erosion occurring closer to the excavated spillway; e) narrow gully erosion at the edge of the excavated spillway

Three approaches were used to establish an alternative, erosion-stable water course around the dam that mimics a natural stream's ability to disseminate energy: 1) the placement of stones and sand-filled sacs on gullies and rills to stop their advance; 2) the placement of a flood-spreading sill to reduce water concentration on an erosion-prone location; and 3) the planting of vetiver grass (*Vetiveria zizanioides*) to stabilize areas around the main watercourse.

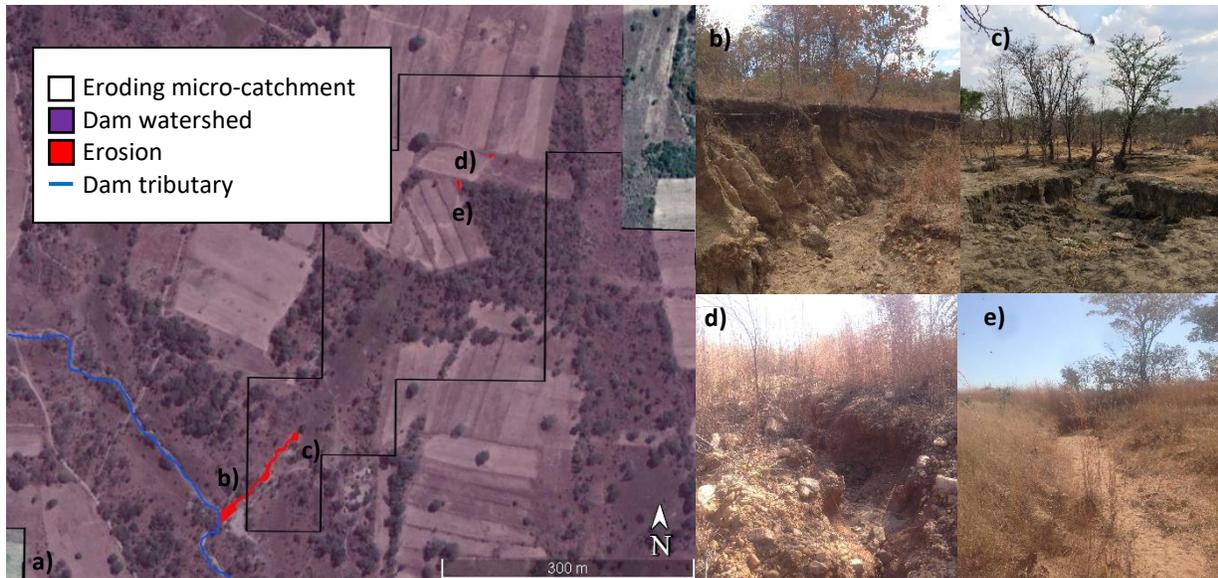
The eroding micro-catchment is experiencing gully erosion both at the start and end of its watershed (Fig. 6). The erosion is a recent occurrence originating from a change in agricultural practices at the top of the watershed. In 2015, down-slope tilling and misplaced water-conservation bunds concentrated water on easily erodible soils, leading to gully erosion along bare land (6d, 6e). Seasonal wetland (dambo) withstand the concentrated flow throughout the middle of the micro-catchment, but active gully erosion at the outlet is advancing into the dambo (Fig. 6b, 6c).

**Figure 6:** a) Schematic of eroding micro-catchment; b) gully erosion at the micro-catchment's outlet; c) gully head; d) narrow gully erosion at base of field with down-slope tilling; e) out-flow from narrow gully cross-cutting fields

It was agreed that the gullies formed at the top of the watershed (Fig. 6d) would be addressed using a method used by the landowner to rehabilitate gullies in the neighbouring catchment: placing logs within the gully, allowing sediment to back-fill, and waiting for captured natural grass seed grasses to germinate for stabilization. The larger, wider gullies at the base of the micro-catchment would be plugged with sacs and rock, like those on the spillway (Fig. 11). However, the large labour demands of Objective 1 and community-wide economic issues from early drought prevented the community from addressing the gullies in the micro-catchment in time, leaving them unprotected against floods.

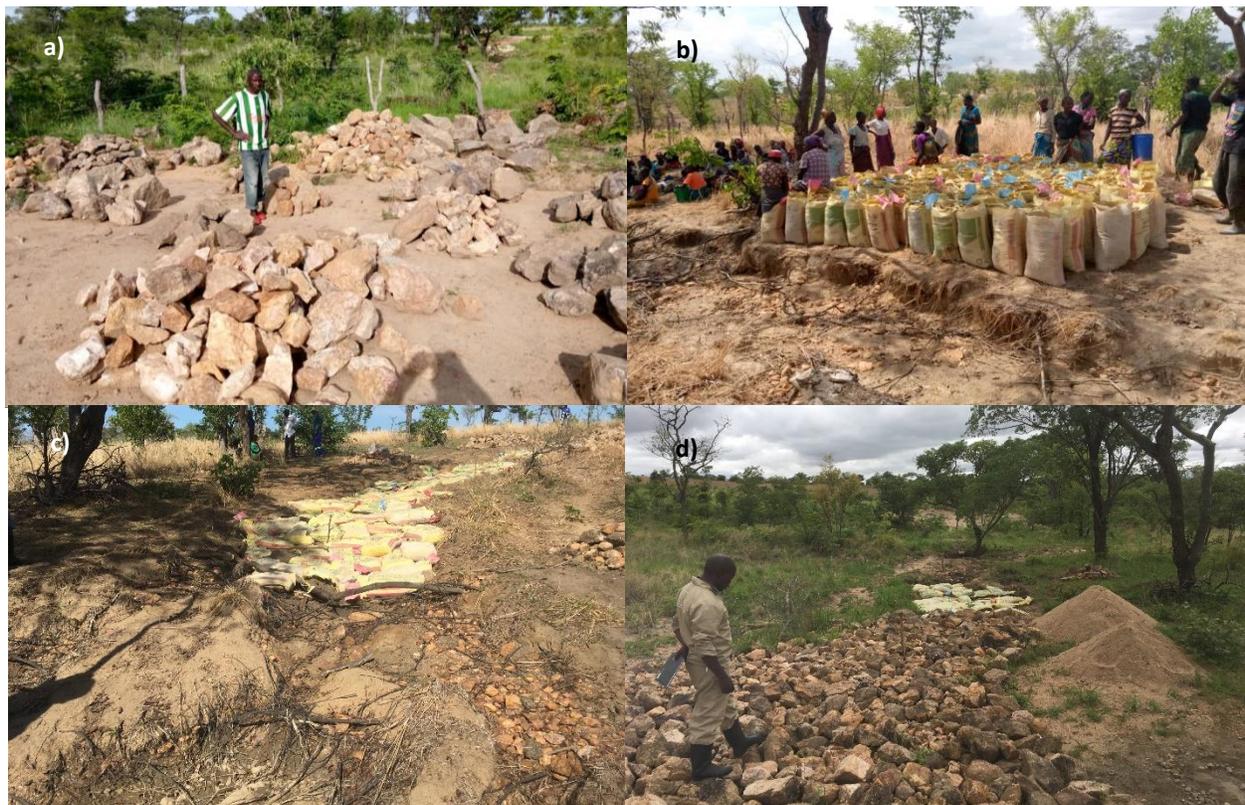
**Figure 7:** a) Dam committee vice-chairperson standing next to rock collected by the community; b) sand-filled sacs to be placed in rill erosion; c) placed sand-filled sacs; d) Maambo (MOA) assessing rock placement atop sand-filled sacs

Following the guidance of the Ministry of Agriculture representative, sacs and rocks were placed to disseminate energy, similar to how the bedrock, boulders, and large woody debris function within a natural stream. Figure 7 shows the community working to place stones and sacs. Due to a limited budget and difficult site access, the work was performed solely using volunteer manual labour. The sacs were placed primarily as a space-filler underneath a "stream-bed" of rock.

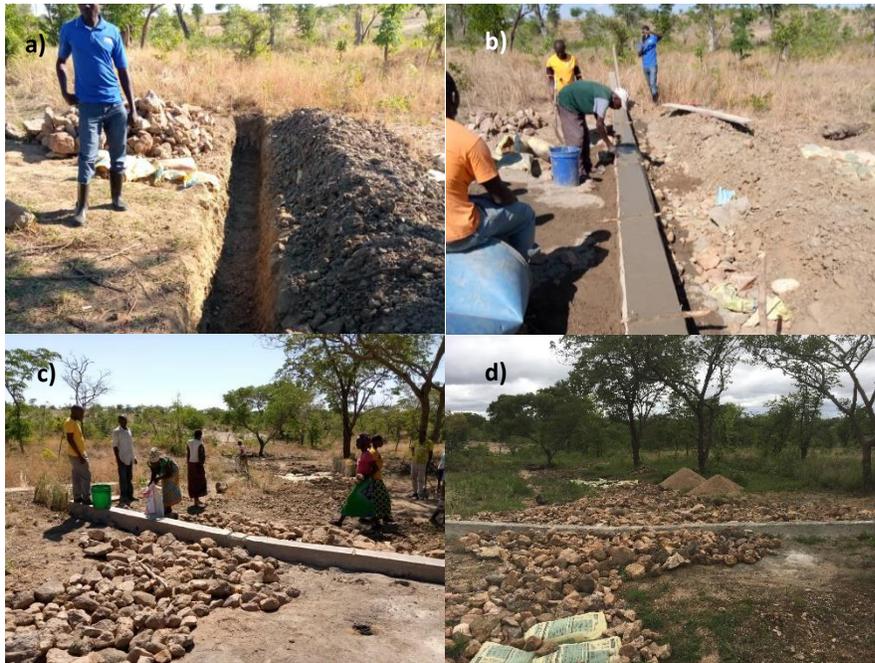
**Figure 8:** a) Flood-spreading sill trench; b) levelling top of sill; c) constructed sill above gradient drop; d) finished sill after rock placement

The sill was constructed to spread the flow of water prior to an erosion-prone, steep section along the watercourse where the rill erosion started (Fig. 8). A 50cmx15cmx10m trench was dug to prevent under-cutting of the rill (Fig. 8a). A concrete sill was constructed and levelled using an ocular builder's level, with a low point placed in the middle to avoid water flowing around the sill (Fig. 8a-c).

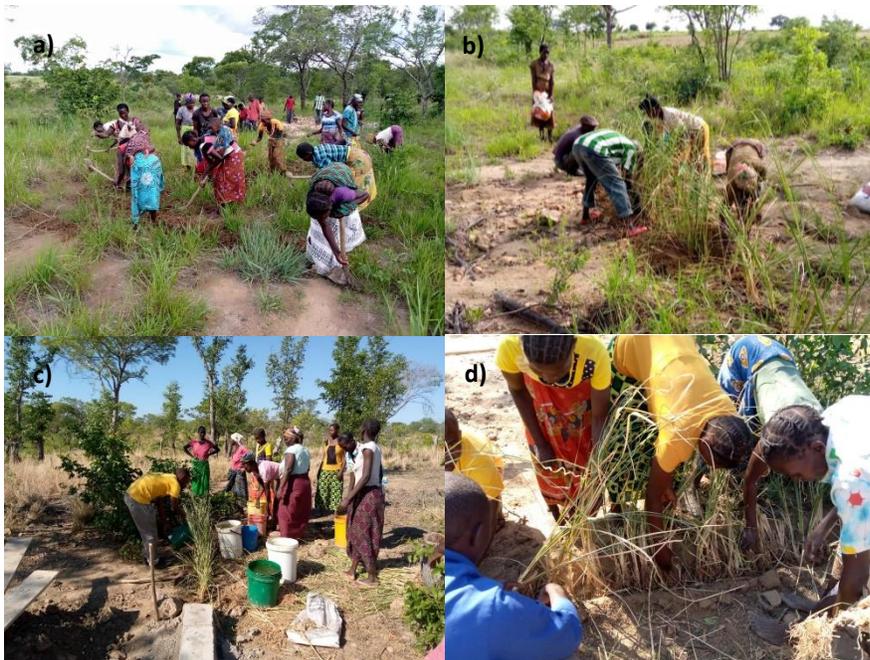
**Figure 9:** a) Women digging trenches for vetiver grass planting; b) planting vetiver grass along bank of sill; c, d) soaked vetiver being planted in contour trench dam spilling.

Vetiver grass (*Vetiveria zizanioides*) was planted adjacent to and upstream of the watercourse (Fig. 9). Vetiver was chosen because of its hardiness, quick ability to root, ability to withstand heavy flows, and proven non-invasive behaviour at neighbouring sites. 300 bundles were sourced from a private farm in the region. The bundles were planted closely along contour trenches following directions from the Ministry of Agriculture. Planting occurred in mid-January after the first rains to benefit from wet-soil and the longest possible duration for rooting prior to the

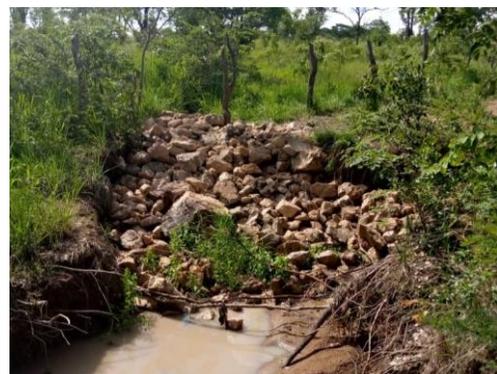
**Figure 11:** Plugged gully on dam spillway the

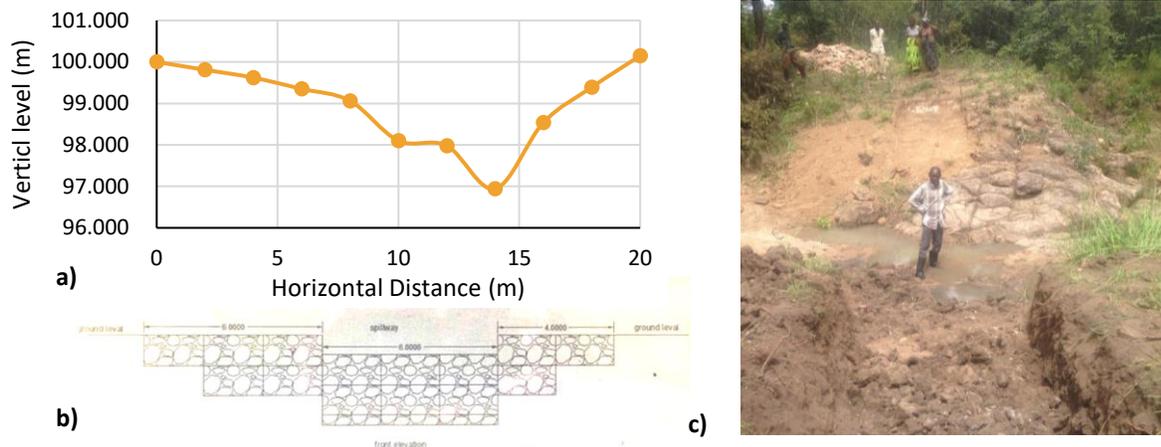
**Figure 14:** a) Stream-bank profile of the check dam site; b) profile-view of check dam design; c) Siandwazi headman standing on the stream-bed of the check dam site

After the delayed completion of Objective 1, it was agreed that once work on Objective 3 proceed rather than Objective 2. Construction of a small gabion check dam would be initiated to mitigate flood intensity, recharge local water tables, capture silt, and increase dry season baseflow. Work on the earth dam spillway finished in early March, so work started on the check dam by mid-March with the knowledge that it may or may not be installed in time for the last floods of the rain season. A stream-gradient survey was conducted to identify the most favorable location (narrow banks; solid, shallow bedrock; shallow upstream gradient; steep downstream gradient). This was found to be 40m upstream of the maximum throwback of the reservoir. A profile of the stream banks was performed using a builder’s level and a design was made by the local Water Engineer for the Department of Water Resources Development (Fig. 14a, 14b). Pre-made gabion baskets made of durable and corrosion-resistant material were sourced for the construction. Initial excavations and rock collection were conducted by the community (Fig. 14c). As of the writing of this report, the structure is awaiting environmental approval before proceeding.

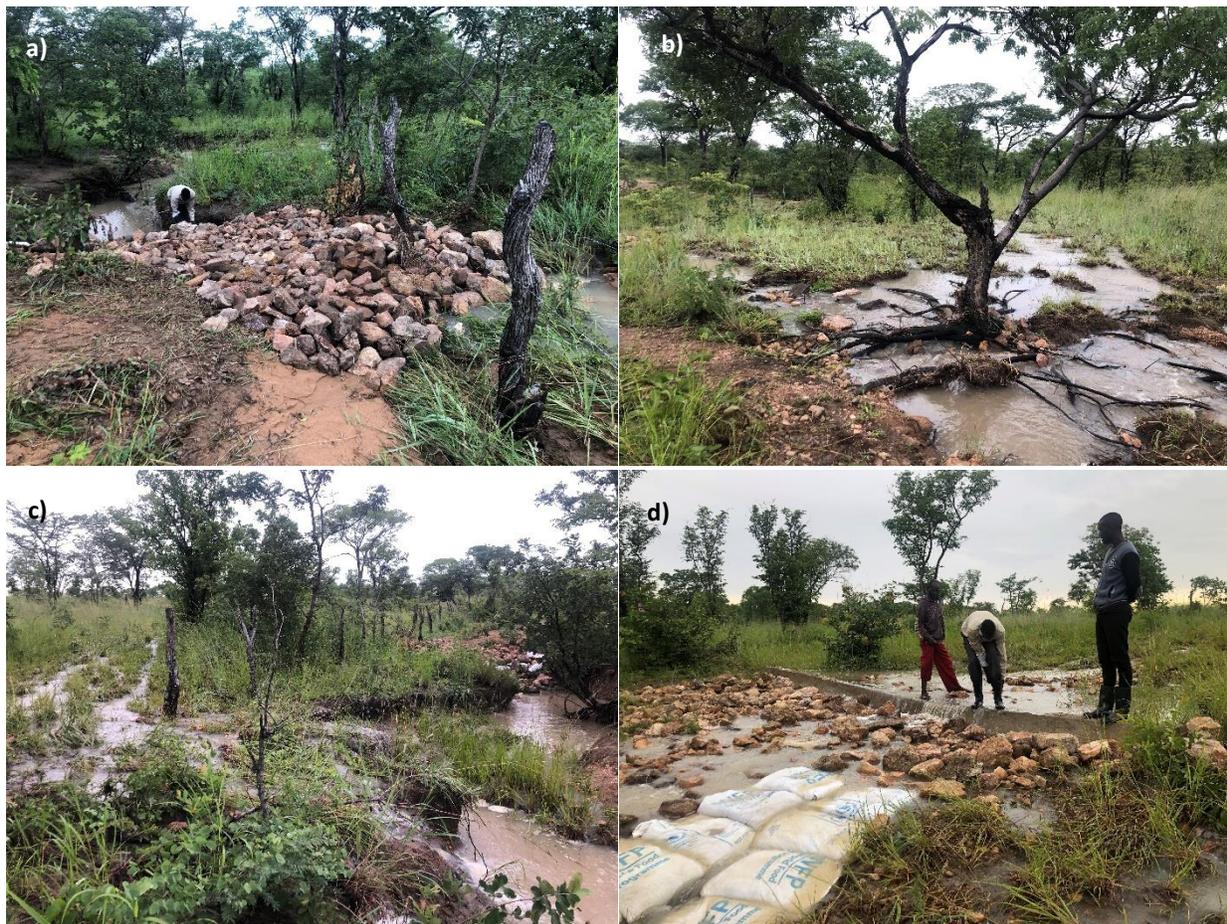
The rills and gullies which were protected remained stable throughout the largest floods of the 2018/19 season (Fig. 15a), but an additional estimated 2.1m<sup>3</sup> was eroded from unprotected sections. Most of this erosion occurred in a flat section of the spillway which was expected to have lower water velocities and be less erosion prone (Fig. 15b). Another example is near the bottom-most gully, where excess water was pushed to fall on an unprotected gully head (Fig. 15c). Surprisingly, this resulted in little soil loss as the bank remained stable until the community could respond with more rock. The sill performed generally well, and the erosion-prone area immediately downstream did not experience any new erosion (Fig. 15d). However, its wings were not extended long or high enough, so water could bypass the structure, threatening erosion. Most of the vetiver grass planted upstream of the main drainage was washed away due to the strength of the floods and limited rooting time, however the grass planted adjacent to the drainage rooted well.

**Figure 15:** a) Plugged gully at outlet of dam spillway; b) flat area of new erosion on unprotected land; c) overflow re-routing flowing over unprotected gully head; d) flood-spreading sill

Efforts to cease 10.5m<sup>3</sup>/yr erosion on the spillway were largely successful. Although roughly 2.0m<sup>3</sup> of soil was lost from unprotected areas, primary erosion-prone areas were stabilized using rock and sand-filled sacs. These protective measures withstood large flood events which damaged infrastructure across Southern Province, including a cement-engineered spillway on a neighbouring dam. The flood-spreading sill performed well, though measures must be taken to prevent water from circumnavigating the structure next rain season. Cuttings of vetiver helped stabilize the areas adjacent to the primary watercourse, however some cuttings were washed away in early floods. Planting next year should commence before the rains using hand watering to establish solid root systems prior early on.

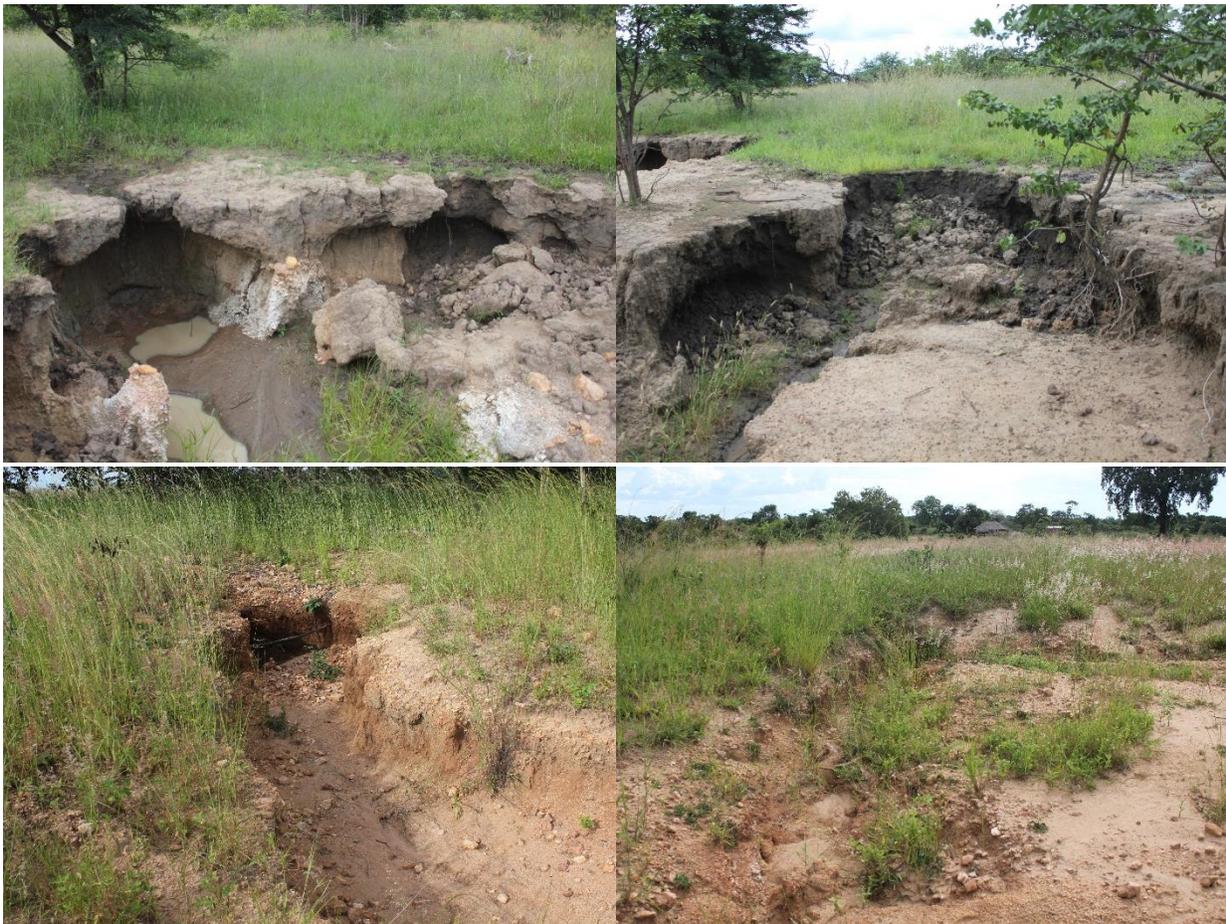
Since none of the planned activities in the eroding micro-catchment went forward, gullies and rills were exposed to floods and grew significantly. It is estimated that this soil loss is around 14.5m<sup>3</sup>. On the field responsible for the previous year's erosion, water followed the same concentrated pathway as the contours were not tilled and the previous down-slope furrows remained. The resultant soil loss manifested primarily as gully slumping at the bottom of the micro-catchment (Fig. 16a,b), however narrow gullies at the top of the watershed also deepened (Fig. 16c,d).

**Figure 16: a, b)** Advancing gullies at the bottom of the eroding micro-catchment; **c,d)** deepening gullies at the top of the eroding micro-catchment

The increase in erosion in the eroding micro-catchment is expected as there was more rainfall this year than last and no preventative or protective measures were taken. Although the land was not cultivated, it still maintained little vegetation cover due to an absence of productive root network from years of tilling. Cultivation could have increased the amount of infiltration by providing some vegetation cover and breaking up a compacted clay crust.

Efforts to prevent and protect against erosion in the eroding micro-catchment did not go forward due to the labour demands of protecting the spillway and drought-derived economic struggles. In combination with exposed gully heads and higher intensity rainfall compared to last rain season, the continued concentration of floods resulted in an increase in erosion from 12.0m<sup>3</sup>/yr to 14.5m<sup>3</sup>/yr. The same measures intended for this year should be prioritized prior to next rain season to prevent further advance of gullies into valuable season wetland. If appropriate and necessary, the farmer could be supported further to perform contour farming or another flood-management approach.
