Riparian Restoration and Erosion Stabilization of a Road Crossing near Richmond Lake Recreation Site

Prepared by Alisha Skelton

University of Victoria
Restoration of Natural Systems Program
ER 390 Final Project
December 4, 2020

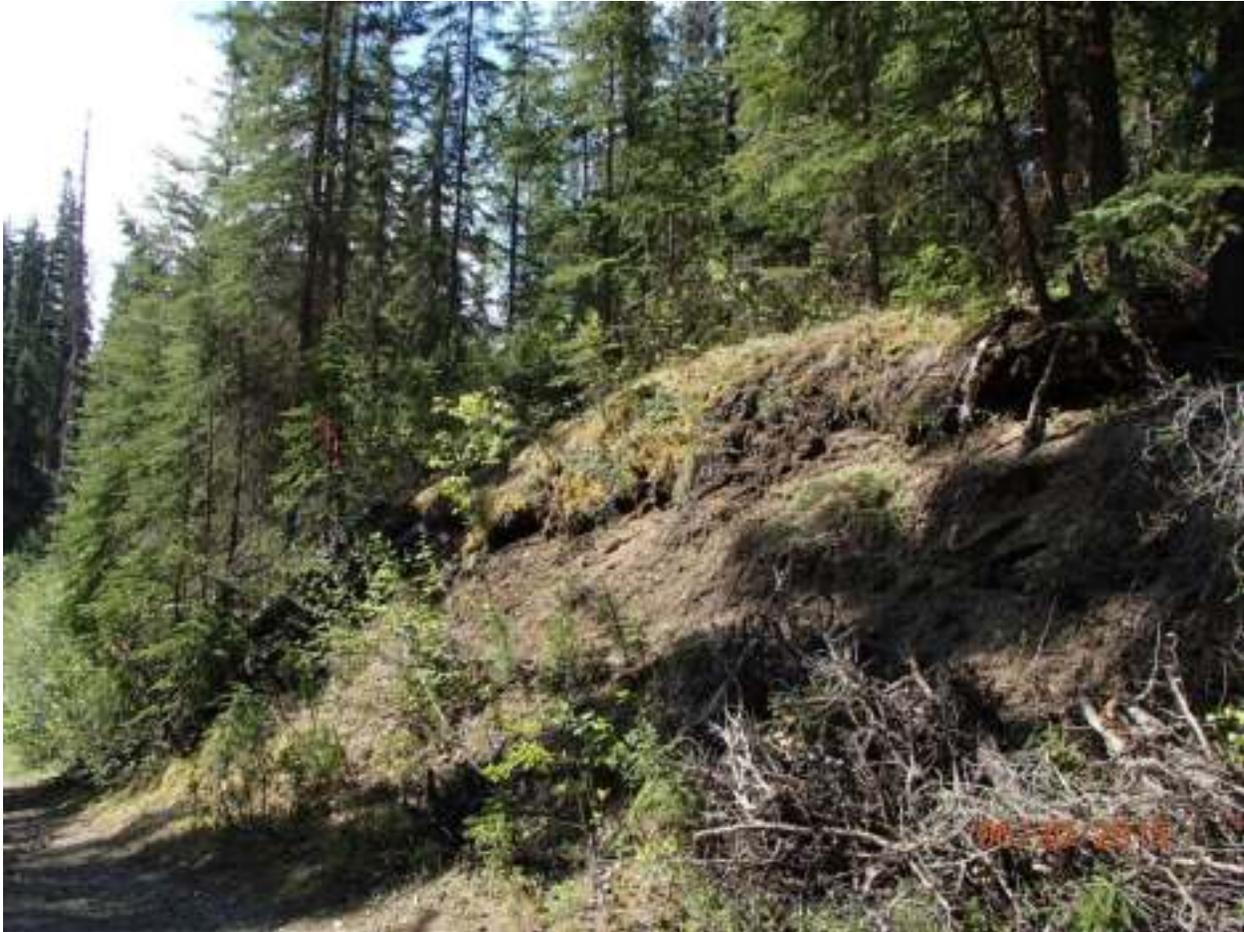
Figure 1- Pre-construction conditions at the stream crossing (2015)

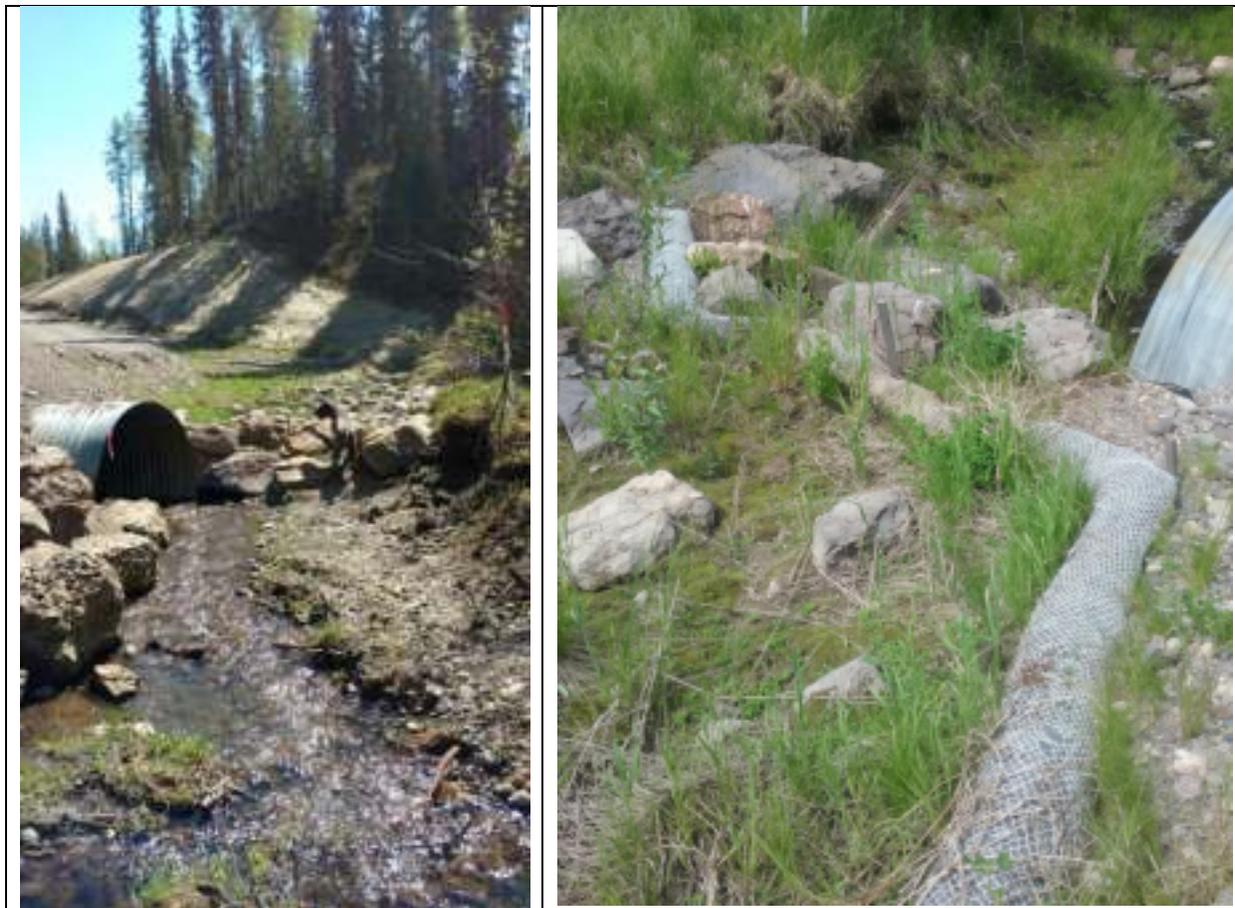
Standard engineering methods of rock anchoring, hay bales and grass seed were in place to mitigate erosion before the rainfall event (Fig. 3); however, the rain on the very fine soils caused the newly disturbed area to liquify and undermine the erosion prevention measures. The engineering officer then installed four fibre sediment logs on either side of the southern side of the stream, erosion blankets were installed on the exposed slopes, more stabilization pools were created for sediment settlement and the ditch-lines were armoured with small rock (5-10cm diameter) (R. Phillips, personal communication 2020). Despite these measures, soil erosion and sedimentation in the riparian area and stream continued. The damage done to the site required restoration to re-establish the natural draining pattern. In 2018, I began to plan further work, in collaboration with Nadina District Ministry of Forests, Lands, Natural Resource Operations and Rural Development (FLNRORD) engineering staff, around the stream at the road crossing where soil erosion was an issue.

Figure 3- Standard engineering rock anchoring and fibre rolls at stream crossing

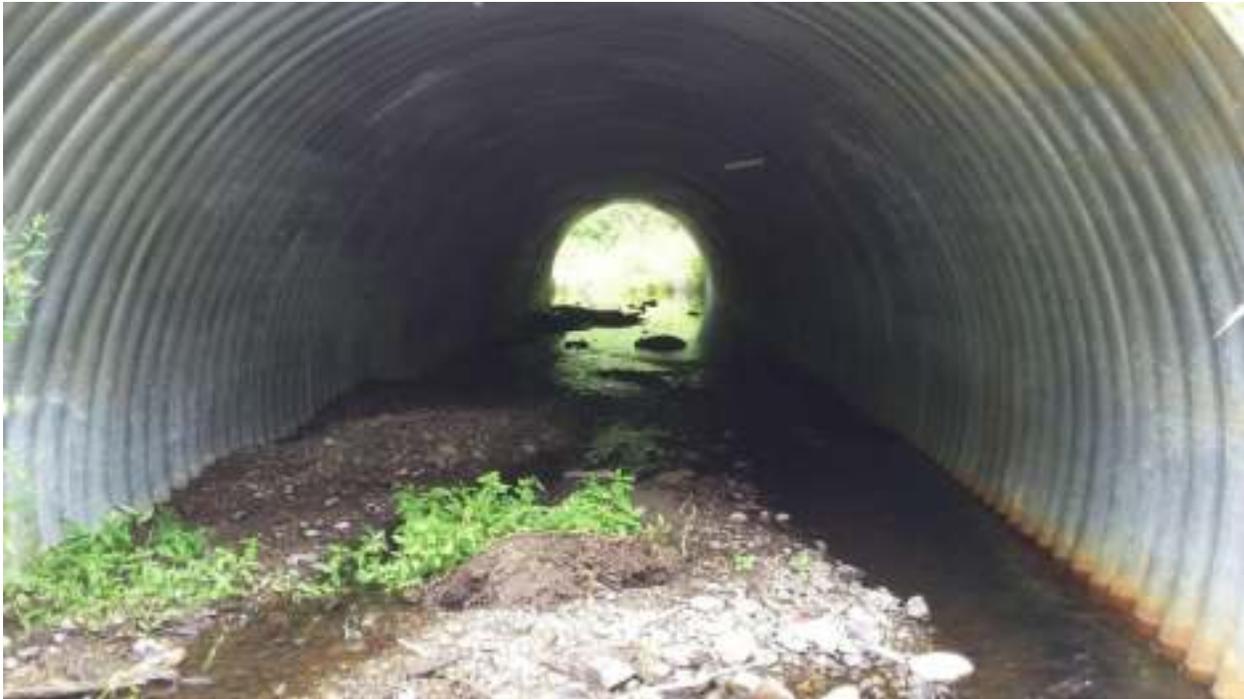
Figure 4- Sedimentation in stream

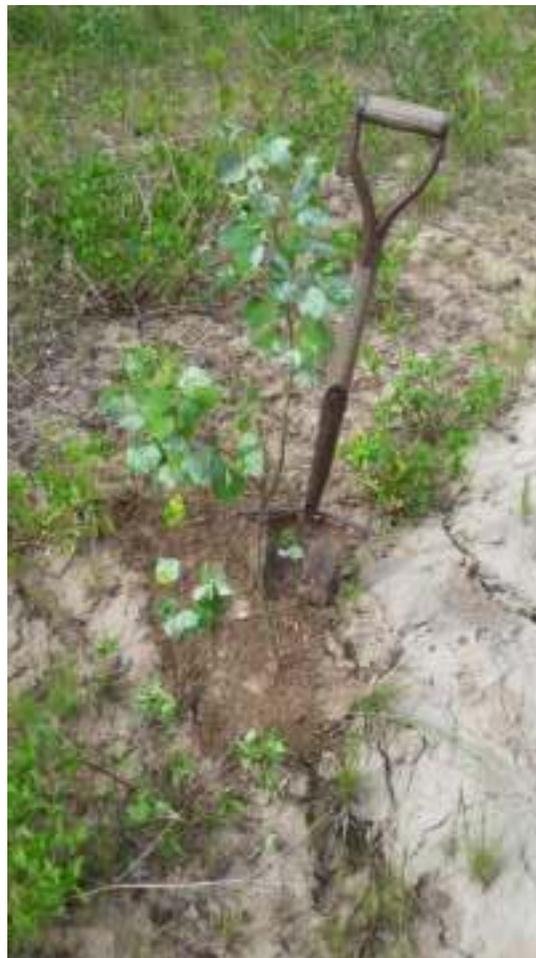
Figure 8– Trembling Aspen transplant

<ul style="list-style-type: none"> ○ Transplanted 32 aspen suckers along hillslope on south side of road, in between the whitebark pine and spruce seedlings (Fig. 8) ○ Completed a slope stability assessment for polygon 1: hillslope ○ Removed oxeye daisy, yellow hawkweed and bull thistle from roadsides and disposed of at landfill (Haaeussler, 2015; Ralph et al., 2017) 	<p>June 23, 2019</p>
<ul style="list-style-type: none"> ○ Re-seeded entire disturbed portion of the project area with a 20 kg mix of grass seed recommended for the area to further manage the erosion of the cut bank and to prevent the spread of invasive and noxious plants. Not all of the seed species were native, rather they are non-invasive and were designed to manage erosion. The mix was composed of 35% annual ryegrass, 25% perennial ryegrass, 30% creeping red fescue and 10% red clover with an additional micronutrient fertilizer (Zuazo and Pleguezuelo, 2008) ○ Cut live willow stakes from wetland and planted in the areas most impacted with sediment near the stream in order to help slow down and filter water and sediment before reaching the stream as well as hold the existing soil in place. The cuttings were between 30-50cm in length and were buried in the wet silt in the riparian area around the stream ensuring that some of their buds or branches were buried in the ground to take root (Fig. 9). Cuttings were planted in groups of 2-4 for better coverage of drainage pathways to the stream (Alaska Dept. of Fish and Game, n.d.; Redfield, 2010). 	<p>June 24, 2019</p>

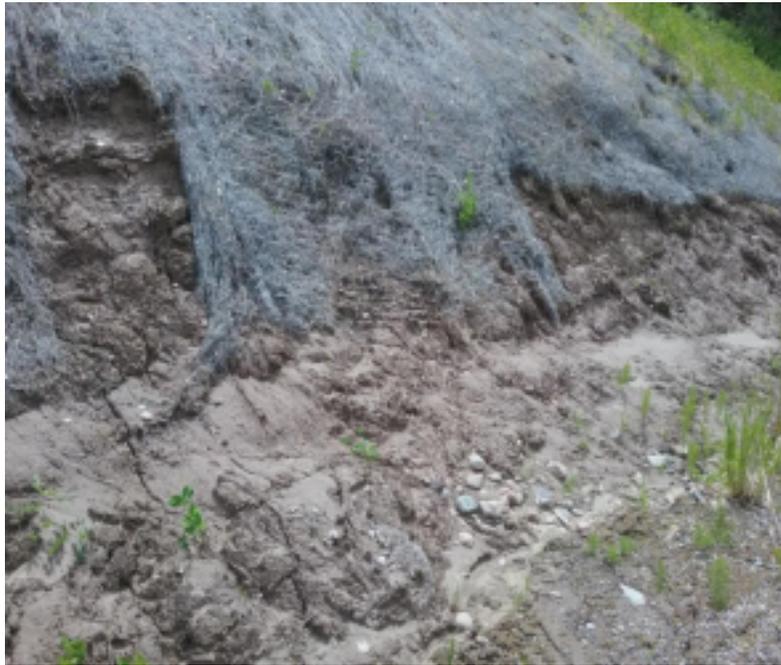
A slope stability assessment was completed in polygon 1 since there was evidence of past and current erosion at the project site. The slope in polygon 1 is moderately steep (67%) to very steep (133%), this combined with very fine exposed soils and damaging rain events has led to widespread gullying of the hillslope and soil slump (figs. 10 & 11). There is some water seepage in the hillslope that also contributes to soil movement. These factors indicate stability concerns and a high landslide hazard risk, so addressing the hydrology of the site and stabilizing the soil in this polygon was prioritized (Chatwin, 1994). This was done by establishing suitable vegetation (Bornsworth, 2015) to address erosion and mitigate further damage to the hillslope, as well as

Figure 10– Soil erosion at the project site, June 2019

Tree planting and grass seeding in June appeared to reduce the amount of erosion occurring on the slopes and the amount of sediment being carried downslope to the stream. Ongoing monitoring of the slope will need to occur to determine if more work is needed.

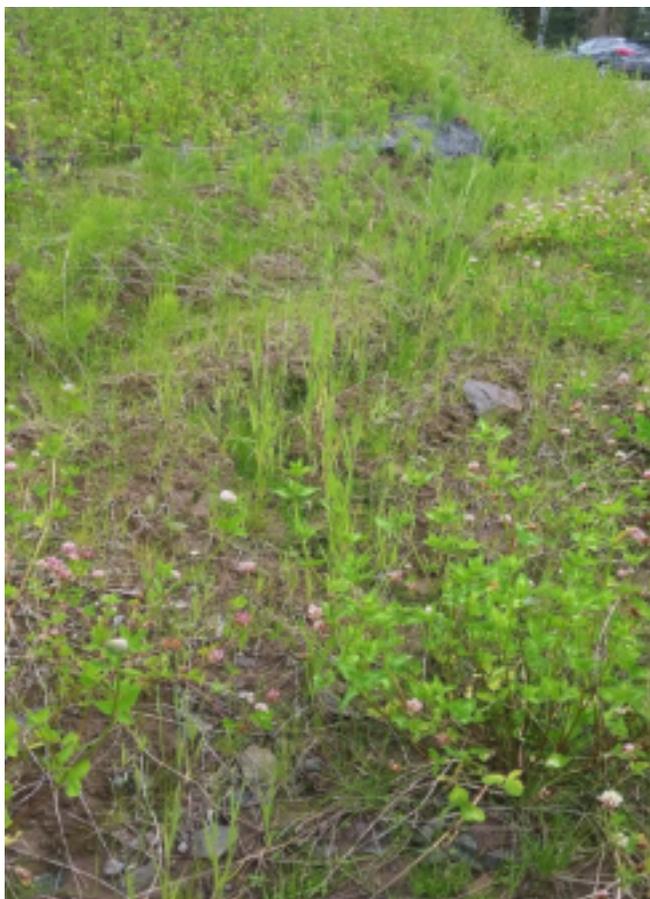
Figure 11– Same location post grass seeding and rainfall, July 2019

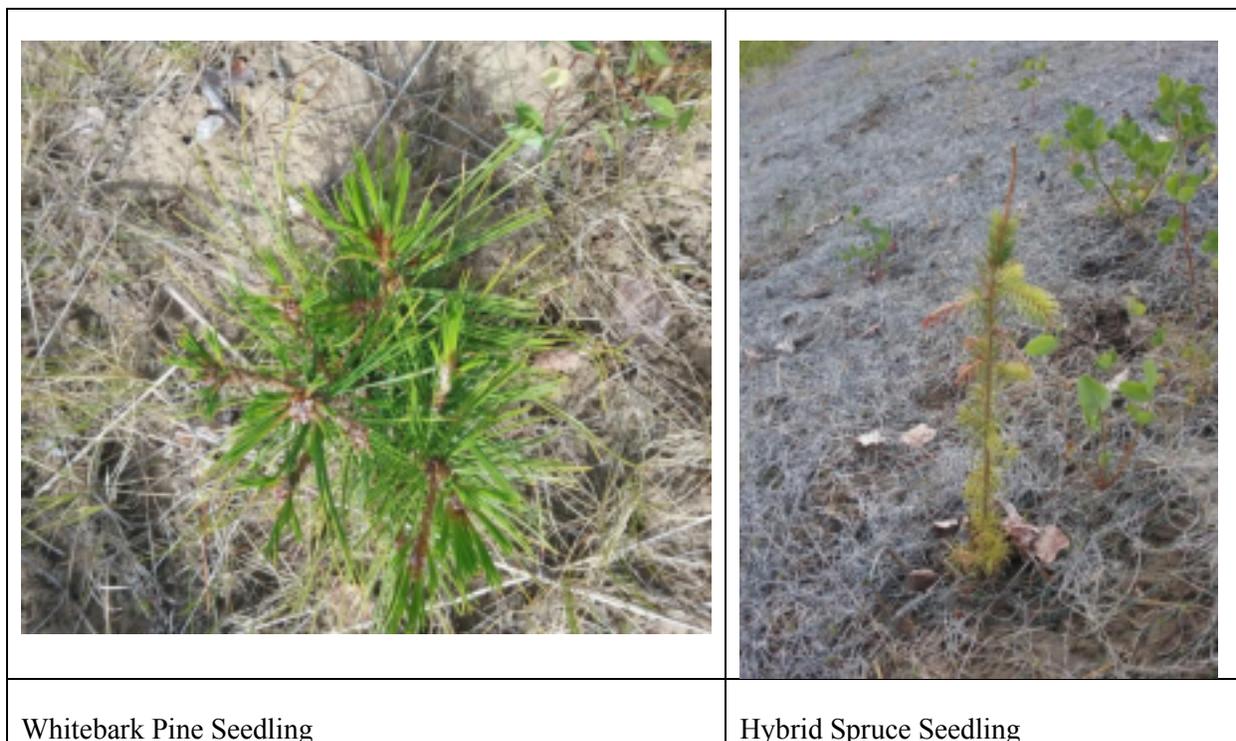
The tables below show that the whitebark pine is growing the best with the least trees showing stress. Despite this site being outside of their traditional range due to elevation, they are the healthiest seedlings and showed evidence of new growth (Fig. 12). The hybrid spruce seedlings struggled in their first year, likely due to the late season planting and a dry summer in 2018, since I was not able to irrigate the site. My second site survey in July 2019 showed both the spruce and pine were less yellow as there had been more precipitation that spring than the year before. The aspen suckers I transplanted in June had mostly died by July. They did not get

Figure 12– Typical condition of planted seedlings, June 2019

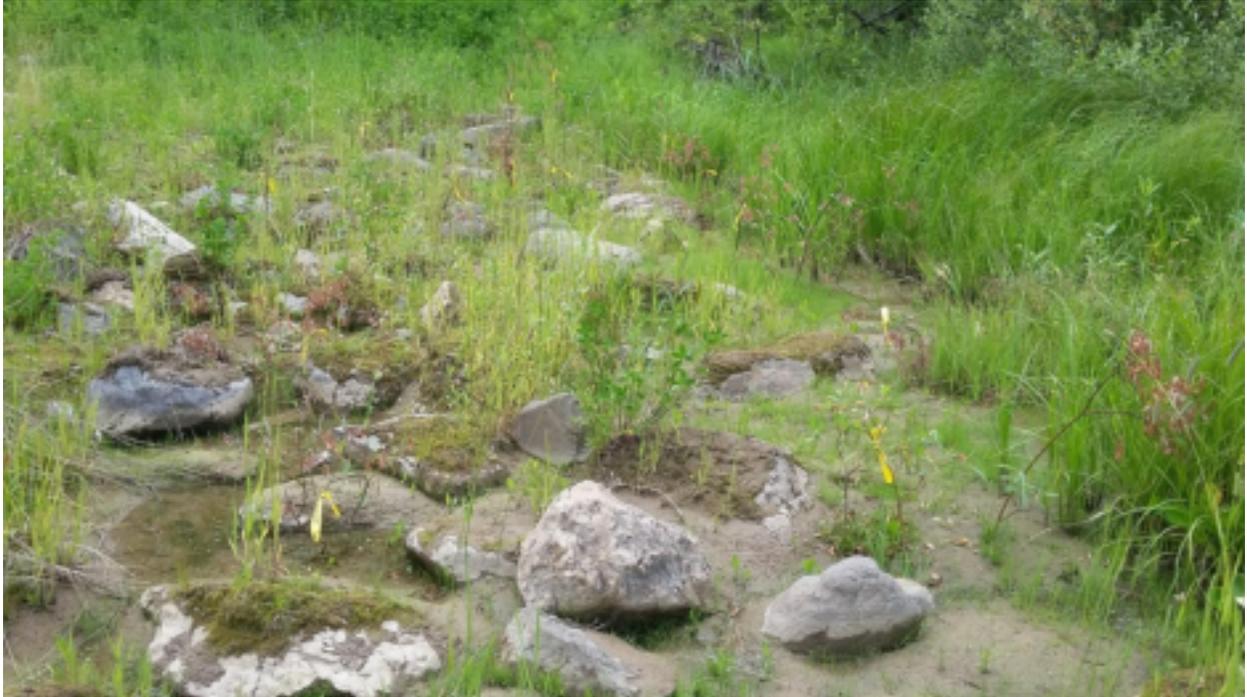
adequate water to re-root on the hillslope and I could not irrigate. The willow had an almost 65% survival rate and new shoots were forming less than a month after planting (Fig. 13). It is possible more willow staking could be done depending on how many transplants survived over 2020. These results and the presence of natural spruce regeneration lead me to think that planting will not need to occur again, especially as natural aspen, spruce and many local plant species are finally starting to recolonize the site (Fig. 14).

Figure 13– Live willow stakes in riparian (flagged yellow), July 2019

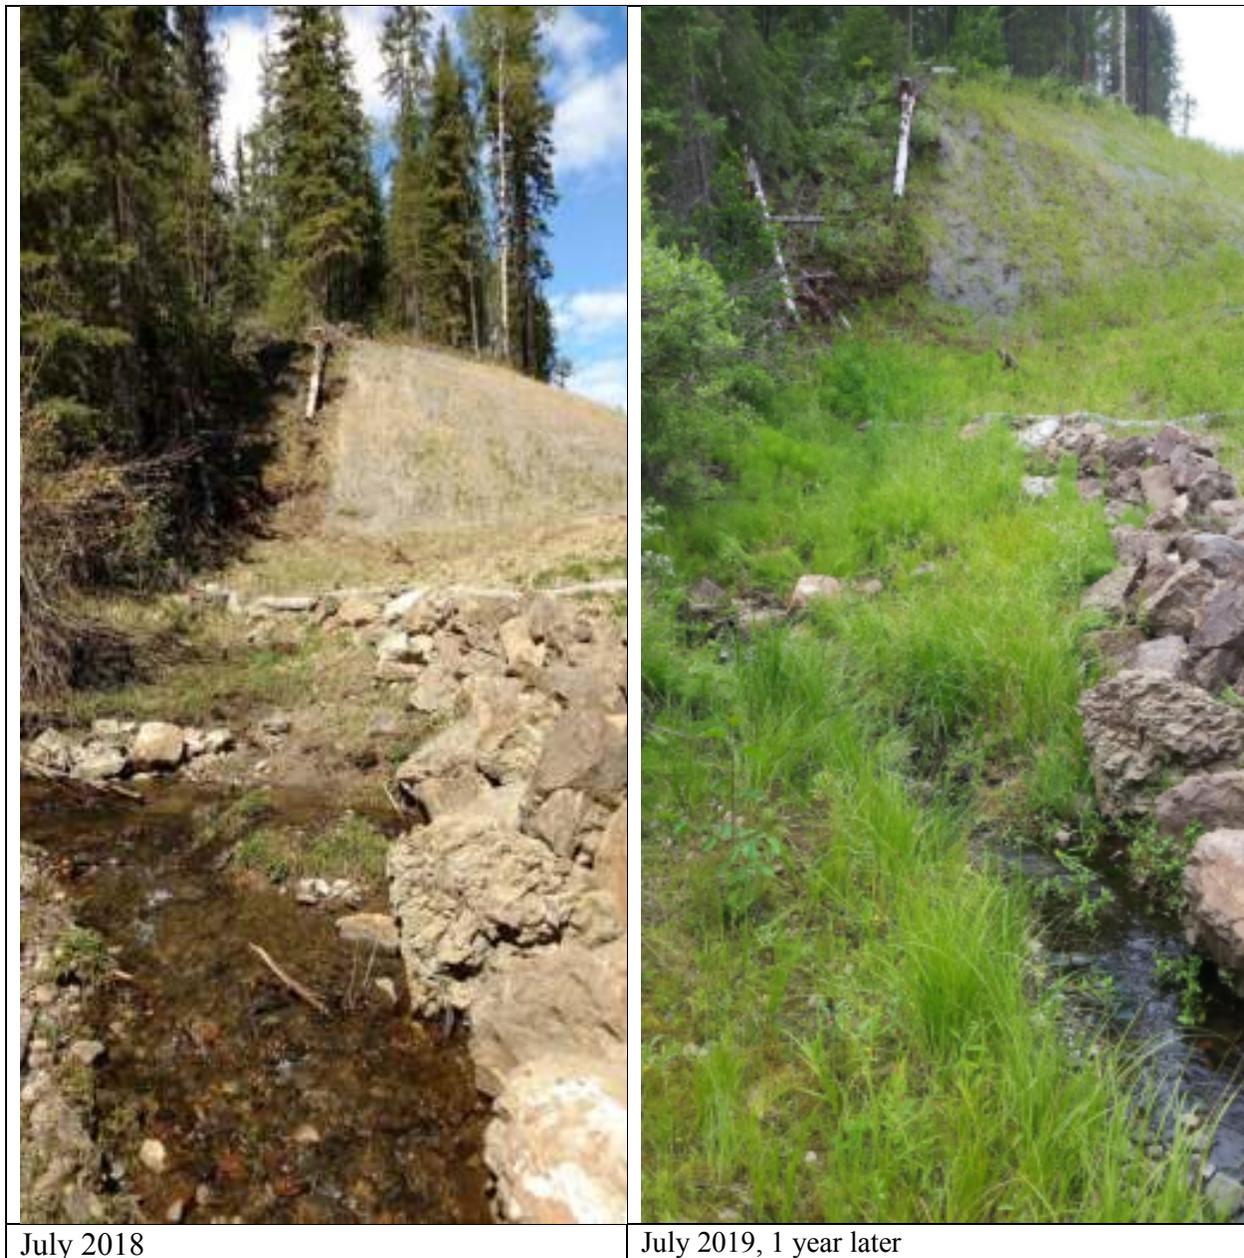
Figure 14- Polygon 2 pre and post grass seeding and tree planting
