Restoration of a Mountain Bike Trail, Three Blind Mice Trail Network, Penticton, British Columbia

**Todd Redding
ER 390 Final Paper
July 28, 2017**

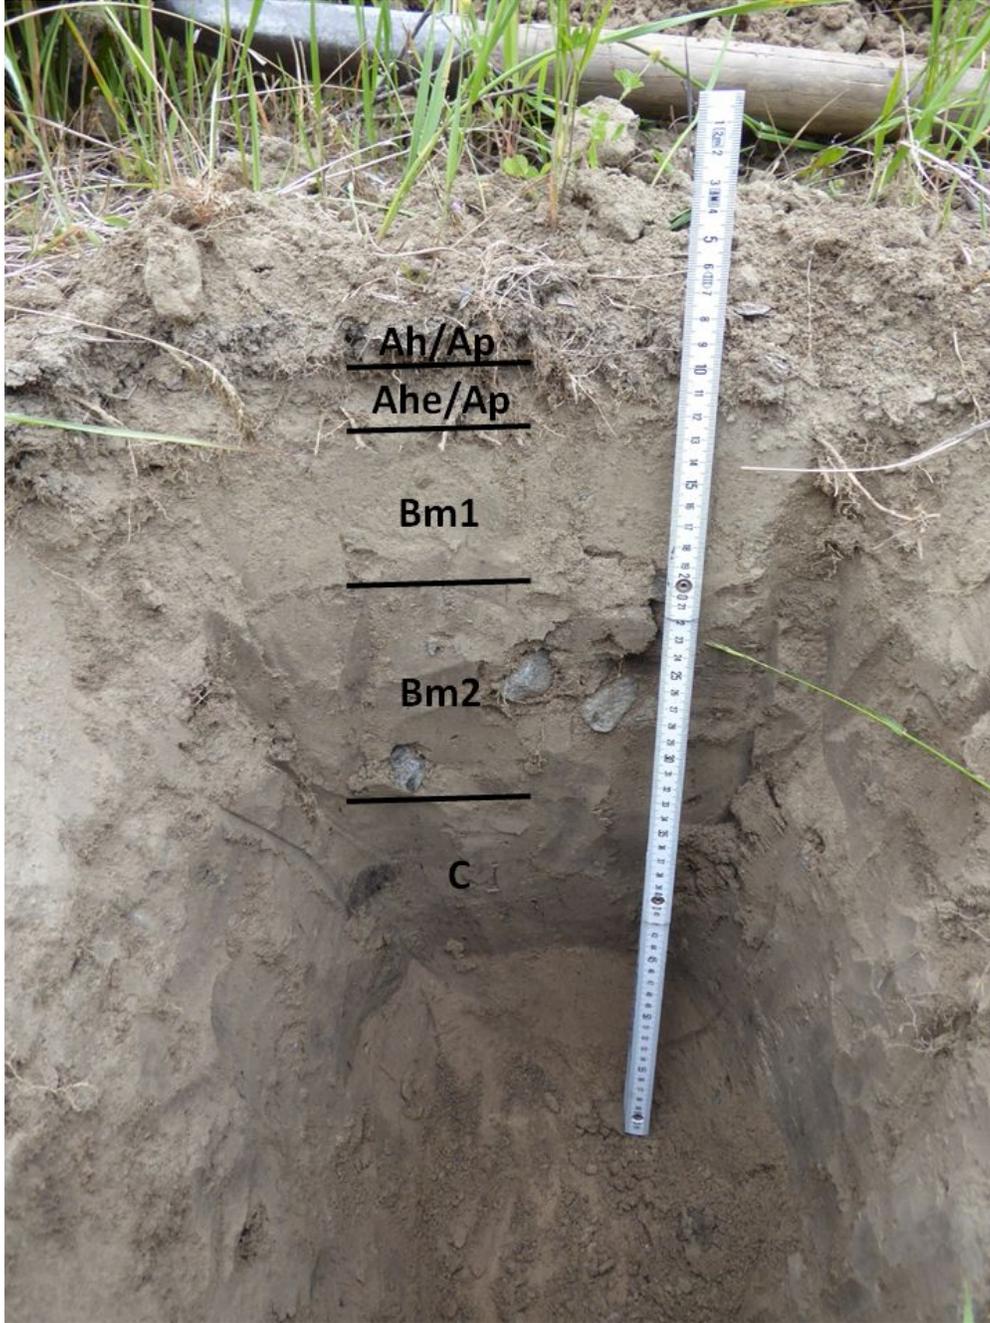
A soil pit was completed in June 2017 adjacent to the restored trail tread (Figure 8). At the time of the measurements, the soils were very dry. The soil properties described were:

The coarse texture of the soils on this site make them at low risk for significant compaction but at high risk of surface erosion due to the lack of cohesion between the grains (Hillel 1982).

Figure 8. Soil pit with horizons shown. See section 2.1.4 for horizon descriptions. (Photo: T. Redding)

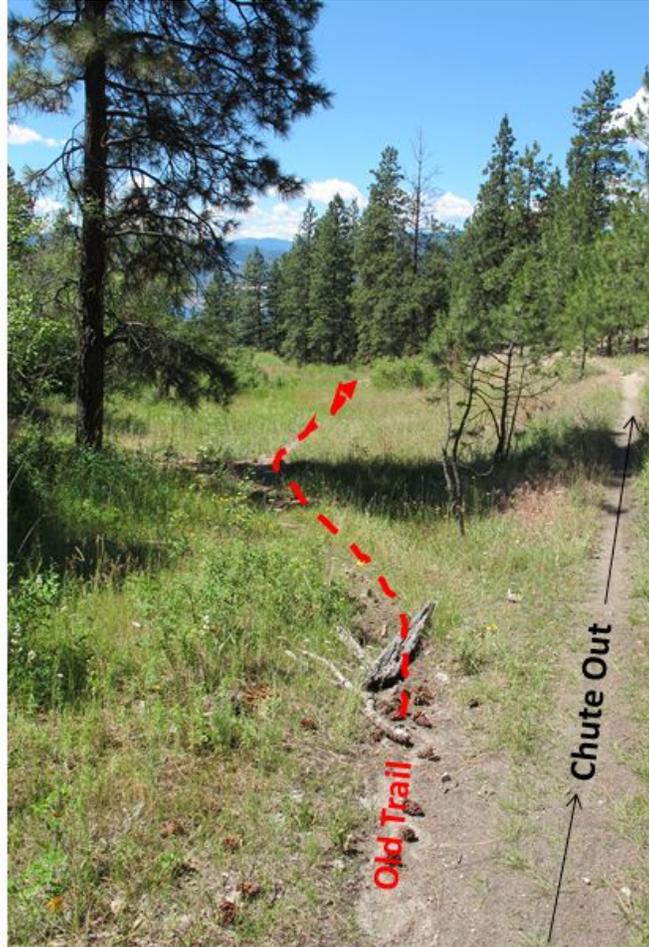
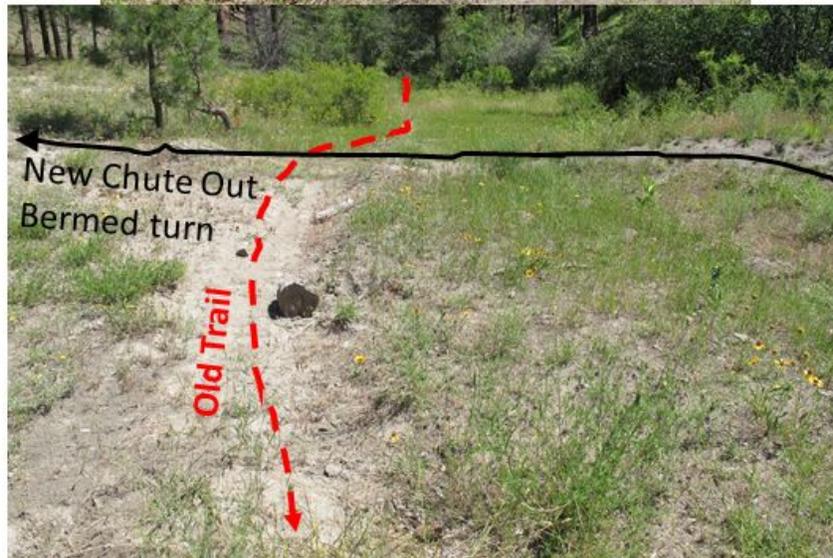
Prior to this project, no restoration work had been carried out on this trail segment (Figures 9 & 10). The field work to carry out the restoration treatments was completed in September 2016. Restoration of the trail tread followed the process outlined by IMBA (No Date), Therrell et al. (2006) and PCTA (2011) included the following steps:

Figure 9. Pre-restoration site photos showing orientation of decommissioned trail segment and newly constructed trail. Top image shows intersection where new trail segment diverges from segment being restored. Bottom image shows path of section being restored and crossing of the newly constructed Chute Out s-curves and berms. (Photos: T. Redding)

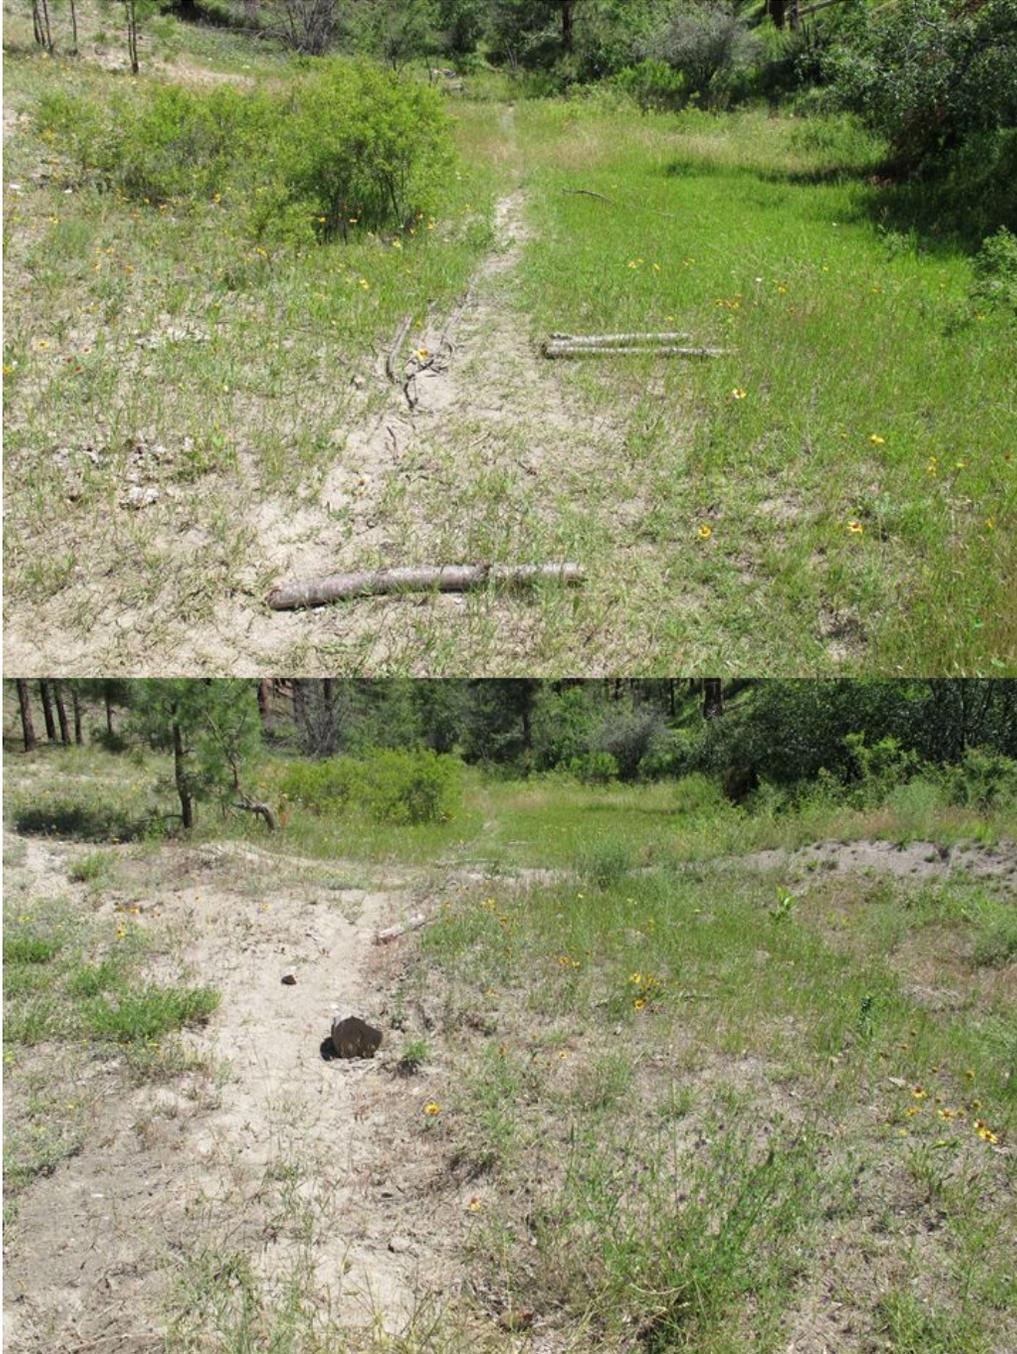
Figure 10. Pre-restoration photos of trail tread. Note slight depression of the tread relative to surrounding ground surface and small accumulations of sediment. A few large pieces of wood have been scattered through the area to discourage trail use. (Photo: T. Redding)

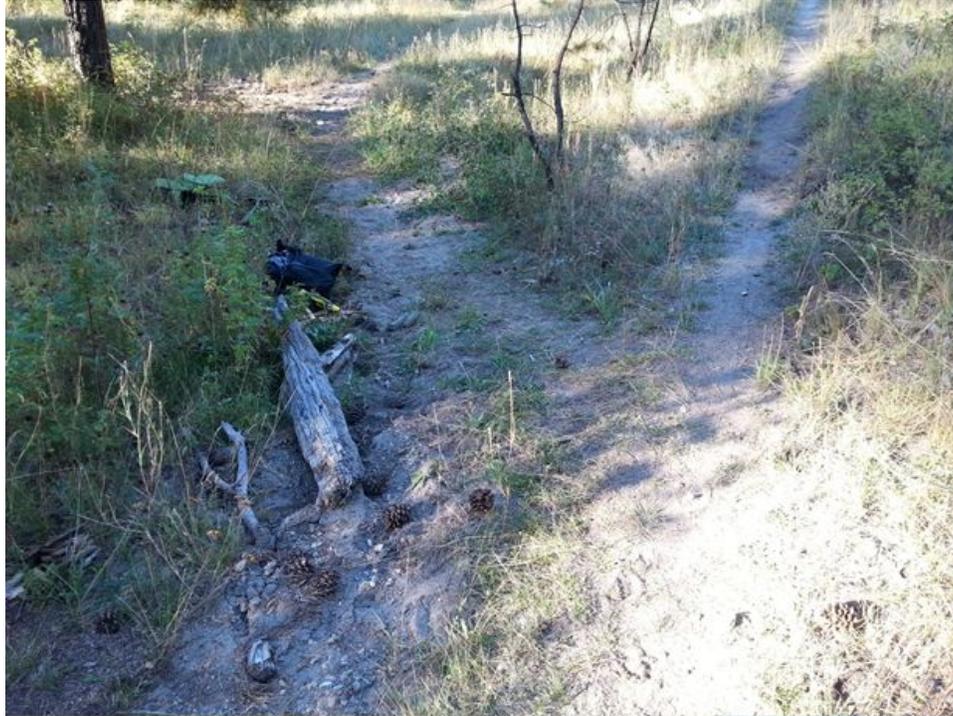
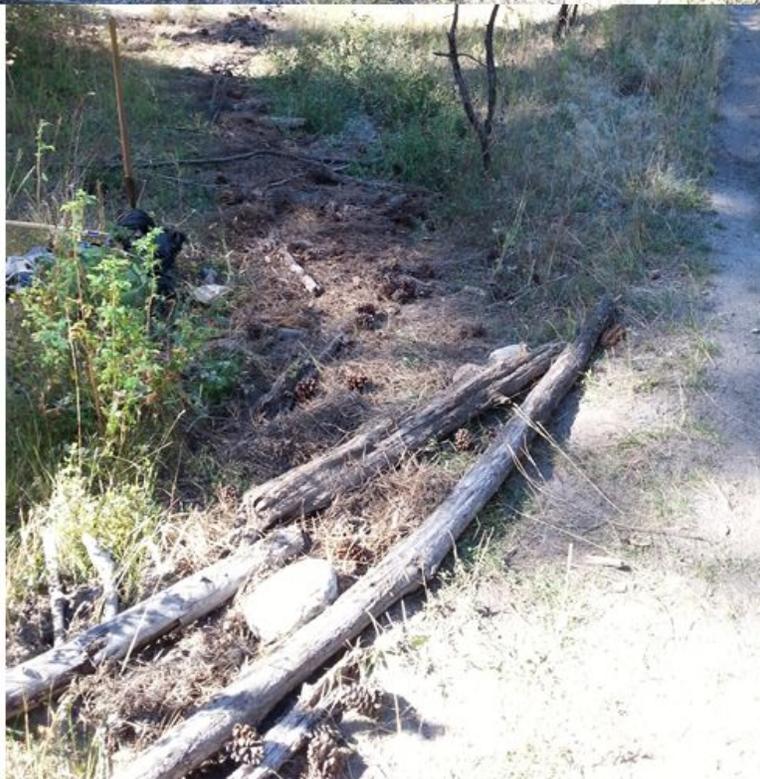
Step 1. The intersection of the trails had been not been blocked prior to the initiation of this project (Figure 11) and there was evidence (tire tracks) of continued use of the trail segment. To make it obvious which trail to follow, logs and rocks were placed across the intersection (Figure 11). The obstacles served a dual purpose of re-routing and bike traffic along with creating a catch-basin feature to contain sediment eroded from the lower ends of the Chute Out trail.

Figure 11. Junction between decommissioned and new segments of Chute Out. Upper photo shows intersection prior to restoration and the lower photo shows post-restoration treatment with organic material spread over the decompacted trail tread. In lower photo note the presence of logs and rocks to disguise and discourage use of the trail and capture and store any sediment running down Chute Out.. (Photos: T. Redding)

Step 3. To control erosion, a barrier was placed at the intersection with the upslope trail to slow water movement, encourage infiltration and contain any sediment washing in at the intersection (Figure 11). Along the trail tread, the soil was decompact manually through digging and then raked to break-up large peds and clods. Once the soil was decompact, rocks and organic matter consisting of branches, wood, cones and pine needles were placed on the surface. These materials act as water flow barriers, camouflage the decompact trail tread and add habitat diversity to the ground surface. These additions of plant matter covered approximately 30% of the decompact soil surface and act as a source of organic matter to the soil as they break down.

Step 5. As covered above, the trail junction was blocked using wood and rocks (Figure 11). In addition, wood and rocks were placed on the decompacted trail tread (Figure 13) to disguise the feature, act as a water diversion feature, sediment collection and provide a diversity of habitat for plants and animals.

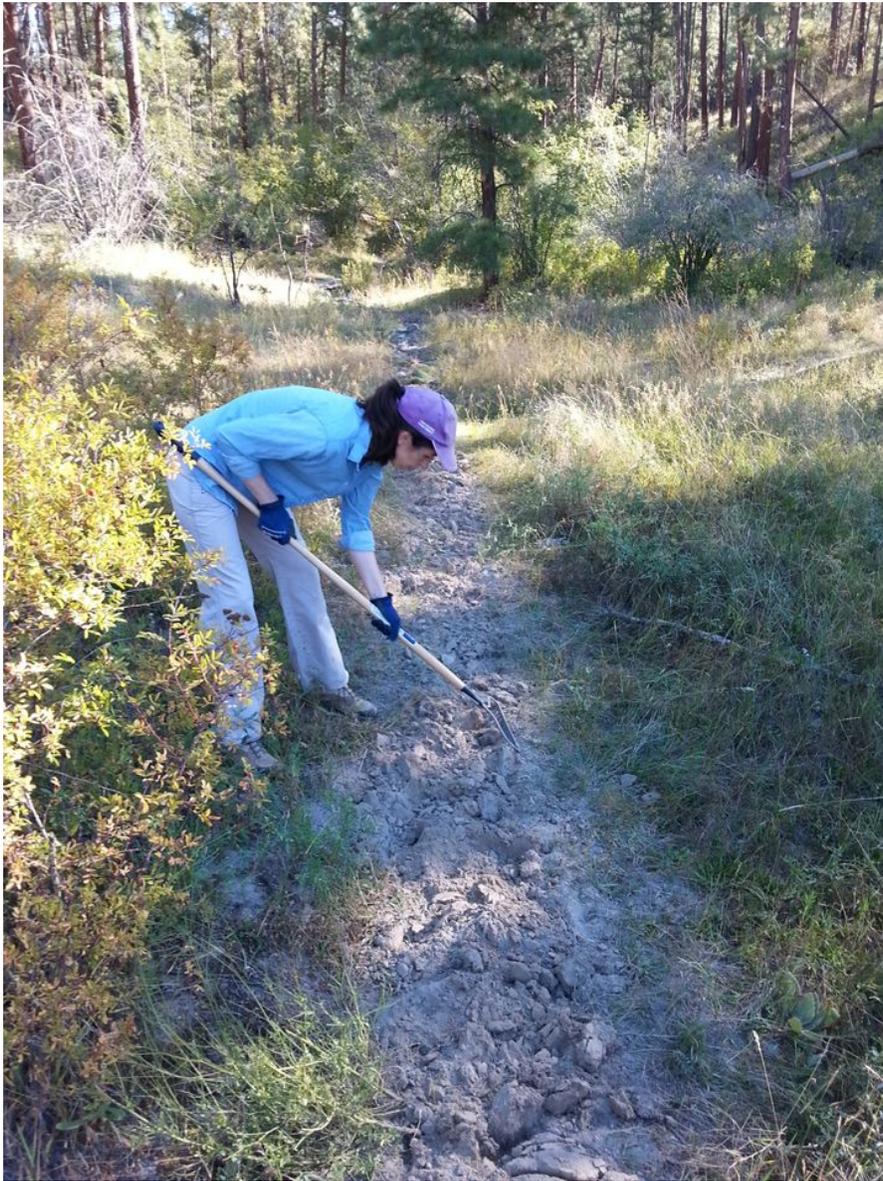
Figure 12. Decompaction of trail tread. The trail tread was manually decompacted by digging followed by raking to break-up large clods. (Photo: T. Redding)

Step 2. The tread of the old trail was manually decompact using a shovel and rake (Figure 12). The decompaction is intended to reduce the soil density, to improve drainage and facilitate root penetration. If the soil is not decompact, there is a greater potential for surface erosion (Marion and Wimpey 2007). The sandy nature of the soil means the amount of compaction was limited. The sandy soil and few coarse fragments meant relatively easy manual decompaction. Improved drainage will act to reduce the potential for soil erosion.

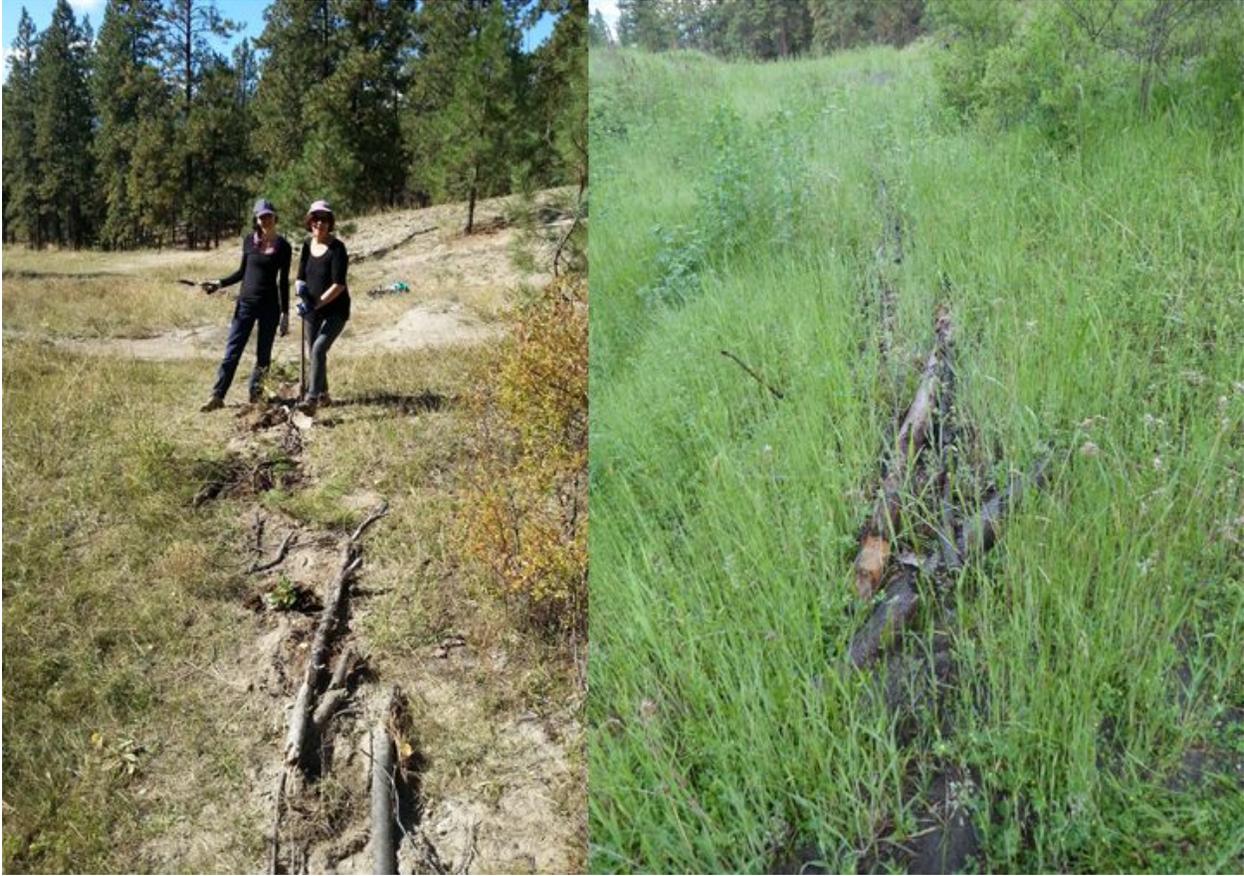
Plant cover of the trail tread increased from pre-restoration to post-restoration. Canopy cover increased from <5% pre-restoration to approximately 40% post-restoration (Figure 13). Increased vegetation cover will assist with reducing erosion potential by protecting the soil surface from raindrop impacts and the roots holding soil in place. As plants are established they will provide increased inputs of organic matter that will improve water holding capacity of the soils to further support plant growth.

Figure 13. Changes in vegetation cover from fall 2016 (left image, immediately post-transplanting) to spring 2017. (Photo: T. Redding)

Step 4. Native vegetation was transplanted onto the trail tread following the manual decompaction (Figure 13). Plants were taken from adjacent undisturbed sites, with the areas they were removed from re-covered with soil and organic litter. The species transplanted included rose, oregon grape, bluebunch wheatgrass, saskatoon berry, rabbitbrush and yarrow. Plants were spaced between 2-2.5 m along the decompacted tread. Given the dry conditions, plants were manually irrigated with approximately 1L each of water at the time of planting and twice more at weekly intervals late September and early October 2016. It was difficult to

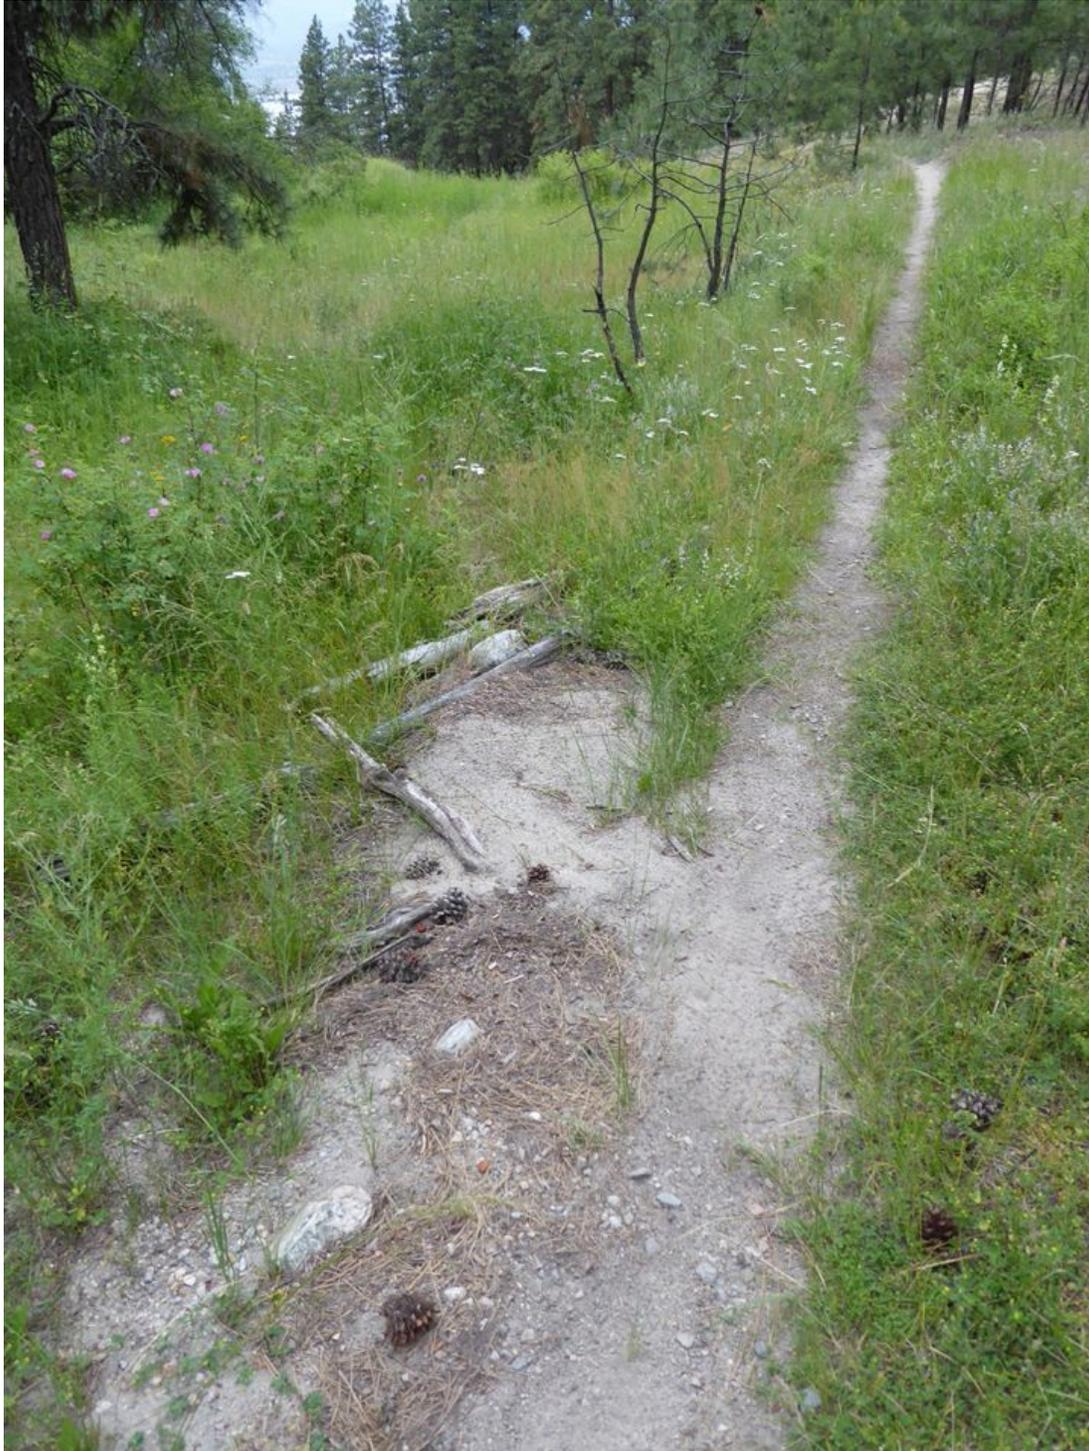
The logs and rocks placed across the intersection with the new Chute Out trail were successful in collecting and containing sediment running down the trail tread (Figure 14). There was no evidence of surface erosion on the decompacted section of trail tread.

Figure 14. Junction between Chute Out and restored trail in June 2017. Note the thick vegetation cover along the restored trail tread. Also note the accumulation of sediment at the junction that was deposited following snow melt and spring rain storms. (Photo: T. Redding)

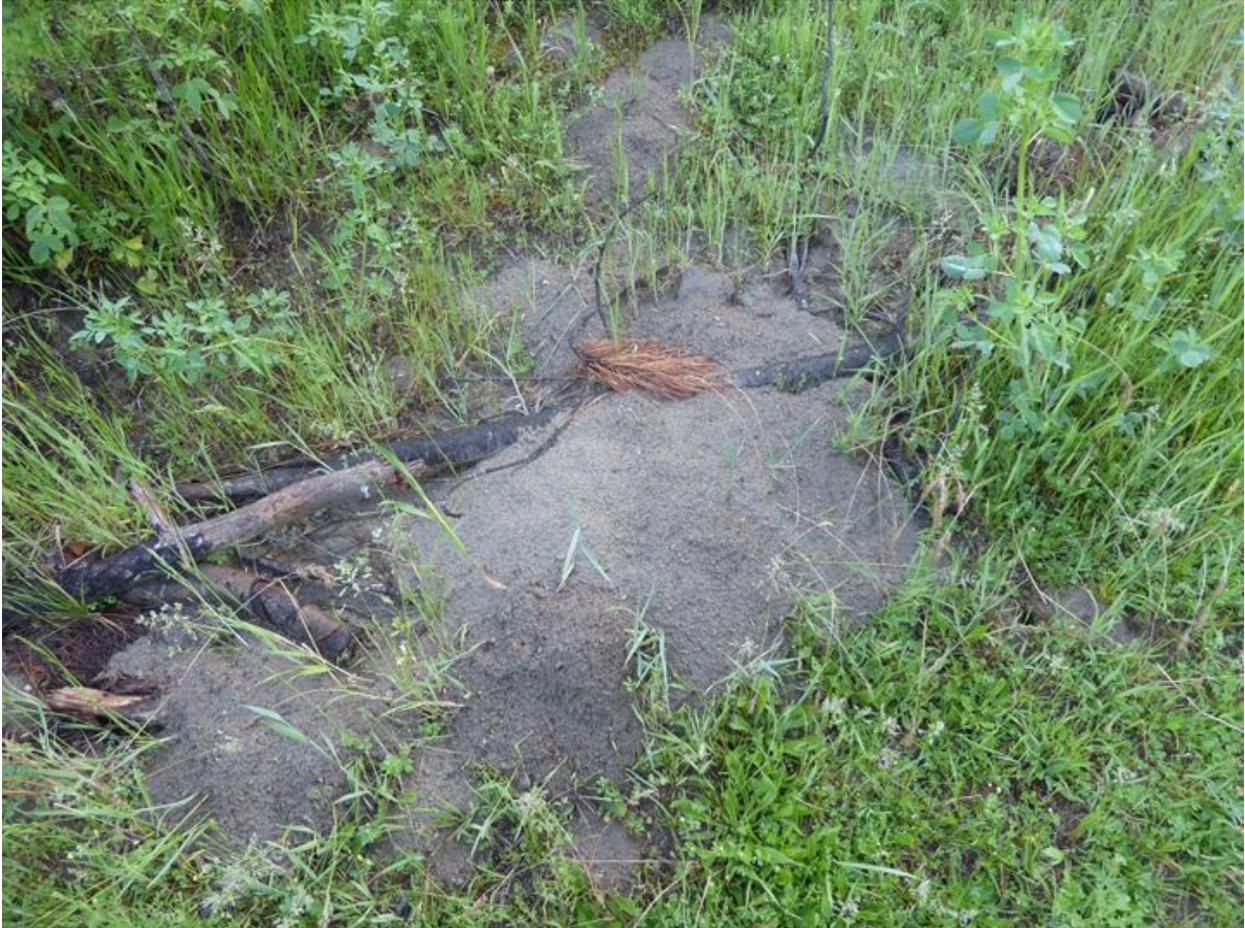
Figure 15. Piles of sediment from ground squirrel activity during winter 2016/17. Note agronomic grasses growing along former trail tread and through sediment pile. (Photo: T. Redding)
