Riparian Restoration of KÉLSET Creek

ER390 Capstone Project

University of Victoria

April 15, 2026

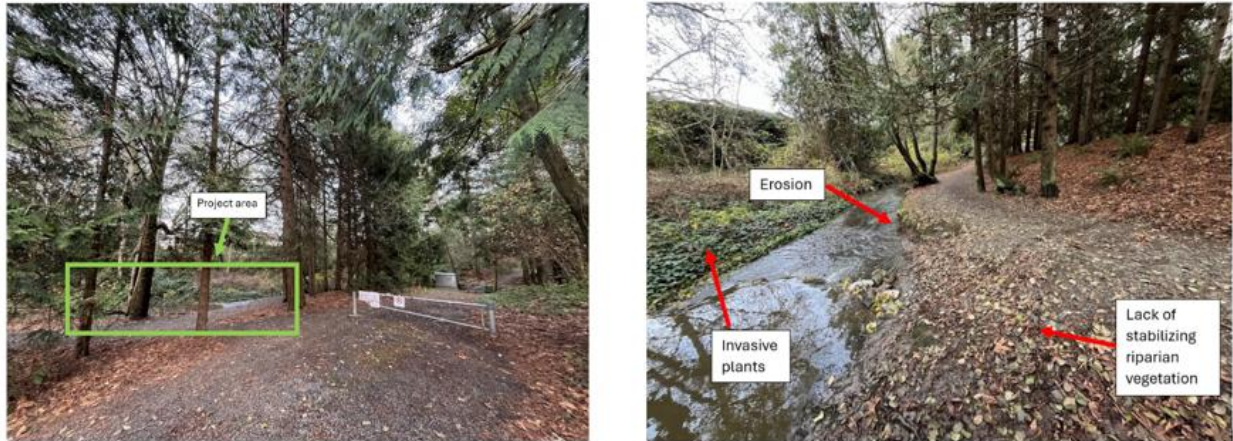
The project site was identified by PSS as a restoration priority due to highly compacted soils, eroding stream banks, and riparian areas sparse in native vegetation and abundant in invasive species (Figure 2). To mitigate these issues, it was initially proposed that the trail running directly adjacent to the target section of creek be decommissioned. By removing the impact of foot traffic, the soil could be decompact and a wider area of bank could be planted with deep-rooted native vegetation that would help stabilize the eroding bank.

Figure 2. The project area (green box) as seen from the Frost Ave (west) entrance of Reay Creek Park relative to the vehicle access trail (left); key ecological issues identified at the project area (right). Photos taken in November 2024.

Decommissioning the streamside trail was proposed as an option because park users would still have use of the vehicle access trail running parallel to the streamside trail. However, consultations with the Town of Sidney yielded the conclusion that the streamside trail must remain for accessibility reasons. The restoration plan could however move forward with planting a narrower strip of riparian area on the right bank next to the streamside trail, invasive plant removal and native planting on the left bank, and the installation of split rail fencing around the project area.

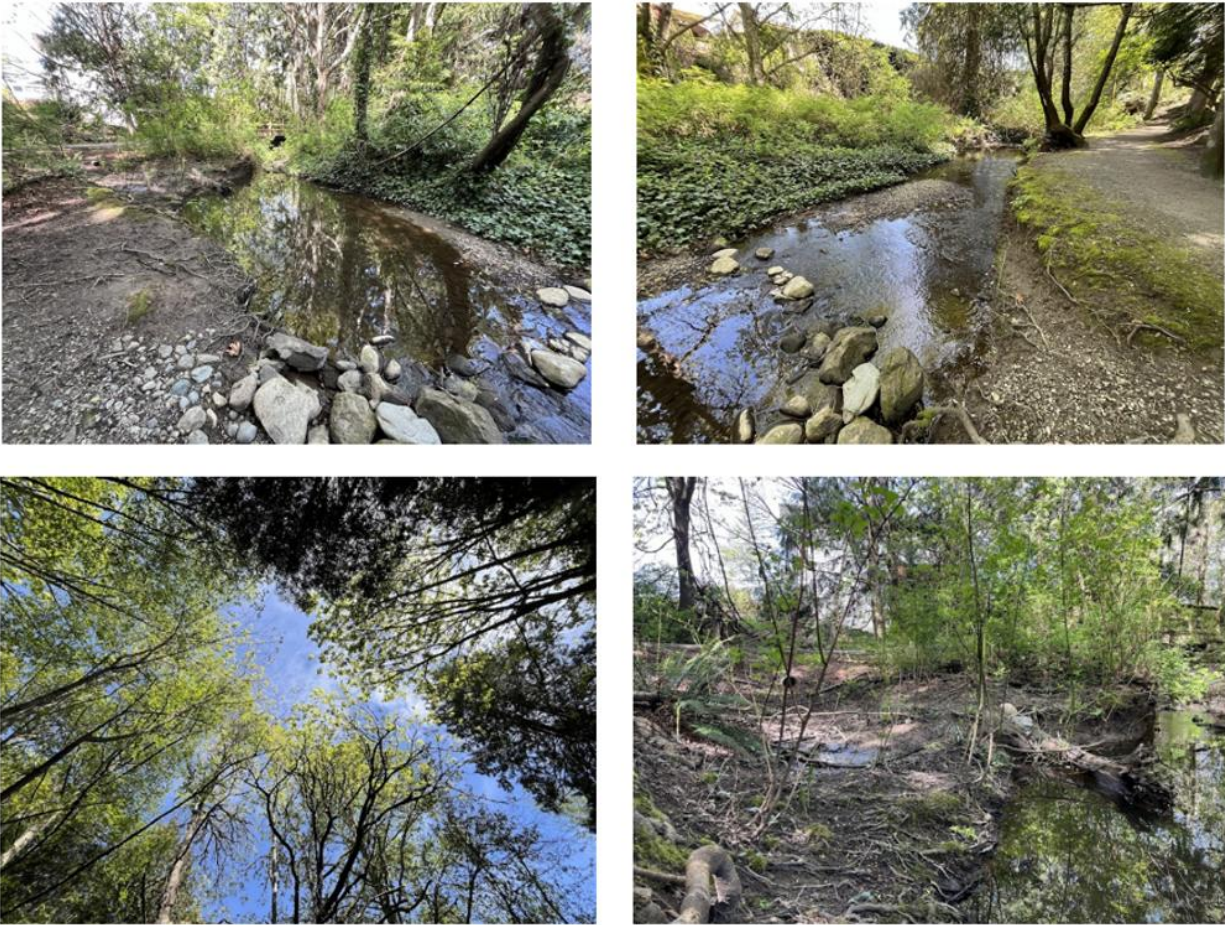
Figure 5. View of the project site from the riffle looking upstream (top left) and downstream, where erosion of the right bank is clearly visible (top right) in April 2025 before restoration. Canopy cover above the project site (bottom left), and the depression at the upstream extent of the project site hosting water-loving species (bottom right).

Soil compaction on the right bank is likely a contributing factor to the sparse coverage of native vegetation. More vegetation exists at the upstream extent of the project area, with decreased coverage downstream, primarily due to the proximity of the streamside trail. Native species along the upstream portion of the right bank include snowberry (*Symphoricarpos albus*; the most dominant shrub species), sword fern (*Polystichum munitum*), and a small western red cedar (*Thuja plicata*). Salmonberry (*Rubus spectabilis*) and red osier dogwood (*Cornus sericea*) are seen in the lower, wetter areas, especially the depression at the upstream extent of the site, where herbaceous Pacific water parsley (*Oenanthe sarmentosa*) is also found (Figure 5, bottom right). Along the downstream stretch of right bank, horsetail (*Equisetum arvense*) grows along the water line and

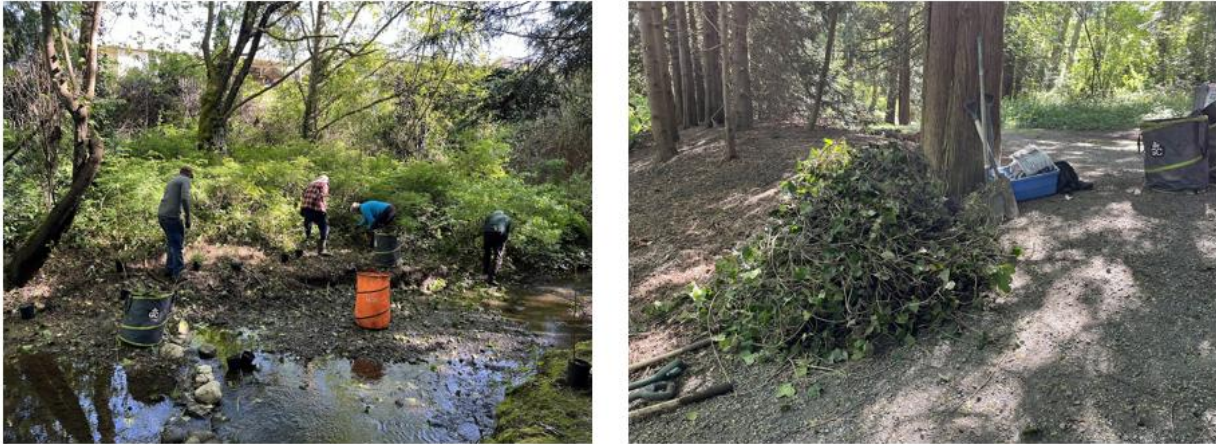
Riparian restoration occurred on April 22, 2025 (Figure 7). Four volunteers in addition to myself and Austin from PSS attended the planting event. The morning started by hand-pulling invasive plants, primarily English Ivy (*Hedera helix*) on the left bank.

Figure 7. Invasive species removal on the left bank of the project site (left) and the resulting plant material for disposal (right).

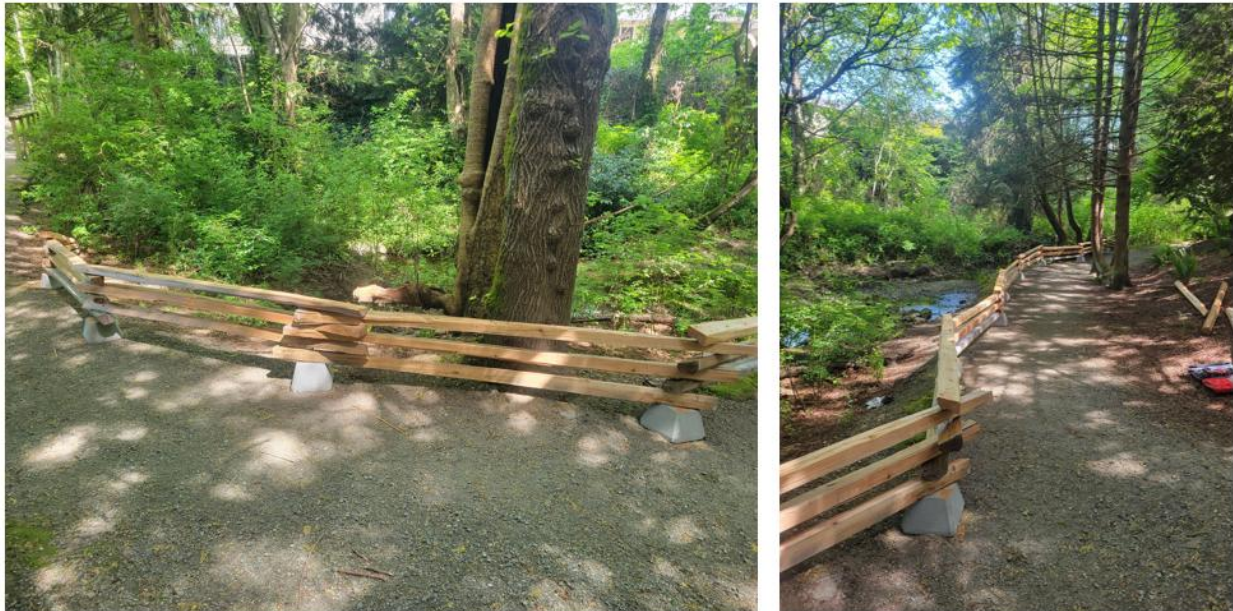
Figure 9. Newly installed split rail fence around the restored area (late April 2025).

Over the year that the fence has been in place, its integrity has remained high. However, there has been evidence that it is not preventing people from accessing the restoration area. Footprints have been observed in the mud within the fenced area and during one site visit, a group of people with fishing rods was observed actively stepping over the fence to begin fishing. This group was politely engaged in conversation and made aware that the fence was there to protect the

- Educational signage should be posted at the site, highlighting the work that has been done and why it is important
 - Additional information about the project area may help dissuade park users from stepping over the split rail fence to access the stream
 - Signage could also provide information for people who fish in the creek, with directions on how best to do so

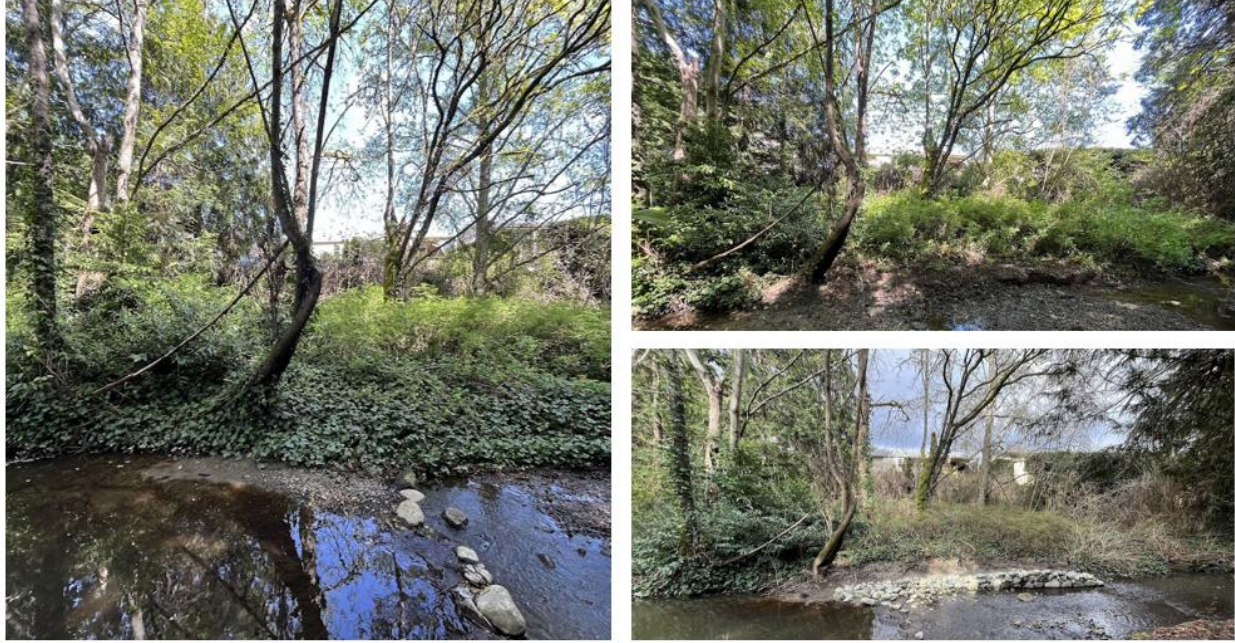
The removal of invasive English ivy and Himalayan blackberry from the left bank was qualitatively deemed successful. While a few shoots and vines were cut back or pulled during monitoring visits, the bank remained reasonably uninvaded, even a year after removal (Figure 11).

Figure 11. The left bank before invasives management in April 2025 (left), after invasives management in April 2025 (top right), and almost one year after invasives management in March 2026 (bottom right).

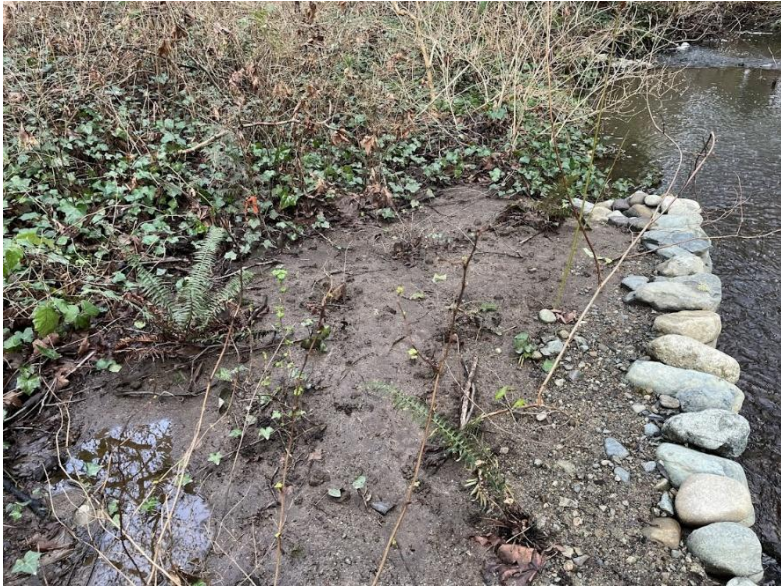
Native plant survivorship varied. Plants on the left bank appear to have been more successful than on the right bank, likely due to less compact soil (Figure 12). As of March 2026, several plants on the right bank, particularly the large area of bare ground just upstream of the riffle and on the downstream stretch along the fence did not survive (Figure 13 Figure 14). Exact survivorship counts were difficult to determine due to new plants being placed in amongst existing native vegetation and poor tracking at the time of planting.

Figure 12. Native plants appear to have had better survival on the left bank. Photo taken in February 2026.

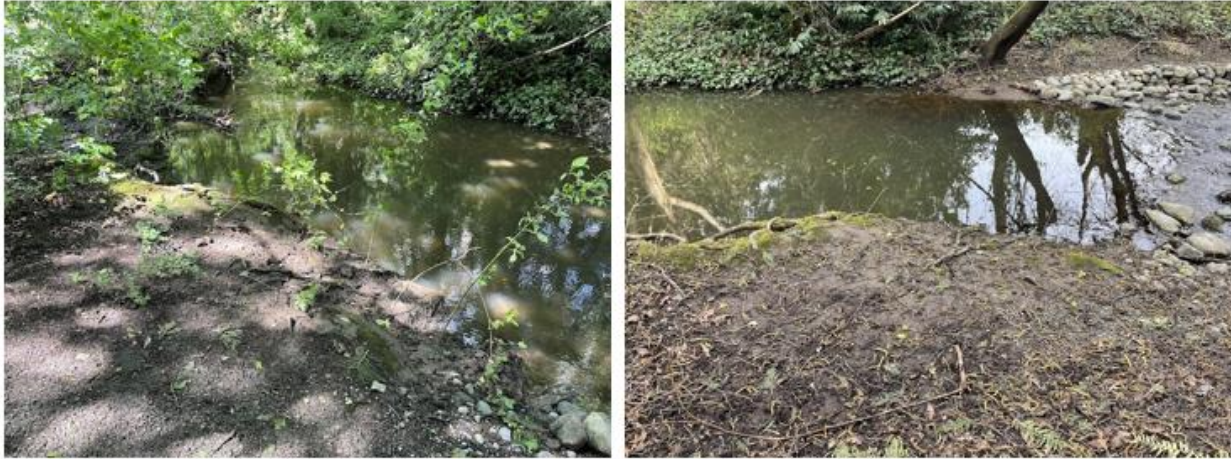
Figure 13. Native plantings in large area of bare soil on the right bank in May 2025 (left) and in March 2026 (right).

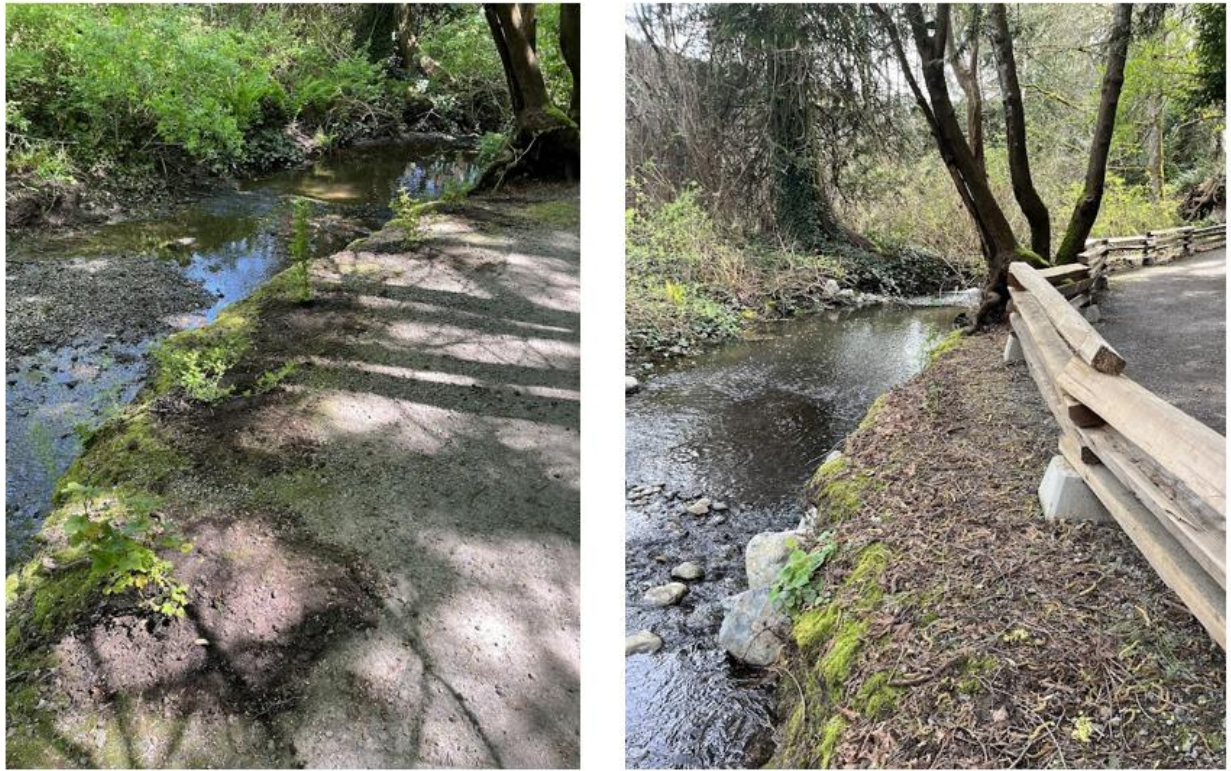
Figure 14. Native plantings along the downstream stretch of the right bank in April 2025 (left) and in March 2026 (right).
