# Soames Creek Riparian Planting Restoration

Sierra Rempel

ER390

University of Victoria

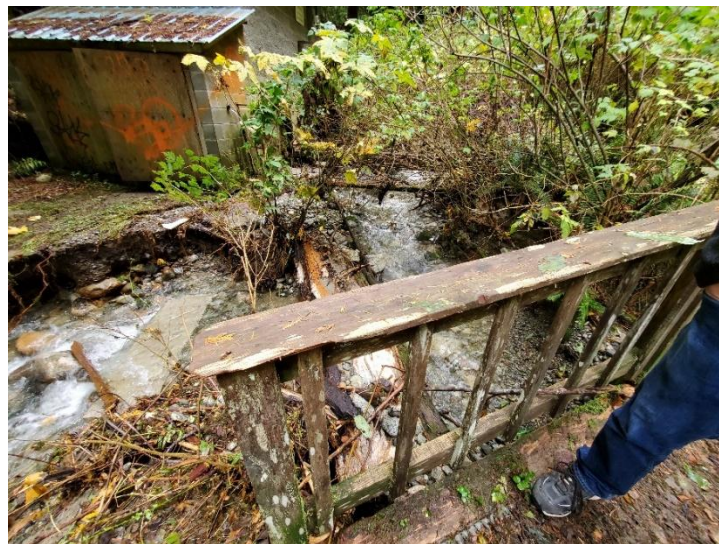
In 2021, an atmospheric river event caused extremely high flows in Soames Creek. This rainfall event caused upstream slope erosion and carried a large volume of debris downstream. This debris caused a blockage which changed the alignment of the channel and begun undercutting the bank near an SCRDR drinking water well pumphouse and put it at risk of collapse, as seen in Figure 1. Redirection of the creek via channel excavation and hardscaping with large angular boulders (riprap), occurred as emergency flood work.

*Figure 1: Photo showing undercutting of bank near SCRDR well pumphouse (SCRDR, 2021)*

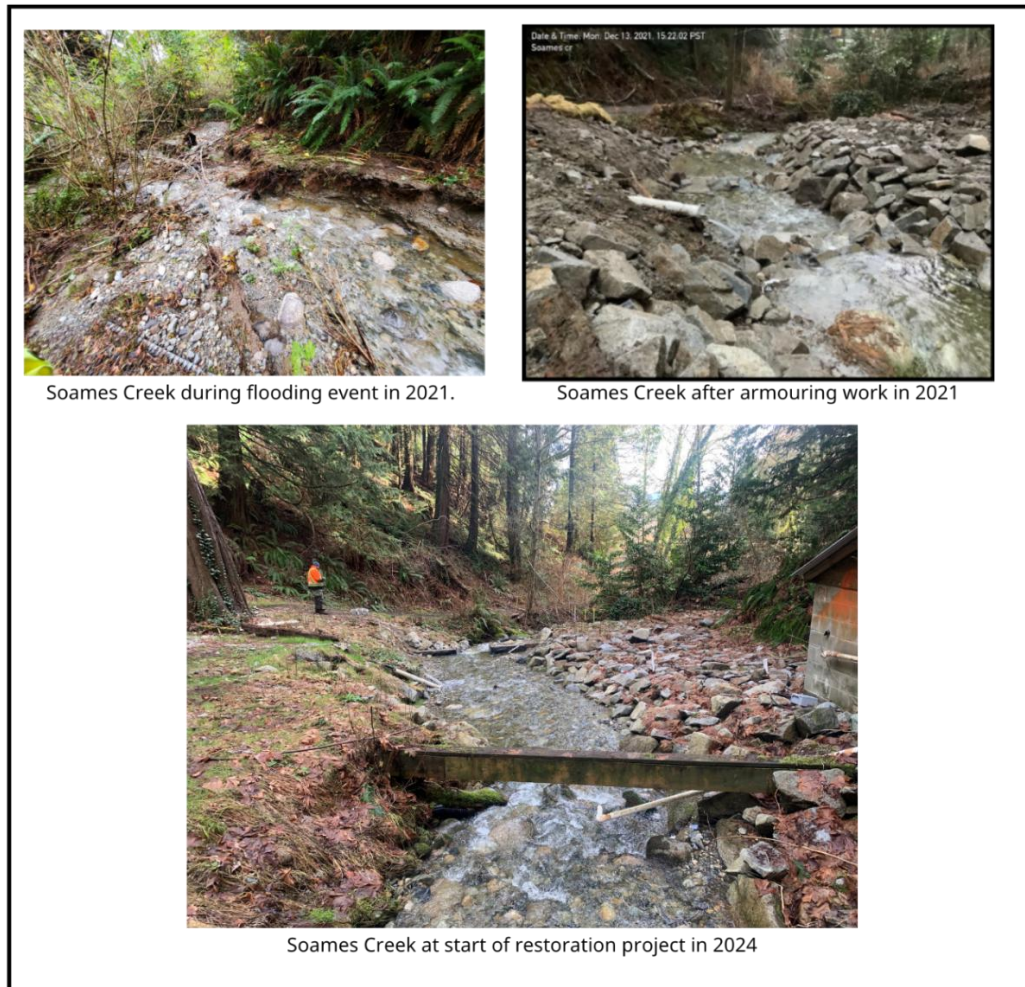
The placing of the riprap resulted in the destruction of existing riparian vegetation in the impacted area as well as the channelization of the stream, which removed the natural floodplain in that specific reach of the creek. Figure 2 shows the process of channelizing the stream from during the flood, after the placement of riprap and the current conditions at the start of the project.

Figure 2: Soames Creek in November 2021, December 2021 and February 2024, facing downstream, before restoration.

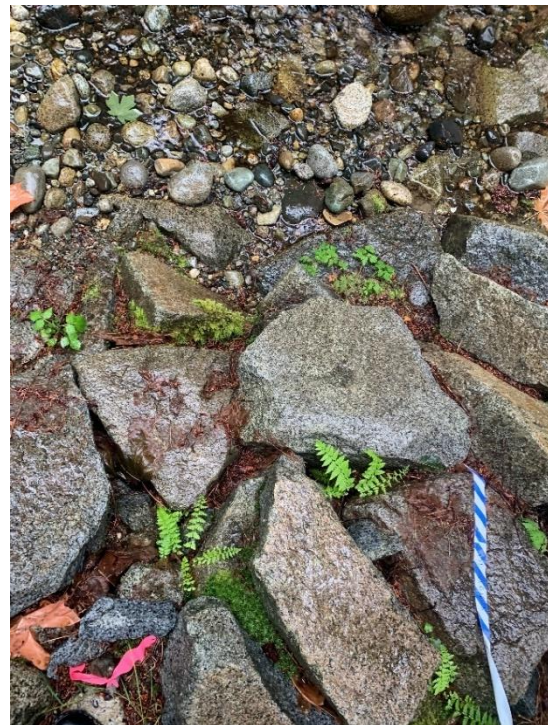
Plot 1 was located on the western side of the project area. The site has been heavily disturbed, with a substrate of angular cobble. The vegetation at this site was mostly herbaceous, with the only tree species present being young alder, approximately 0.5-0.75metres (m) tall. Some invasive herbs were seen, including fox glove (*Digitalis purpurea*), herb robert (*Geranium robertianum*), and periwinkle (*Vinca minor*). The constraints of the flowing stream on one side of the plot and significant extent of the cobble at this site limits the connectivity to other vegetated areas nearby. The inability for plants to spread naturally due to spatial constraints, and lack of soil presence may result in species typically found in this biogeoclimatic zone to not become established without planting intervention. Figure 7 shows the rocky substrate and limited soil, with the small ferns emerging through the riprap along the streambed.

Figure 7: Plot 1, with rocky substrate and limited soil, with small ferns poking through.

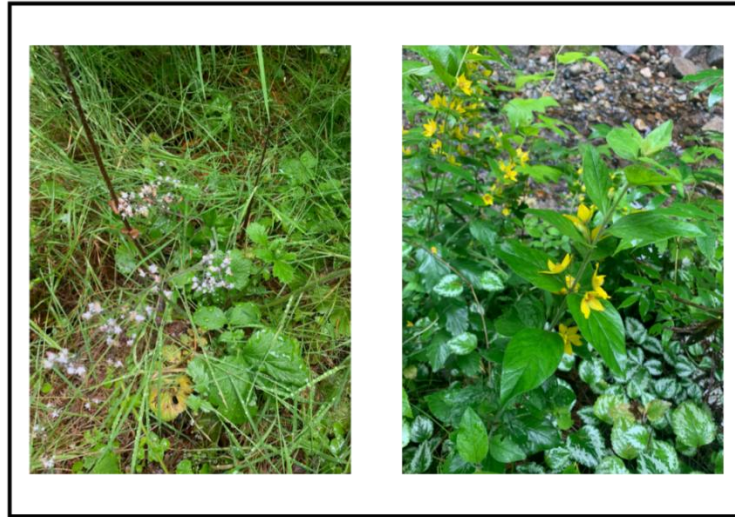
Plot 2 was located on the eastern bank of Soames Creek, and which was heavily disturbed by vegetation removal and compaction during the flooding in 2021, but was not armoured with any materials. There is limited mature shrub and tree vegetation at this site compared to all other sites

Figure 8: Herbaceous plants seen at Plot 2.

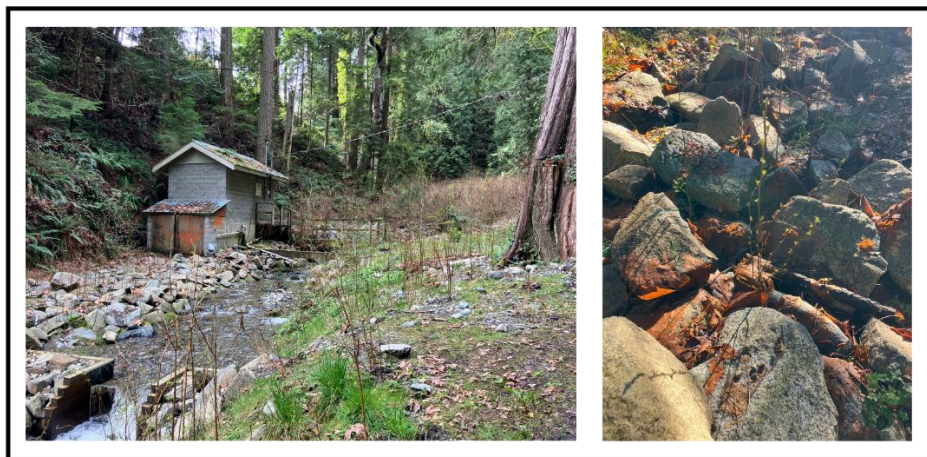
Figure 11: A March 2025 site visit shows budding shrubs, and a 99% plant survival rate.

The project successfully reviewed, surveyed and replanted riparian area vegetation at a portion of Soames Creek with native vegetation that will provide streamside canopy cover, and increase the overall species diversity in the area. The success of the planting for the purpose of bank stabilization should be assessed in the future, as the roots establish, and rain events occur. An indicator of success is the physical stabilization of the creek and banks through times of high stream flow. As of March 2025, there is an estimated 99% survival rate of the planted vegetation.

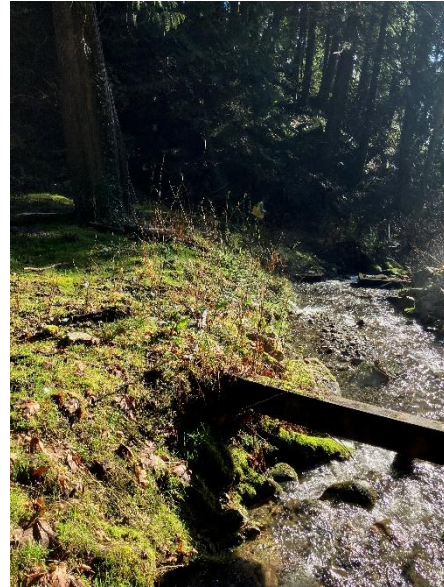
*Figure 12: Site photograph taken from the footbridge looking downstream, during a March 2025 site visit.*

Ongoing monitoring of the site should be completed as newly planted vegetation becomes established. Visual monitoring of the site can be completed by SCRD staff during routine checks of the water infrastructure on site, which happens in early spring, and is ongoing through the summer. In order for plantings to be deemed successful, 80% of plants must survive. If more than 20% die over one year, replanting will be required (Ministry of Environment, 2008). After the summer growing season, any plants needing to be replanted should be done so after the dry summer season. Photos should be taken during this monitoring as described above.

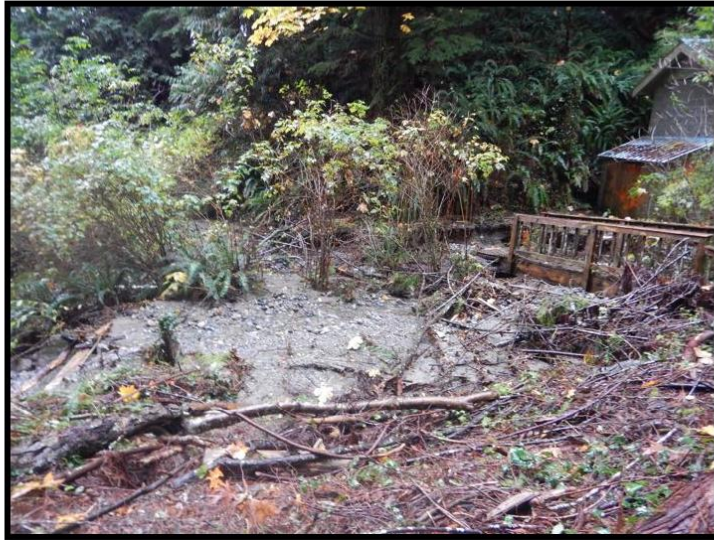
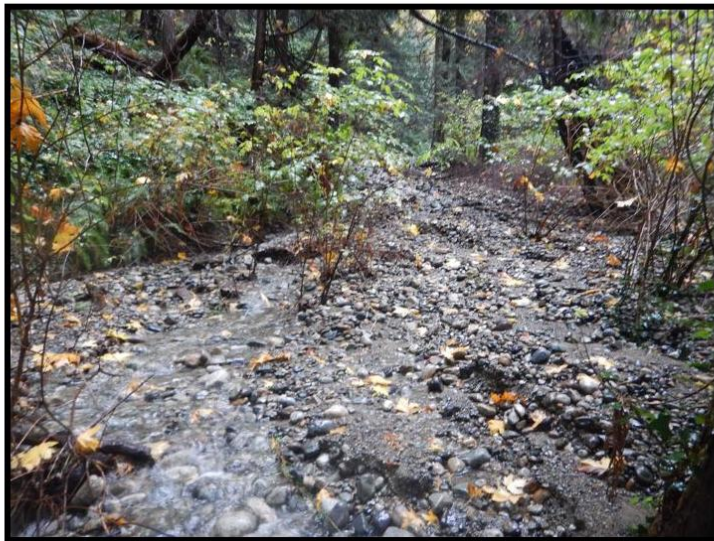
1. Debris jam at the access bridge near the well building resulted in channel avulsion, pushing channel towards the building.
2. Evidence of large volume of mobile bedload and debris, infilling the channel and causing small debris jam.
3. Large upslope bank failures resulting in large movement of sediments comprised of sands and small gravels. Large sediment at mouth of the southern tributary. Banks have failed contributing mobile sands and gravels.
4. MOTI culvert at Marine Drive is infilled at the inlet reducing capacity. Backwatering occurring accelerating bedload build-up.

**Photo 1:** Soames Creek at the SCRD well building. An upslope failure (October) and extreme highwater events (November) has resulted in the creek channel infilling and the channel avulsing, eroding the area around the well building creating unstable and unsafe conditions for the structure.

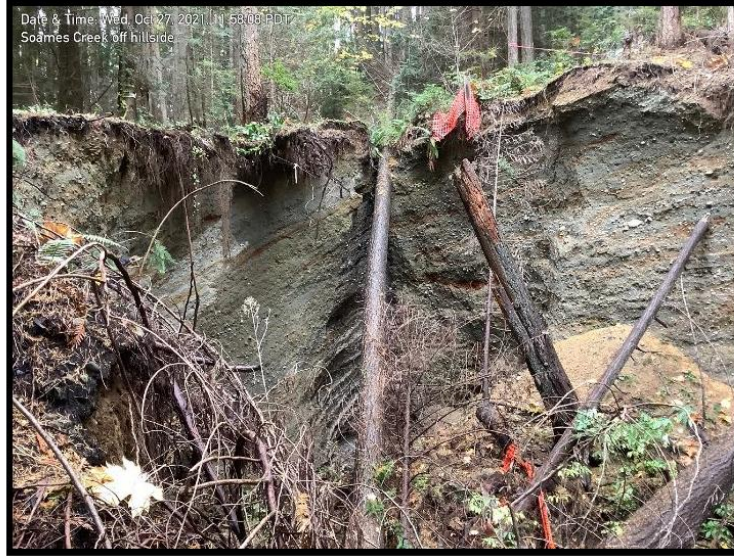
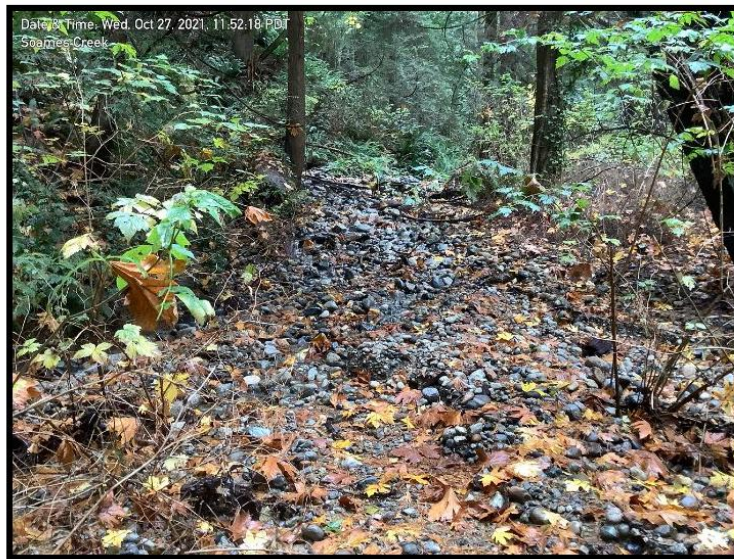
**Photo 2:** The area of slope/bank failure in a Soames Creek tributary, located above the well building. The result is significant large wood debris and bedload input into Soames Creek mainstem, resulting in the channel avulsing (changing directions) and forming numerous debris jams.

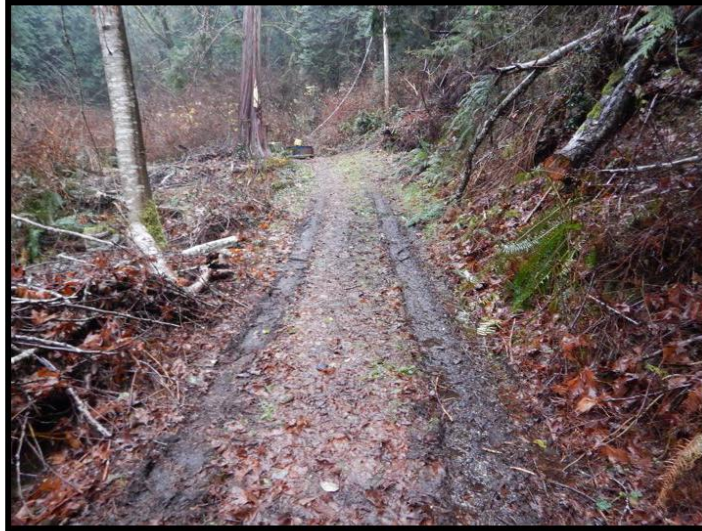
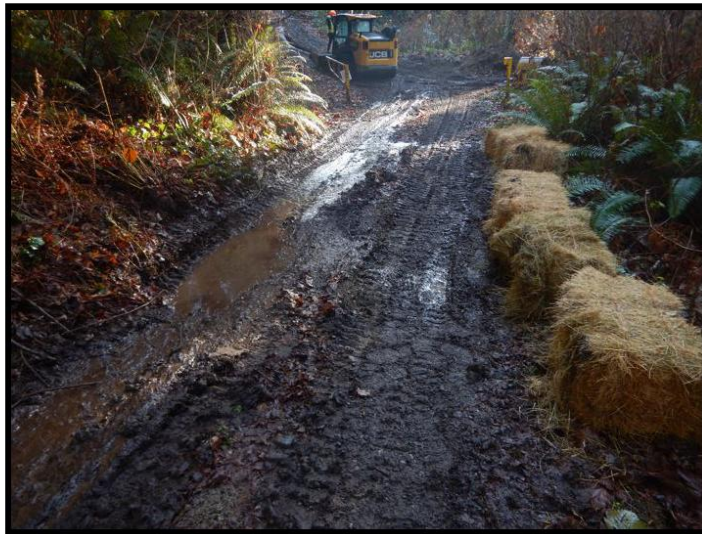
**Photo 3:** The main access road to be used for the reconstruction/excavation of the creek channel. The roads presents the greatest risk for sediment input. The access road was lined with hay bales and eventually capped. Once complete the hay was broken apart and used to cover the road to limit the possibility of sediment transport during poor weather.

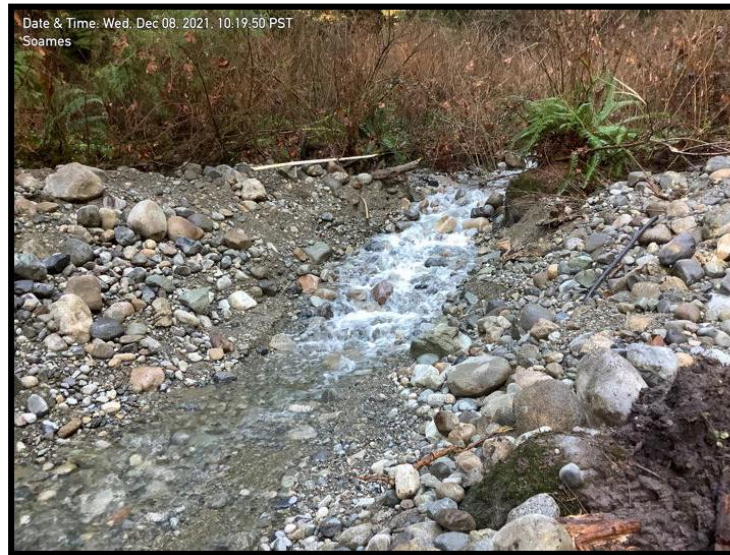
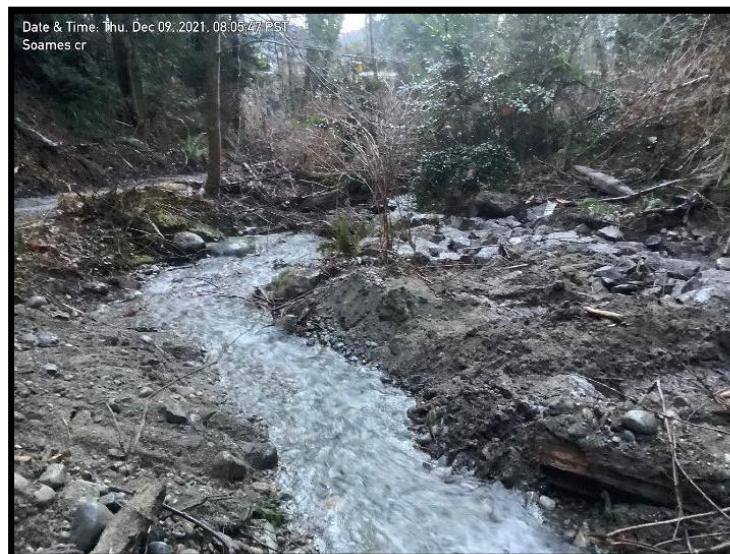
**Photo 4:** Newly excavated channel. This is the original channel that was infilled following the upstream “events”. The works and engineering design required re-establishing the original channel, located away from the building and infrastructure.

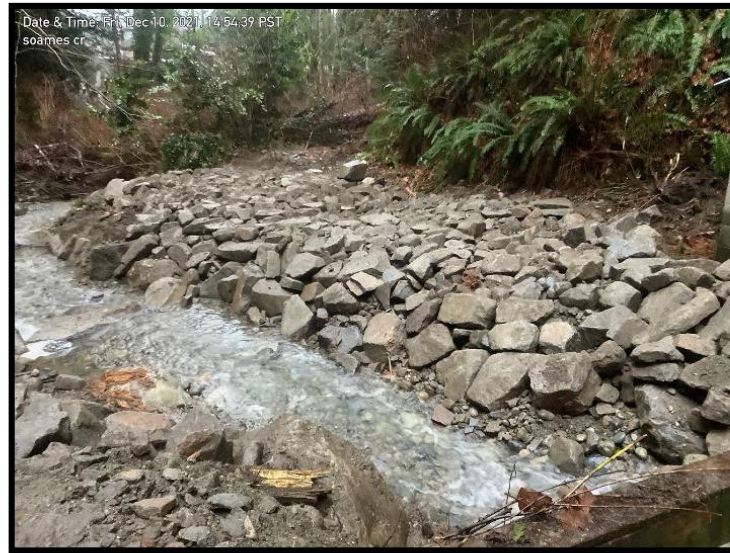
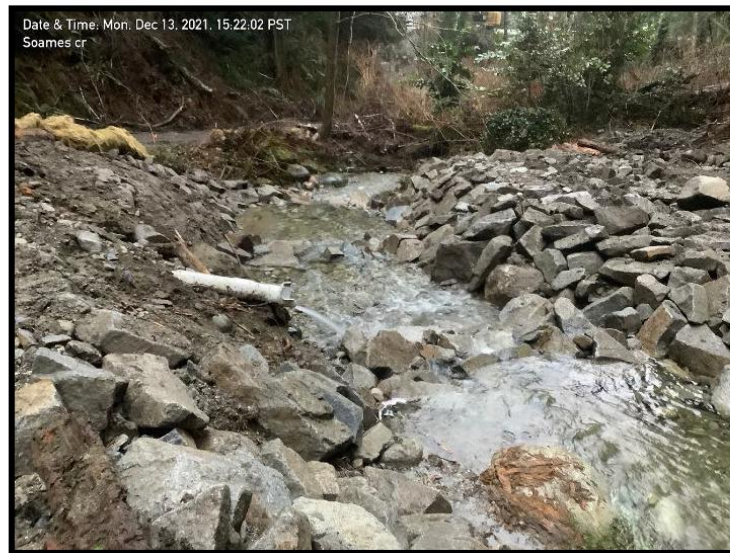
**Photo 5:** Finished channel above and below the SCRD well building. The channel, along the slope on the right bank was armoured and a series of weirs build within the channel to reduce the grade and help dissipate stream energy.
