Rippon Creek Restoration Initiative

Executive Summary

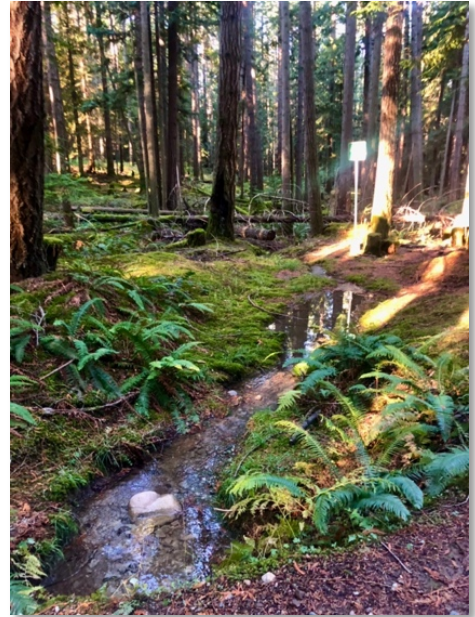
The reach of Rippon Creek by Mount Maxwell Road was chosen as a site of intervention because it is experiencing excessive erosion, sedimentation and harmful runoff and it has a lack of riparian plant diversity/ecological structure (Figure 3). CARL has been studying the Maxwell Creek Watershed for the past two years and identified a culvert that runs under Mount Maxwell Road as a choke point for the above problems. This region is expected to experience more frequent and severe extreme weather events (Prairie Climate Centre, 2021) such as atmospheric rivers, which increase the need for intervention to prevent current ecological issues from becoming exacerbated. Intervening at this site should be understood as one project of many in a long-term vision of restoring these ecosystems at a watershed scale. The objectives of intervening in Rippon Creek are to improve water quality (by slowing water velocity and reducing erosion/sedimentation), to increase soil moisture (to prevent the risk of catastrophic wildfires in the watershed) and enhance wildlife habitat (by creating more in-stream habitat through adding Large Woody Debris ((LWD)) and increasing the diversity and cover of native riparian plants). Approximately half of the watershed is governed by a Salt Spring Conservancy covenant which restricts most human activity including ecological restoration projects. The proposed restoration project is adjacent to the covenant land and owned by the NSSWD.

Figure 3: Rippon Creek Restoration Site, Downstream View from the Mount Maxwell Road Culvert

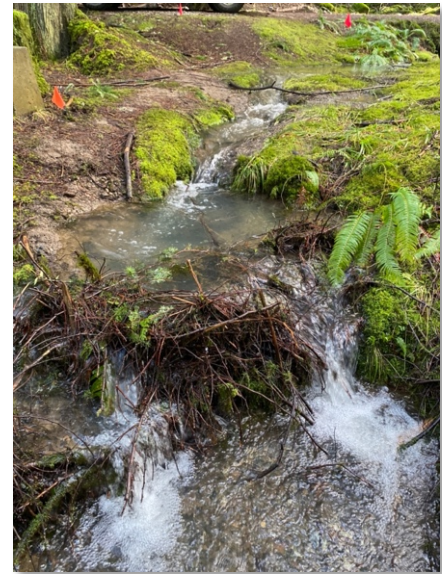
armouring on the opposite side of Mount Maxwell Road. This section of creek resembles a channelized ditch with no off-channel or pooling habitat. The bank stability grade that was given at the time of our initial assessment is higher than it would be if this reach of the creek was reassessed in 2024. Over the past year, bank stability has declined and headcuts have formed, which make the issue of erosion more apparent (Figure 4). Overall, this reach of Rippon Creek was given a grade of 36 out of a possible 135 points meaning that this reach would be considered in a ‘marginal to poor condition.’ This assessment is an important piece of evidence for why intervention here is necessary.

Figure 4: Headcut in Rippon Creek by Mount Maxwell Road. Photo by Keegan Thomas.

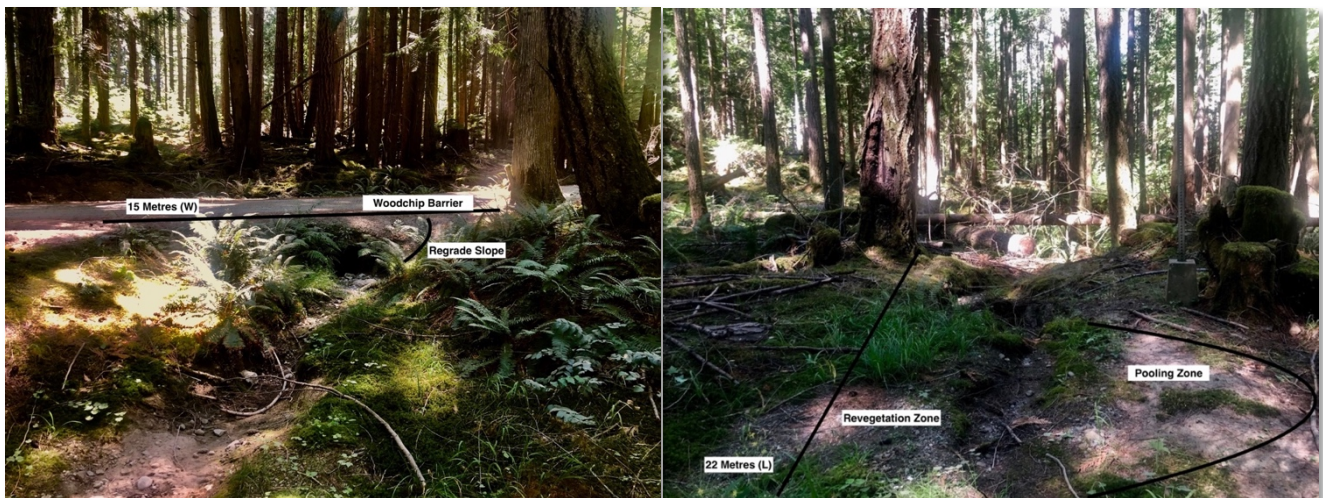
Figure 6: Theoretical Design by Karlis Hawkins

The initial theoretical design was drawn up by me (Figure 6). I proposed creating a side pool with the goal of slowing water velocity, increasing soil moisture and creating wetland habitat. I proposed revegetating areas along the creek with native riparian plants. In order to reduce water flows

from over top of Mount Maxwell Road which occur during heavy rains, I proposed building a woodchip barrier to filter water before it reaches the creek bed. Lastly, I wanted to regrade the slopes on either side of the culvert and vegetate it to increase filtration and reduce sediment in the creek. The theoretical design was shown to experts and used to inspire a technical design.
