TETAYUT (SANDHILL / SHADY) CREEK RESTORATION: REMOVING BARRIERS TO FISH PASSAGE AT THE PAT BAY HIGHWAY (17) IN CENTRAL SAANICH, BC

Prepared by: Andrew Anderson, EIT, AAg
BC MoTI Environmental Management Branch
Victoria, BC
V00866500

Prepared for: Val Schaefer, PhD, RPBio
Academic Administrator, Restoration of Natural Systems
University of Victoria

Submitted: February 2019

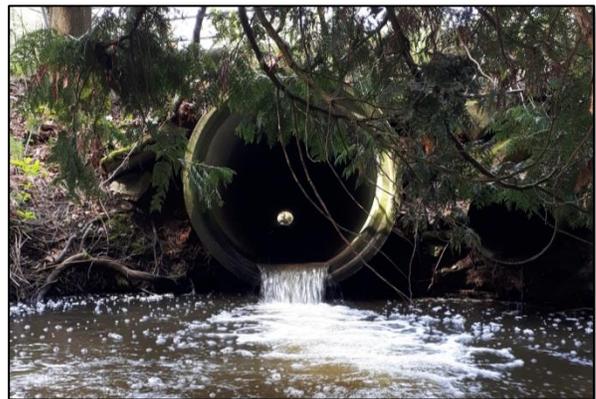
Due to the nature of the culvert’s long smooth barrel ideal for generating high velocity flows, a plunge pool over a metre in depth has formed in the channel downstream of the highway. Despite this pool being excellent fish habitat, the formation of the pool has resulted in a perched culvert 40 cm above the nearest downstream control elevation causing a major barrier to fish migration in the Creek.

Figure 2: Standing in Tetayut Creek downstream of the culvert looking upstream at the perched culvert (Anderson, 2018)

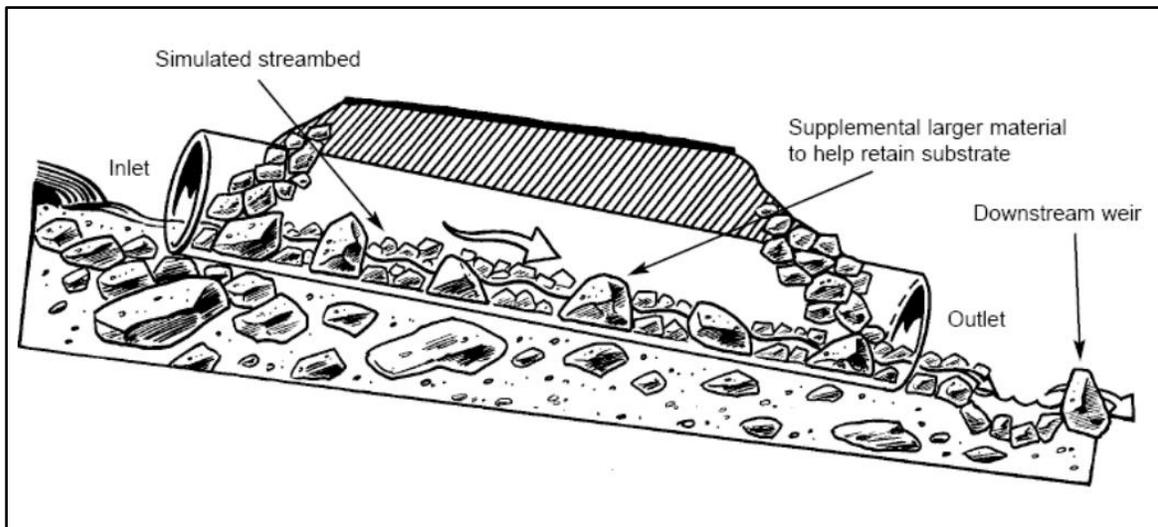
- An embedded closed bottom culvert (Figure 3), where the embedded material is made up of native bed materials and installed at a specified depth or ratio of the culvert diameter; or
- An open-bottomed structure that leaves the natural channel bed intact.

Figure 3: Embedded culvert installation with natural channel bed material and an appropriate gradient and outlet pool control. (Fish-stream Crossing Guidebook, 2012)

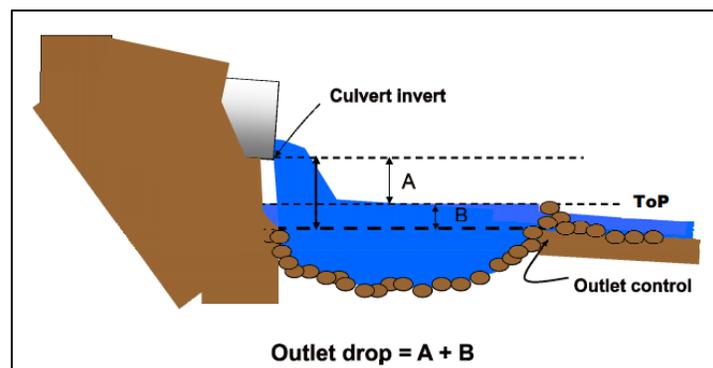
4. Raised or elevated outlet. This occurs when the culvert outlet's invert elevation is above the downstream streambed control (Figure 4). An outlet drop forms from velocities eroding the downstream channel such that the channel bed degrades and an outlet scour pool forms (like that in Tetayut Creek). This phenomenon can also be referred to as a perched or hanging culvert. Under ideal conditions, some species of adult salmonids can leap over this obstacle if they are given a sufficient run from the outlet pool, but this is not always the case.

Figure 4: Determination of an outlet drop (Protocol for Fish Passage Determination of Closed Bottomed Structures, 2011)

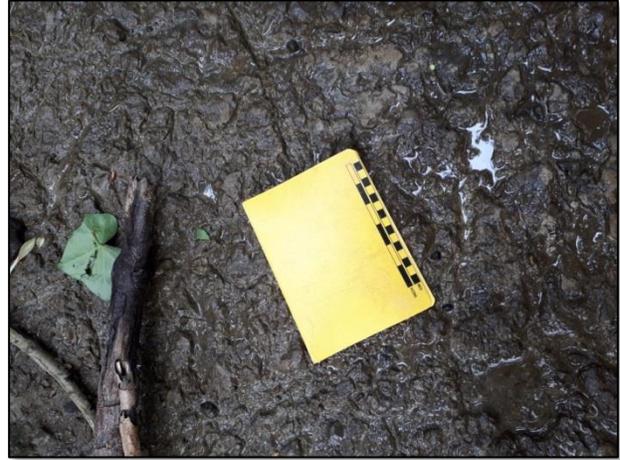
Figure 5: Dense, erosion resistant clay encountered along the banks of Tetayut Creek (Anderson, 2018)

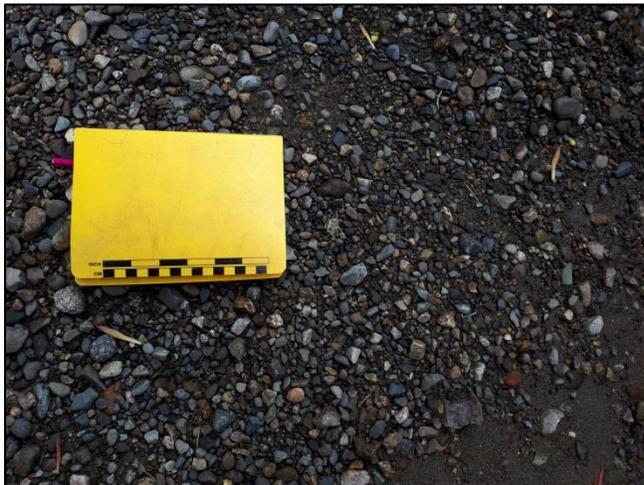
Low gradient channels like Tetayut Creek (1.05% channel slope near the culvert) lack the ability to transport large sediment (e.g. cobbles and boulders >75mm) and debris (e.g. coarse woody debris). The marine deposited sediments that make up the watershed are fine grained in nature, ranging in size from <0.063mm (silt and clay) to coarse gravels (up to 63mm) (International Organization for Standardization, 2017) (Figure 6). This implies there is a lack of large sediment throughout all reaches of the watershed. These assumptions were field confirmed by the absence of stranded debris and an absence of accumulated sediment at the inlet of the Highway 17 culvert, where converging flows have a tendency to deposit large materials that don't fit through the barrel of the culvert.

Figure 6: Gravel bar encountered during site visit where particle diameters range from 5 mm to 20 mm (Anderson, 2018)

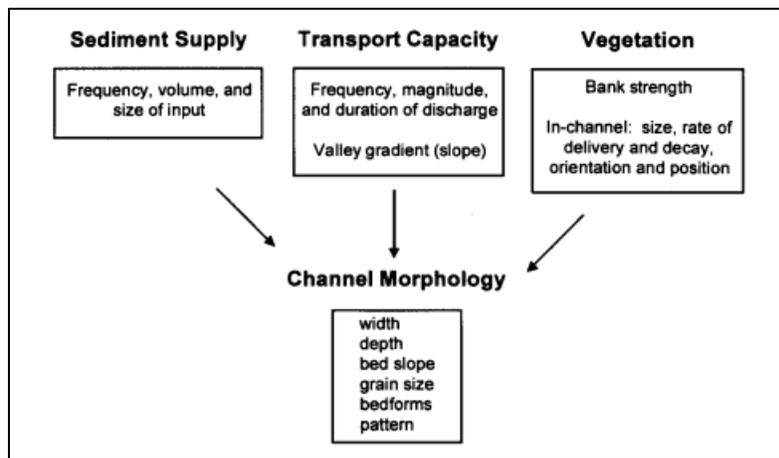
Stream classification is a complex process that depends on many variables related to environmental conditions, sediment source, transport capacity, and vegetation (Figure 7). For smaller and intermediate streams of British Columbia (bankfull width <20 m) this process can be simplified to three morphologies defined by The Channel Assessment Procedure Field Guidebook (BC Ministry of Forests and Ministry of Environment, Lands, and Parks, 1996). These classifications are:

Figure 7: Determination of stream morphology from independent landscape and watershed variables (Montgomery & Buffington, 1998)

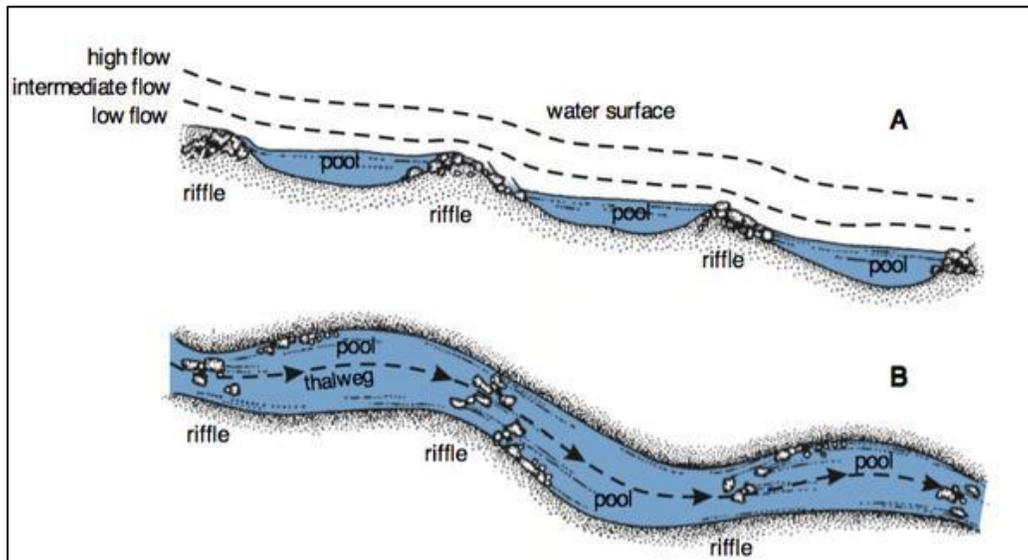
Tetayut Creek can be defined as a naturally meandering stream with a low gradient and depositional areas containing gravelly bed materials. Given the nature of riffle-pool morphologies isolated to low gradient channels (<2%) (Thompson, 2018), it is fair to consider the reach of Tetayut Creek near Highway 17 a riffle-pool channel (Figure 8).

Figure 8: Riffle-pool morphology in plan and profile view (Natural Stream Processes - River Course, 1999)

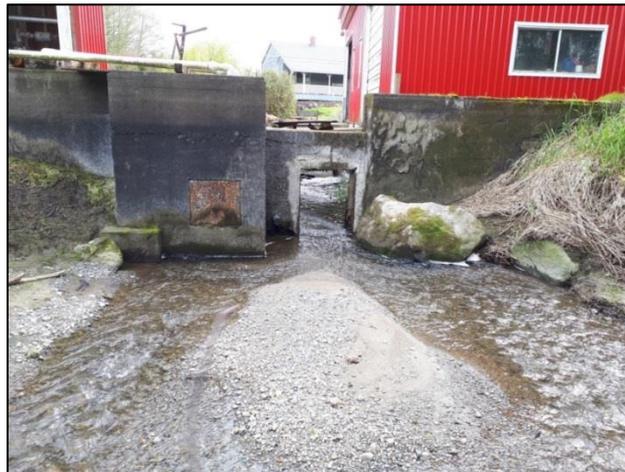
Figure 10: Looking downstream from Tetatyut Creek at concrete gravity dam with steel plate sluice gate (not present) 350 m upstream of Highway 17. Notice the sandy gravel substrate in the channel. (Anderson, 2018)

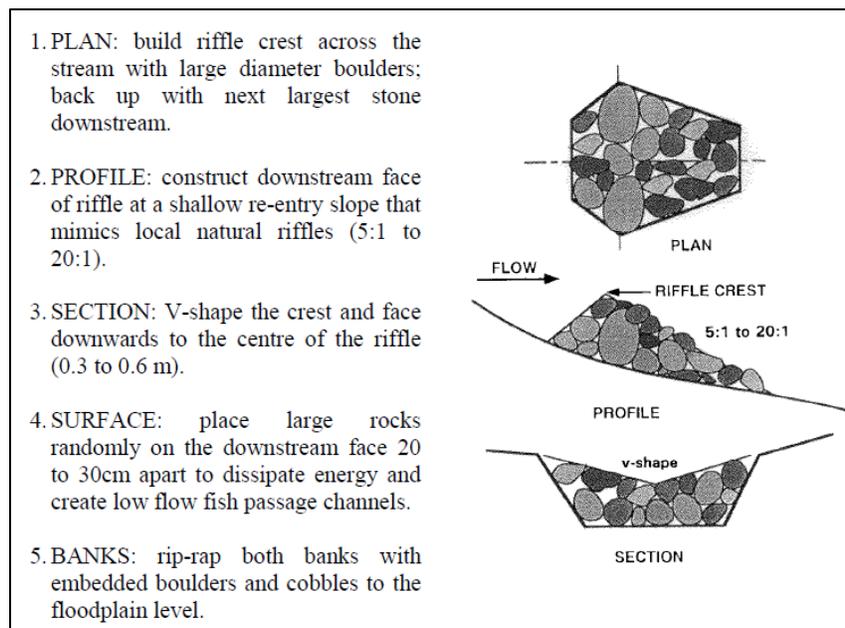
The shape of the rock riffle in plan view resembles a coffin, where the widest section extends up the banks of the channel (Figure 11). The riffle crest stabilizes the entire riffle structure thus it must be keyed into the channel with large rocks. The crest is v-shaped to promote the flow of water through a control elevation. During construction it is imperative that the riffle itself is well sealed so that during low flows water does not leak through the rocks but is instead conveyed over top of the structure.

Figure 11: Shape of constructed rock riffle (Newbury, Gaboury, & Bates, 1997)

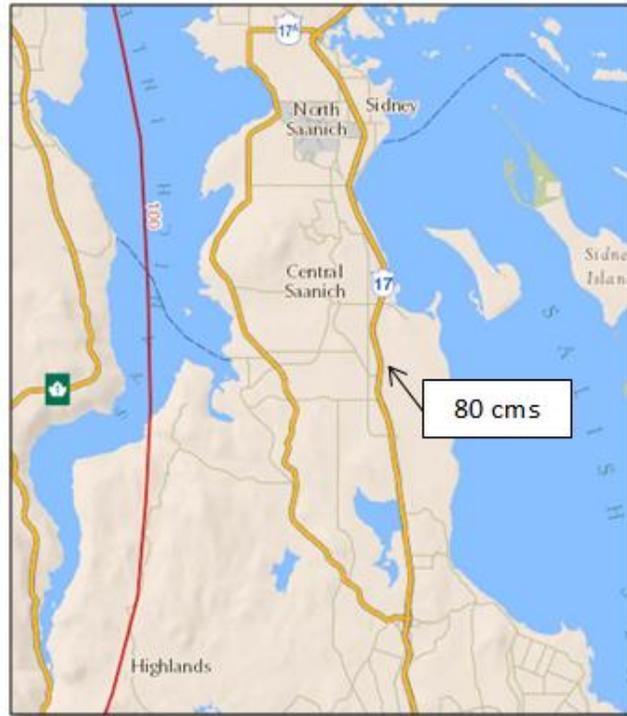
Where Q_A is the flow rate in the specified watershed (m³/s), Q_{100km^2} is the flow rate determined from the isolines for a 100 km² watershed (m³/s) and A is the watershed area (3.07 km²). Using iMapBC's 100-year isoline layer, the Q_{100km^2} isoline value was determined to be 80 m³/s (Figure 12). Using the Coulson and Obedkoff (1998) relationship, the total discharge for the 100-year peak event is 5.19 m³/s.

Figure 12: Q_{100} discharge estimate for 100km² watershed using BCSI isolines (iMapBC, N.D.) (north at top of the page, NTS)

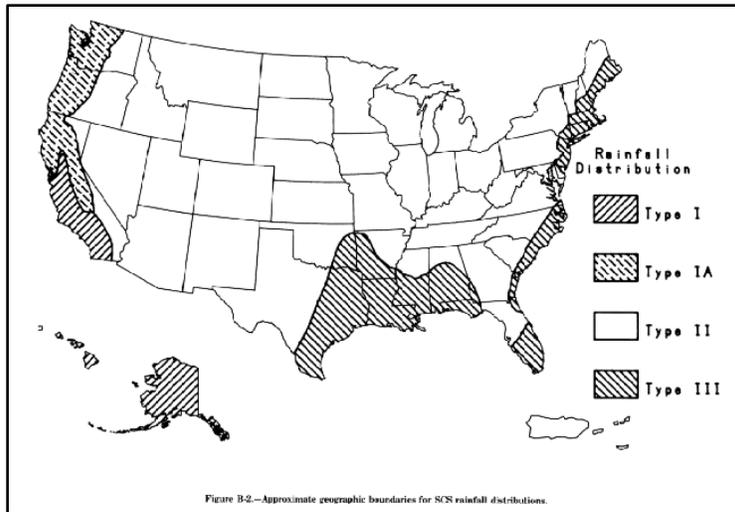
The unit peak discharge depends on rainfall distribution types that have been mapped for the U.S. as shown in Figure 13. Assuming a type IA distribution based on map extrapolation of the distribution extents, the peak discharge, q_u was determined from Exhibit 4-IA as 84 cfs/mi² per inch of runoff (csm/in) (U.S. Department of Agriculture, 1986). This calculation also requires the calculation of a runoff depth (P_e) based on an assumed 24-hour storm length.

Figure 13: Figure B-2 from TR-55 (U.S. Department of Agriculture, 1986)

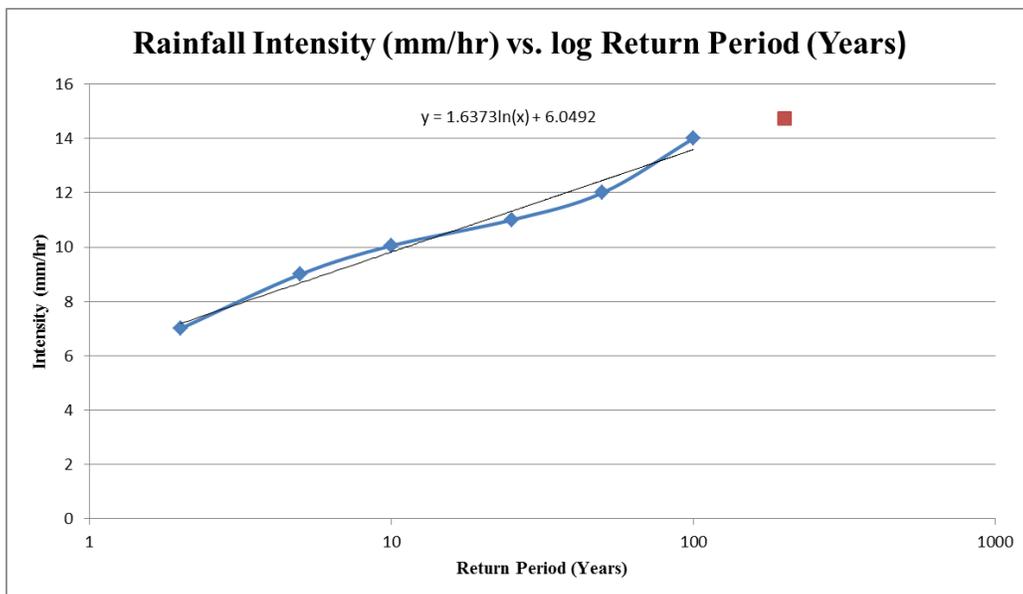
To arrive at the 200-year rainfall intensity, the existing rainfall intensity values from the Victoria Airport (1018621) IDF curve (Government of Canada, 2014) were plotted against the return period on a normal-lognormal plot, and the 200-year intensity (shown in red in Figure 14) was extrapolated using a lognormal trendline. The ratio of 200-year/100-year rainfall intensities was found to be 1.05.

Figure 14: Plot of Victoria Airport (1018621) weather station rainfall intensity (mm/hr)

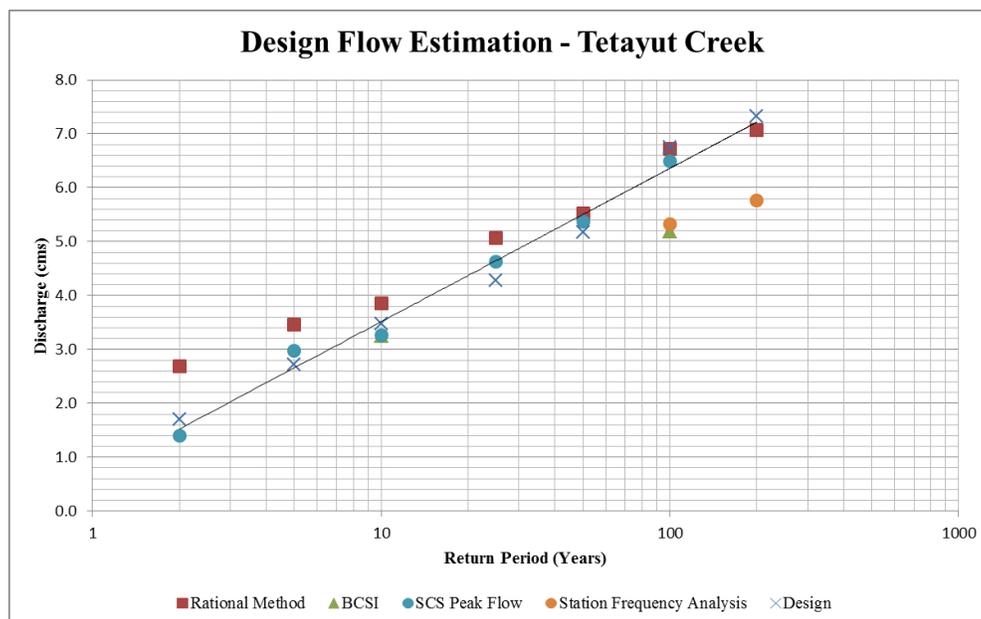
The final design discharges are the product of the peak instantaneous flows multiplied by the climate change factor (Appendix E). The design discharge for all return periods can be found in Figure 15.

- Q_{100} discharge (Pre-climate change) 5.32 m³/s
- Climate Change Factor of Safety 1.27
- Q_{100} discharge (climate change adjusted) 6.75 m³/s

Figure 15: Summary of peak instantaneous design flows

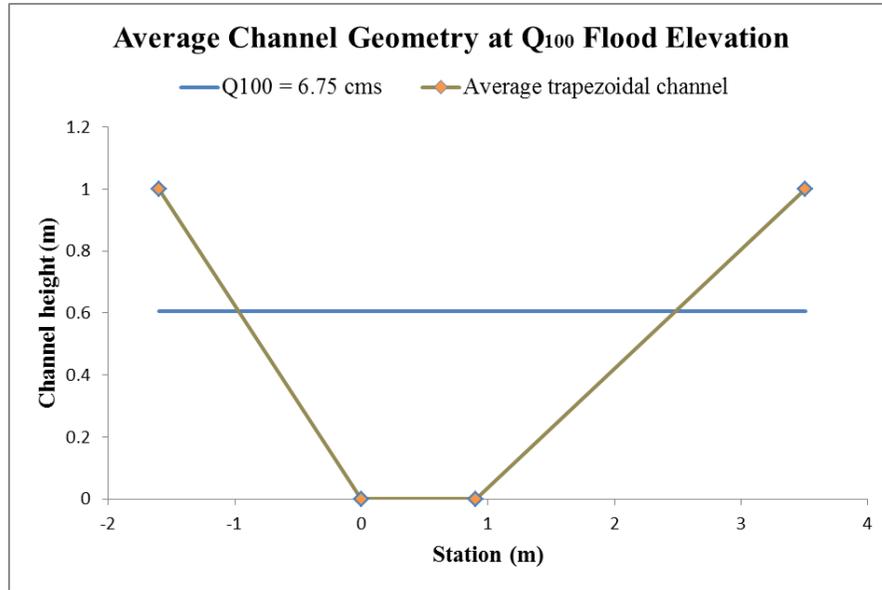
The combination of water flowing through a specified geometry with a defined roughness provides a visual representation of the water surface elevation (Figure 16). This water elevation is what is used to assess the performance of the riffles.

Figure 16: Average channel geometry of Tetayut Creek from survey data presented in Table 4 with Q₁₀₀ flood elevation

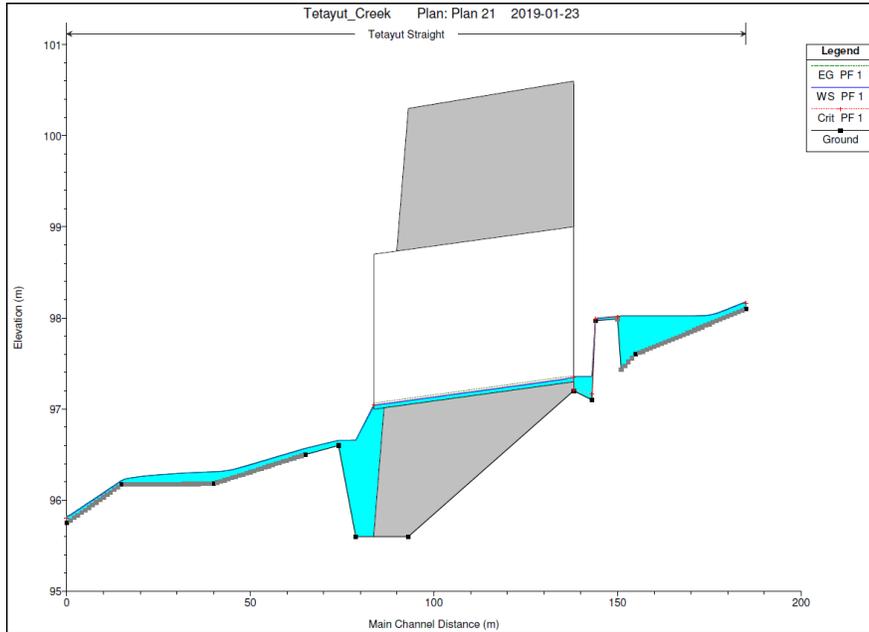
Figure 17: Culvert before instream riffle construction with 40 cm outlet drop at low flow

Figures 17 and 18 demonstrate that the restoration works flood the culvert sufficiently under low flow conditions, eliminating the perched culvert.

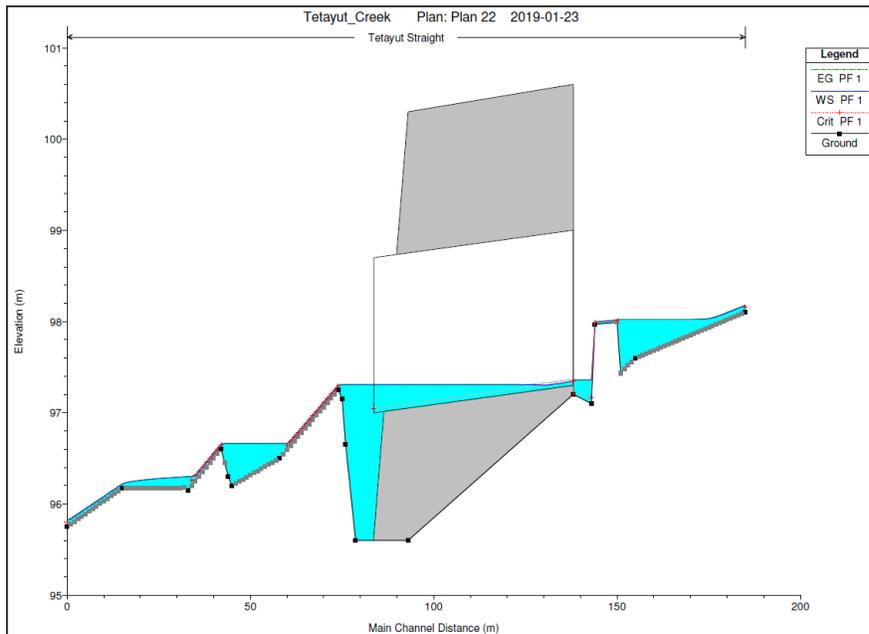
Figure 18: Restored riffle-pool channel morphology with backwatered culvert at low flow

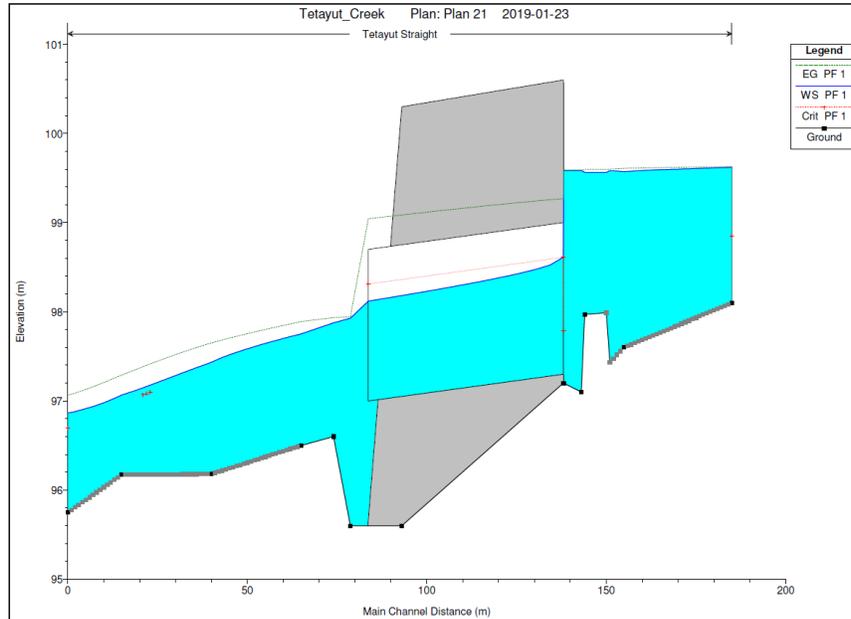
Figure 19: Culvert before instream riffle construction at Q_{100} discharge

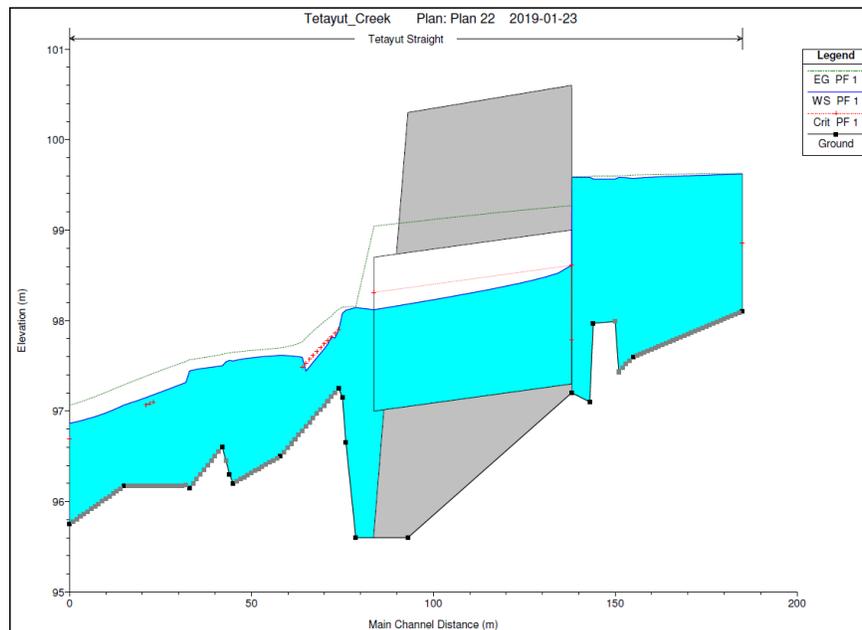
Figure 20: Restored riffle-pool channel morphology at Q_{100} discharge

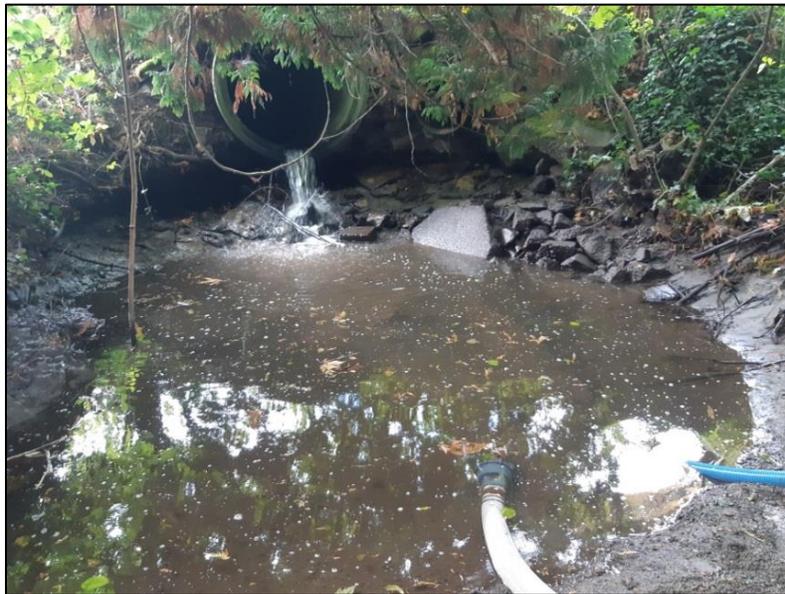
Figure 21: Looking upstream at outlet where pumps are working to isolate the scour pool (Anderson, 2018)

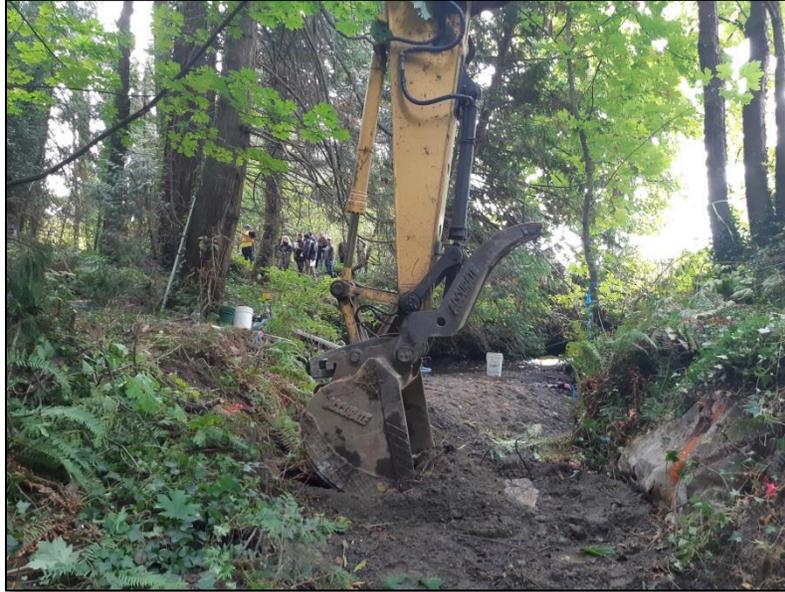
Figure 22: In channel looking upstream at dewatered channel where excavator is breaking ground to toe in the keystone rocks of the first/upstream riffle crest (Anderson, 2018)

The riffle construction was field fit from the original design based on site conditions. This included moving the first/upstream riffle crest (Figures 22 and 23) approximately five metres downstream from the proposed location due to easier excavator access to the Creek. The second/downstream rock riffle

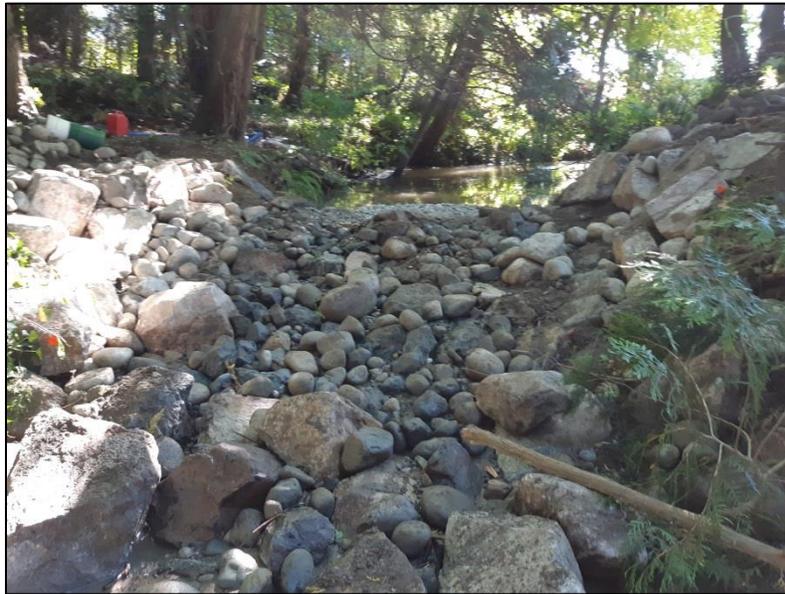
Figure 23: In channel looking upstream at completed first/upstream riffle (Anderson, 2018)

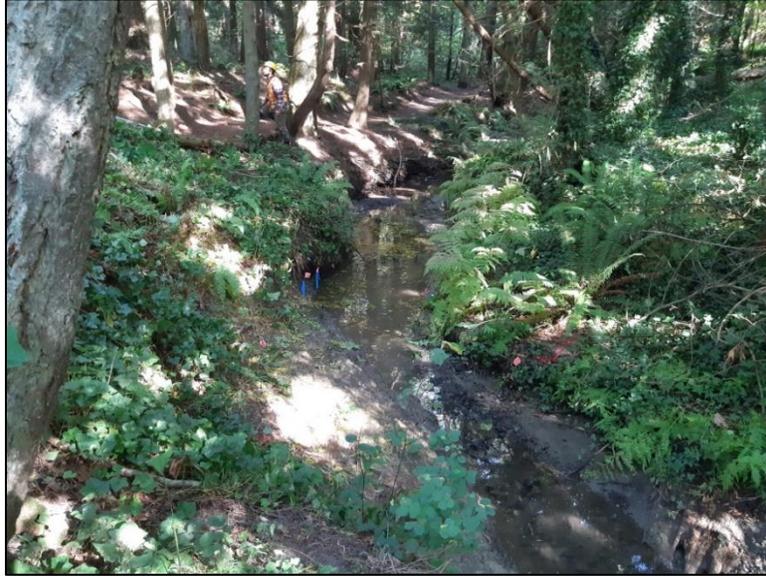
Figure 24: Looking downstream from left bank at second/downstream riffle prior to construction (Anderson, 2018)

(Figures 24 and 25) was also moved up approximately five metres to match the spacing requirements of the riffle-pool sequence proposed by Newbury et al (1997), this also landed the riffle on a meander bend where the additional rock serves as bank protection.

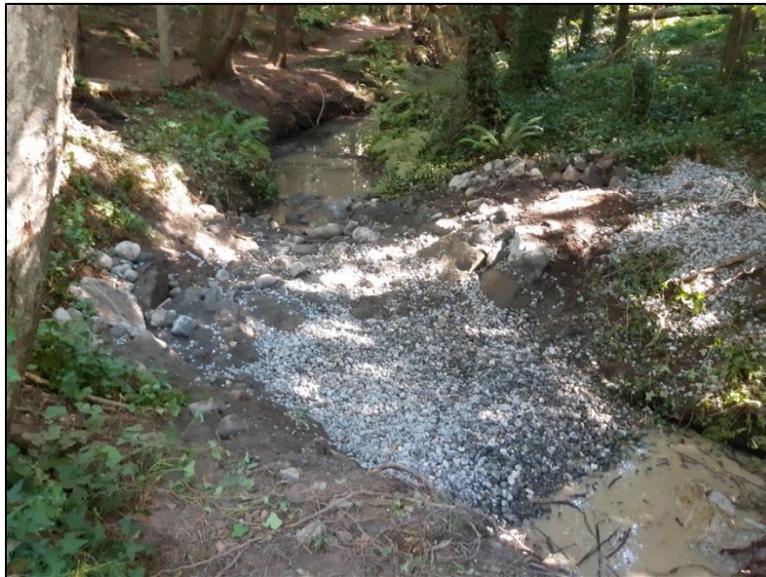
Figure 25: Looking downstream from left bank at completed second/downstream riffle (Anderson, 2018)

To prevent dewatering of the riffles at low flow, clay fill was provided in-kind by SHAS. The clay was used to pack the rocks together in combination with repurposed sediment from the channel to prevent leakage through the coarse rock fill. A pond liner provided by Ian Bruce was used at the base of the upstream riffle as an extra precaution to prevent leakage due to the naturally porous in-situ materials.

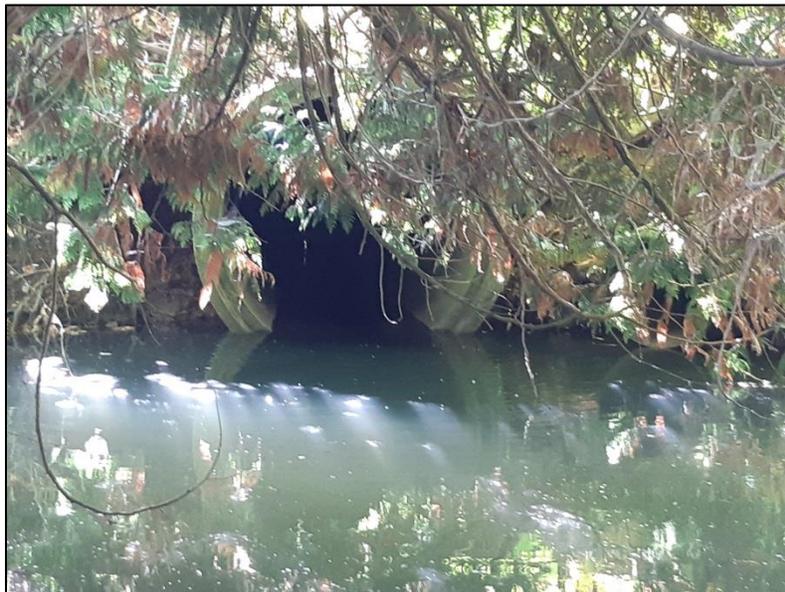
The construction of the two riffles led to the model-anticipated backwatered culvert depicted in Figure 27.

Figure 27: Submerged and backwatered outlet (Anderson, 2018)

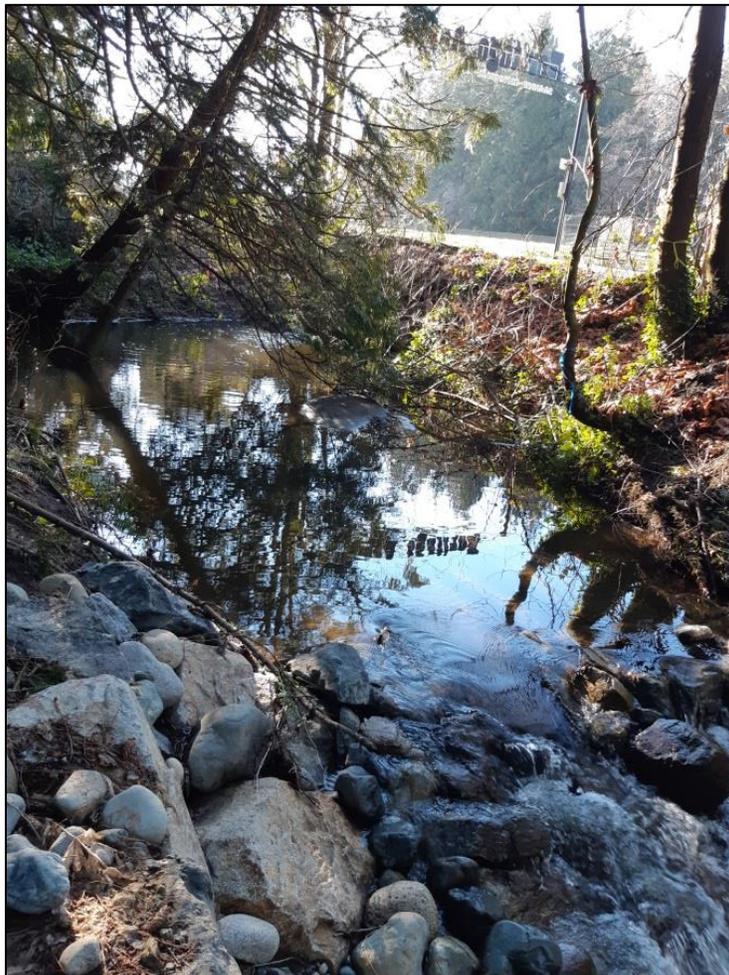
Figure 28: January 2019 - standing on the right bank looking upstream towards culvert at pool habitat created from the first/upstream riffle crest four months after construction (Anderson, 2018)

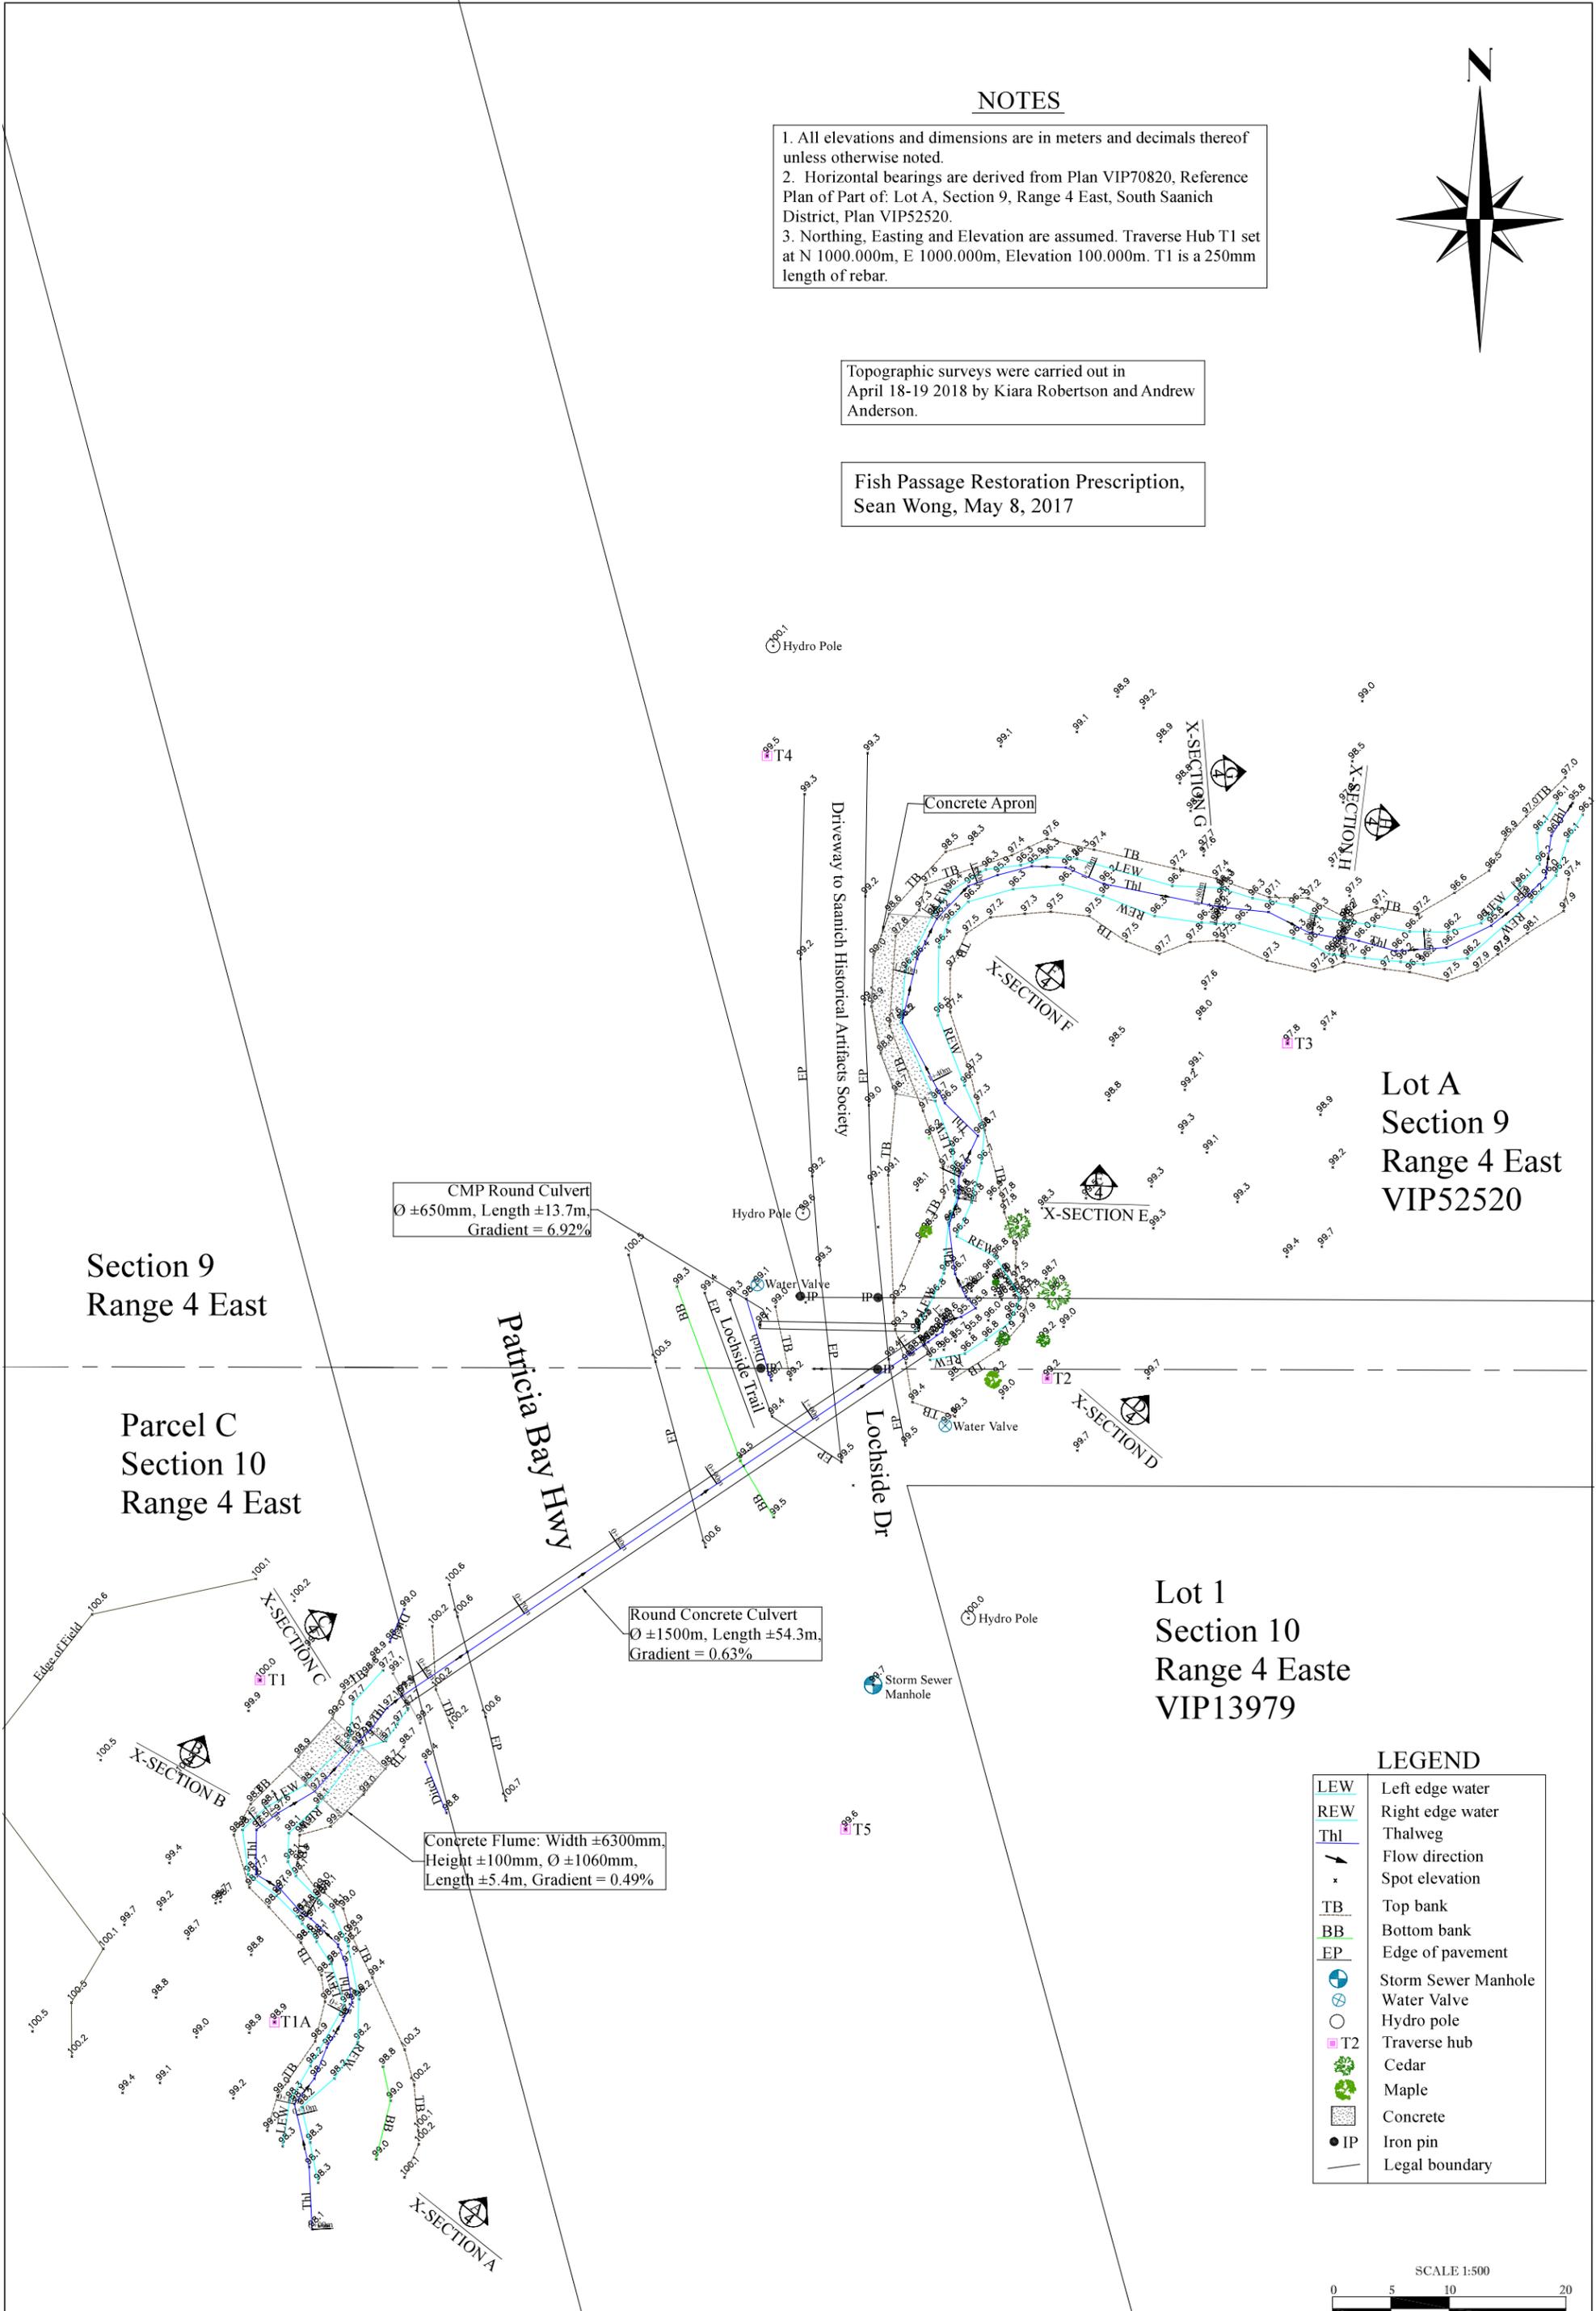
CMP Round Culvert
 Ø ±650mm, Length ±13.7m,
 Gradient = 6.92%

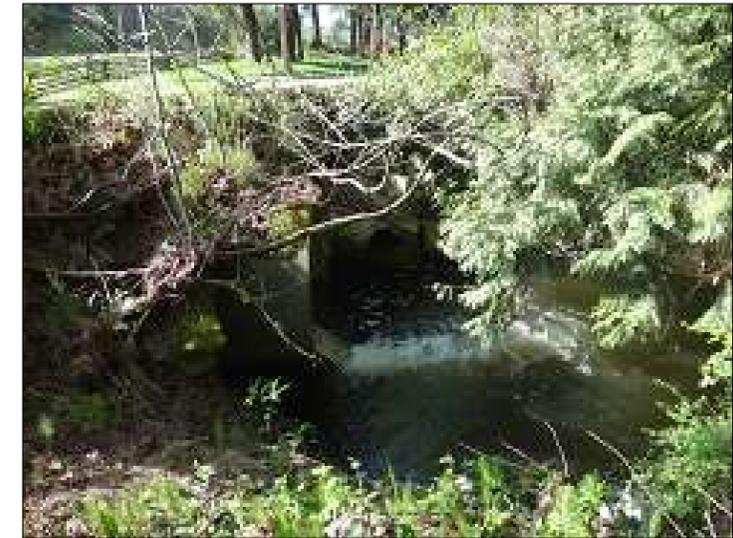
Outlet

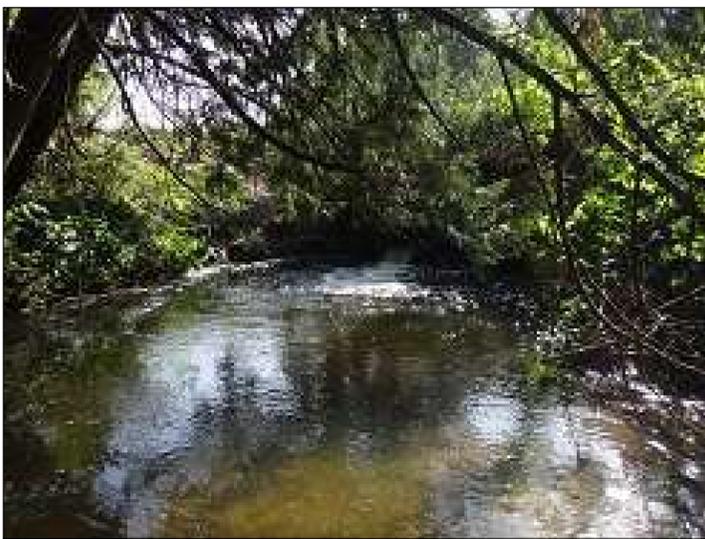
Outlet Pool
