SARRANA CREEK RESTORATION

Peter Blenman
ER 390 Final Project

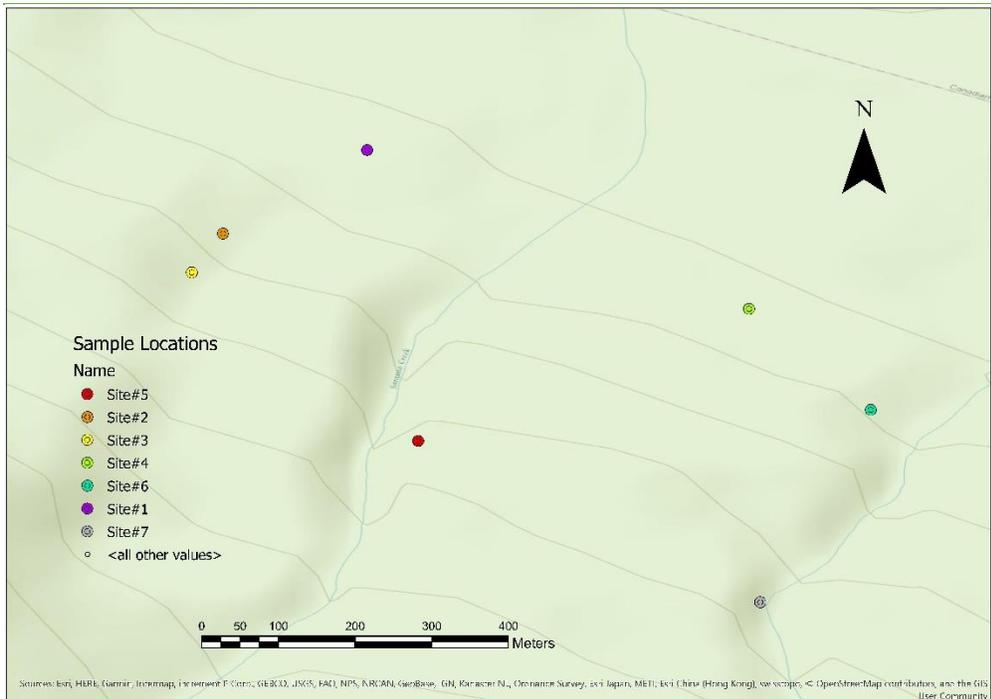
Figure 7 Map of the study using Sentinel-2 satellite imagery acquired on October 5/2018 (Google earth).

The site had five different braids of water flowing about 50-metres west of the original drainage of Sarrana Creek. The source of the hydrological regime shift was not obvious though there are many cumulative blowdown events in the study area (refer to Figure 8). The main drainage has not been flowing since 2009 or earlier. The west side of the creek has saturated soils and evidence of watering up. This side has multiple layers of blowdown creating terraces and micromorphology that retains the water and impacts the vegetation regime. On the east side of the original creek channel, the soils are xeric, and the vegetation composition is different than the rest of the study area (refer to figure 7).

Site #2 is located upslope from sample #1 on the west side of the original creek channel (refer to Figure 7). The tree layer consists of cedar and spruce and the shrub layer has mostly thimbleberry, blueberry, and huckleberry (refer to table 5 and Figure 11). The site is wet with stiff club mass dominating the moss layer and larger shrubs growing such as highbush cranberry and saskatoons.

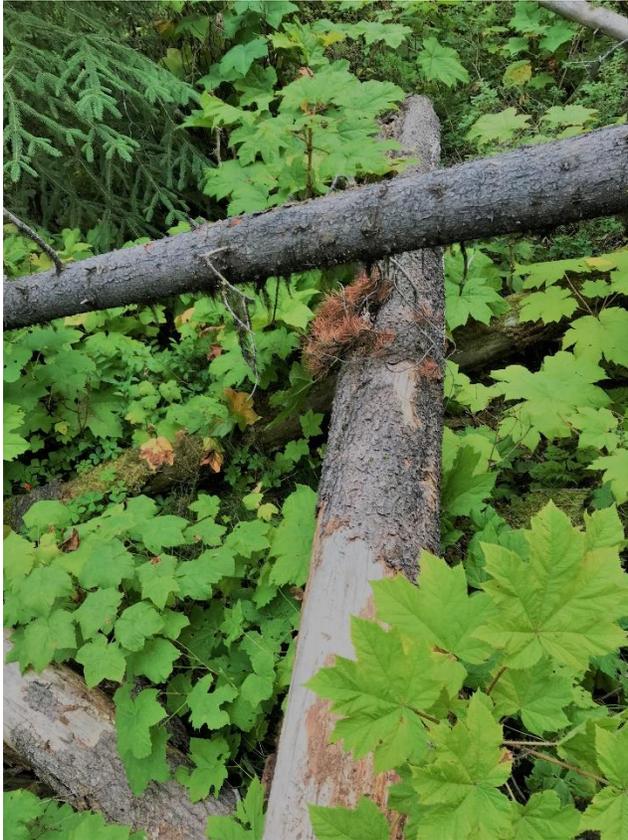
Figure 9 Evidence of recent blow down at the study site.

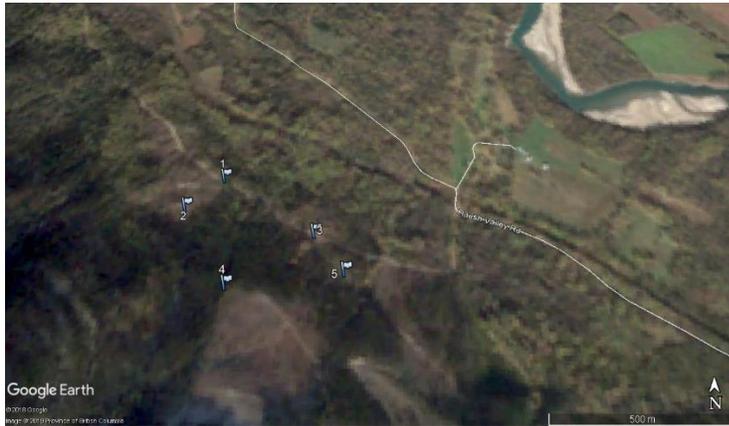
Figure 17 Soil pit sample and slope site assessment locations (Google earth).

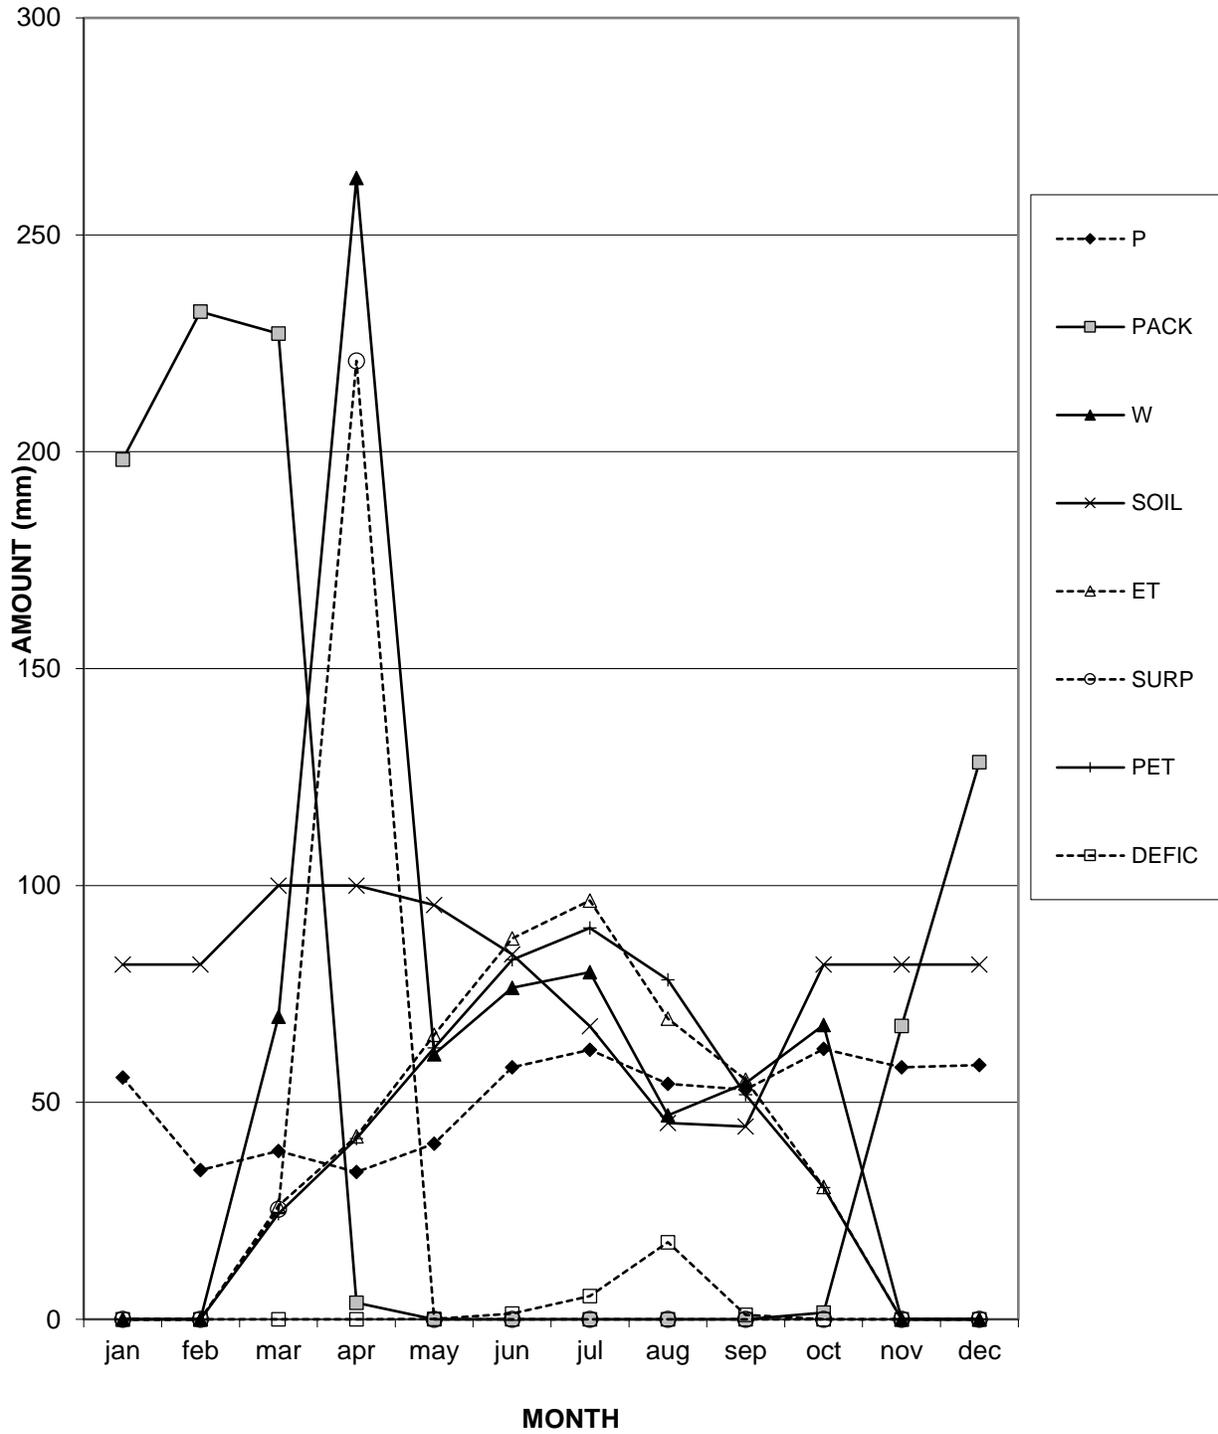
Figure 18 Thornthwaite-type Water Balance model chart for Dunster BC.

Month:	MONTHLY WATER BALANCE DATA												Year
	Temperatures in C, water-balance terms in mm.												
	J	F	M	A	M	J	J	A	S	O	N	D	
P	55.7	34.4	38.8	33.9	40.5	58.1	62.1	54.3	53	62.3	58.1	58.6	610
T	-7.7	-4.2	0.16	5.69	10.1	13.5	15.4	14.8	10.5	5.07	-2.2	-6.9	4.52
F	0.00	0.00	0.03	0.95	1.00	1.00	1.00	1.00	1.00	0.85	0.00	0.00	
RAIN	0	0	1	32	41	58	62	54	53	53	0	0	354
SNOW	56	34	38	2	0	0	0	0	0	10	58	59	256
PACK	198	232	227	4	0	0	0	0	0	2	68	128	
MELT	0	0	57	224	4	0	0	0	0	9	0	0	294
INPUT (W_m)	0	0	70	263	61	76	80	47	54	68	0	0	720
PET	0	0	24	42	63	83	90	78	52	30	0	0	462
$W_m - PET$	0	0	44	221	-5	-13	-22	-40	-2	37	0	0	
SOIL	82	82	100	100	96	84	68	45	44	82	82	82	
$\Delta SOIL$	0	0	18	0	-4	-11	-17	-22	-1	37	0	0	
ET	0	0	26	42	66	88	97	69	55	30	0	0	473
$SURP=W-ET-\Delta SOIL$	0	0	25	221	0	0	0	0	0	0	0	0	246
$DEFIC=PET-ET$	0	0	0	0	0	1	5	18	1	0	0	0	26

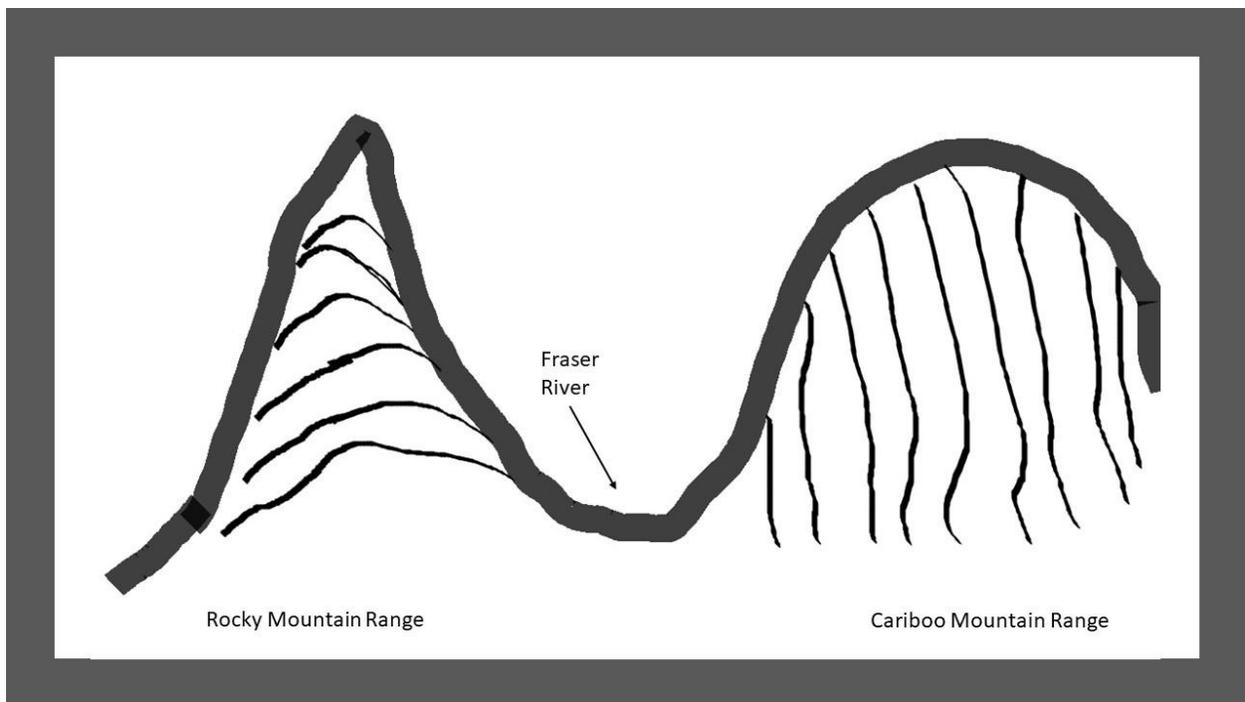
Figure 19 Drawing representation of the rock structure of both mountain ranges at the study site.

The assessment was conducted on the ridge above the sample sites by driving up to about 1200 metres and then walking on the spine. The top of the ridge resembled a tor with blocks cleaving to either side of the ridge and falling down the slopes. The ridge here is the front range of the Cariboo Mountains and thus the sedimentary rock is thrust vertically upright creating the block shape (refer to Figure 19). The placement of this rock allows for water to seep, flow, and be held in the rock. The mass wasting mechanism of freeze and thaw hydrofracturing impacts the structural integrity of the slope (Bierman & Montgomery, 2013). Above the Sarrana creek drainage, there is evidence of cleaving of the ridge that had contributed to previous landslides.

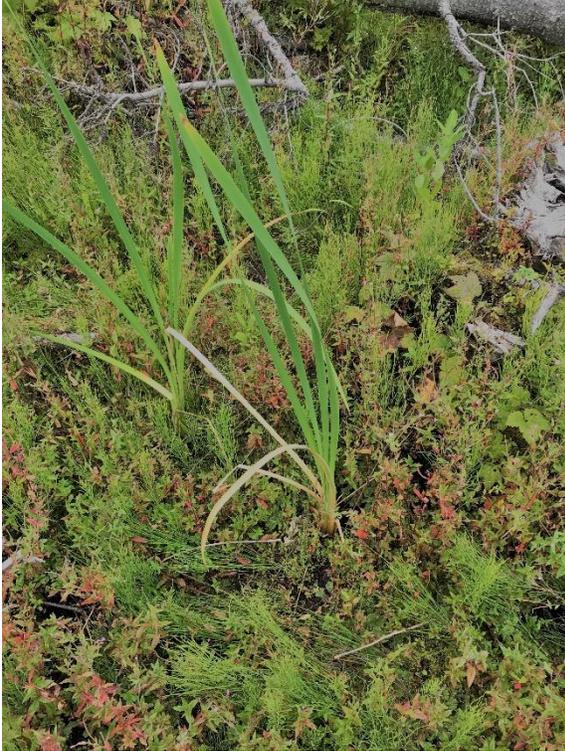
Figure 20 Wetland area with bulrush growing in the saturated soil.

The area adjacent to the west side of the old creek channel is seeping water and conifer regeneration is non-existent. The wet area is about 10 metres higher than the old creek channel. Thus, the old creek channel is not the root of the extra water on the site. The 400-metre stretch of area has saturated soils, subterranean water flow, and new channels of overland flow from blowdown and anthropogenic trail building. The site also has downed logs that are creating micromorphological that is creating pools and terraced wetlands (refer to Figure 20). Sites 2 and 3 on the westside have Devil's Club present indicating subsurface water flow as the club likes to have it's roots wet but not continuously submerged in water (refer to Tables 5 and 6) (Kranabetter & Shaw, 2003). The Devil's Club is also an indicator of areas prone to seepage and wetness. The forest manager commented that one of the braids of Sarrana Creek that empties into the ditch runs clear all year around (Theissen, 2018). This suggests that the groundwater and surface flow are intertwined in this area being an influent and effluent region for groundwater recharge and discharge (refer to Figure 21) (Bierman & Montgomery, 2013).

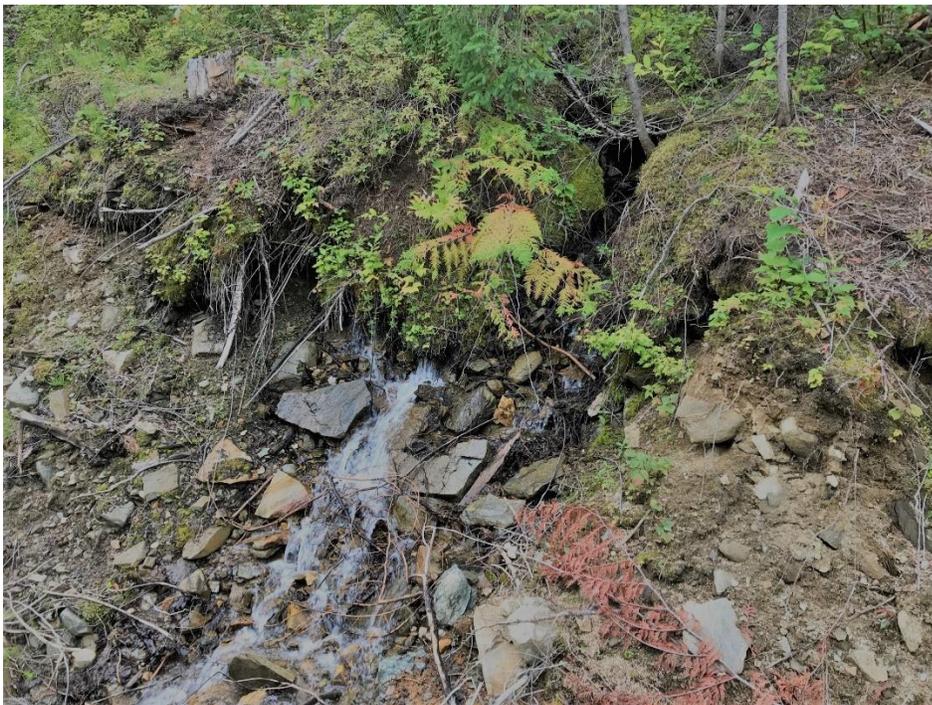
Figure 21 Stream outlet that runs clear all year around.

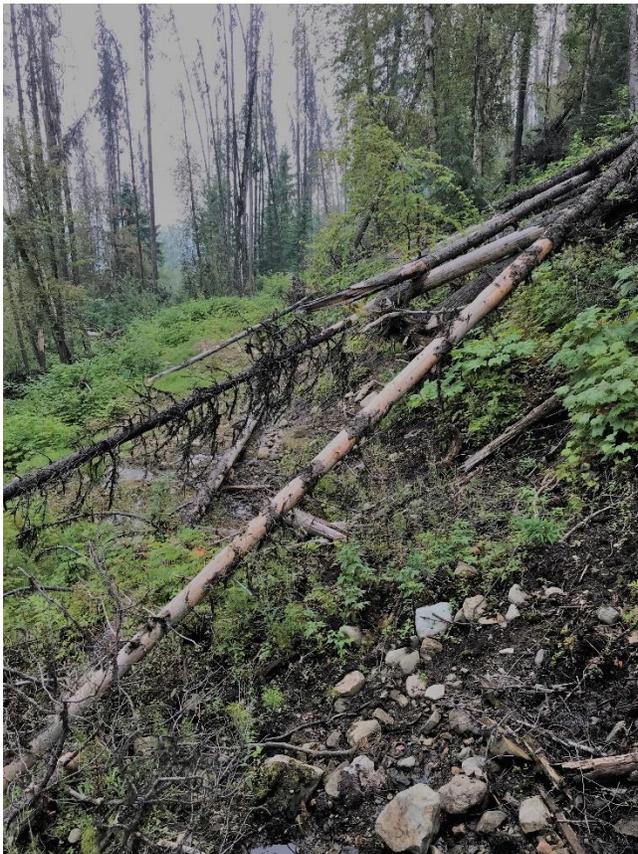
Figure 22 Old skid trail now a new stream braid on the east side of Sarrana Creek.

The riparian east of the old creek channel is a network of small streams and under ground water flows. There is no evidence that blowdown is responsible for the creek's new hydrological regime. The water runs through this area below in rocks and boulders strewn through the area from a previous rock/landslide (refer to Table 11). It also appears that the area has a history of wetness and braided flow with rich organic soil layers and moderate draining soil profiles (refer to table 12). A major problem in the region is that because there is no formal channel flow, tracks made from timber harvesting have become new streams (refer to Figure 22). Above this area, the soils are dry and show no evidence of the soil saturation in the riparian area (refer to Figure 7). The vegetation sampled site 8 and 9 also have Devil's Club present suggesting similar hydrology to the wetland area west of the creek bed. This area is draining better and the ditch along the road below is collecting the 400-metre swath of water flow.

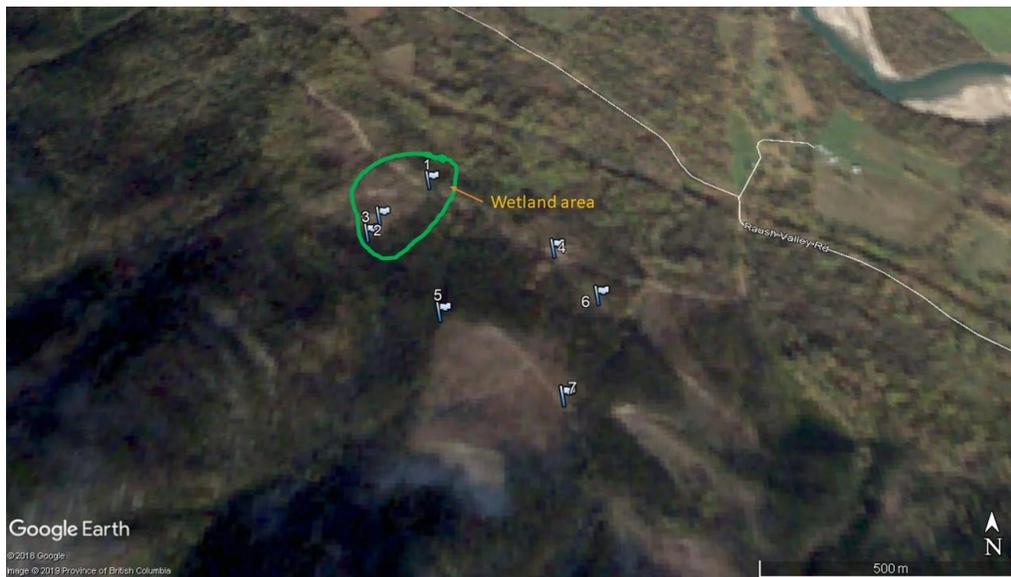
Figure 23 Sentinel-2 image showing the sample sites and the wetland area (Google Earth).

The restoration of the area west of the Sarrana Creek would involve the removal of fallen logs that were left after harvesting and MPB mortality blowdown and regeneration of tree species. At this point in time, the area is too wet for such a restoration endeavour and a couple of years the hydrology may become more xeric. The results of the Thorn Waite model showed that the soil in the region is subject to evaporation of water from the soil (refer to Figure 18). If the DCF is set on growing trees on this site in the future the site needs to be drier that could be accomplished by planting water-loving trees such as willows. In my opinion the area should be left alone because the hydrology in this region is unpredictable and uncertain. In addition, the wildlife in the area is thriving in these sites due to the biodiversity and large swath of forest between the cut blocks.

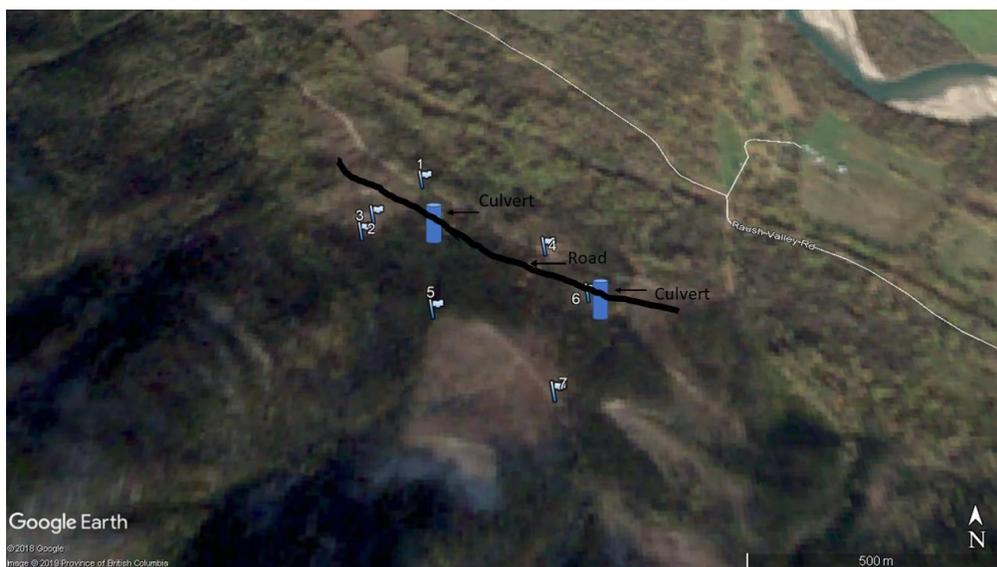
Figure 24 Sentinel-2 image showing the sample sites and the culvert installation area (Google Earth).

The area between the two creek channels in Figure 24 along the logging road needs timber removal and a couple of culvert installations. The water is now running as sheet flow over the roadway this is because the ditches are full of large and coarse woody debris with no culverts to handle the sporadic flow in this region. The first step would be removing the wood from the existing ditch. Then excavating the ditch to be about 0.75 meters deep and 1.66 meters wide. At the two original creek channels, two culverts would be installed with a diameter of 0.5 meters. The road and terrain are already graded naturally for the two culverts to collect water for about 175 meters in each direction (refer to Figure 24).
