RESTORATION OF CENTENNIAL WETLANDS, SHERWOOD PARK, ALBERTA:
WEED COMMUNITY COMPOSITION AND MANAGEMENT

Final Report
ER390 | Restoration of Natural System Practicum
Brian Eaton
Student ID# V00694761

December 1, 2016

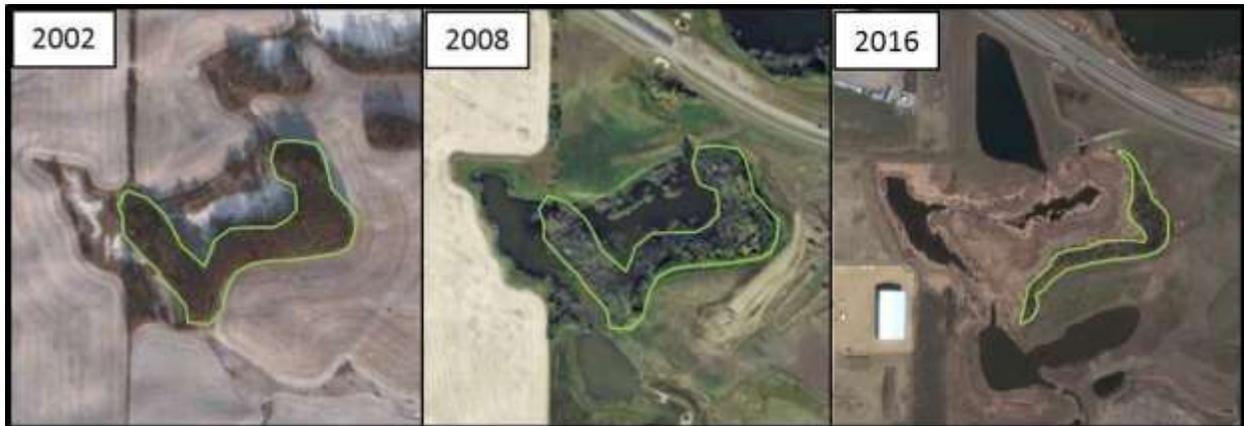
Figure 4. A time sequence showing the original extent of the forest around the Centennial Wetlands (2002), the flooding of the riparian zone (2008), and the loss of a significant portion of forest following the flooding (2016).

The green line outlines the extent of standing trees in each image. Images modified from Google Earth, version 7.1.2.2041.

been impacted by a flood event in the wetland complex in 2008, followed by extensive mortality within the stand (Figure 4). As a result, more than half of the previously treed area was converted to snags and abundant downed woody debris (Figure 5). While this material provides habitat for many smaller wildlife species, including cavity nesters, invertebrates, and small mammals, this level of fuel loading represents a potential fire hazard.

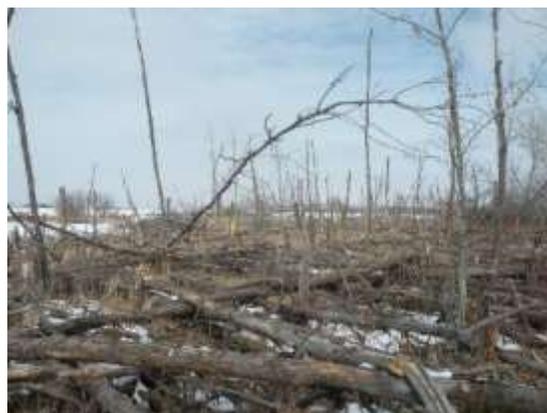
Figure 5. Snags and downed woody material along wetland margin at Centennial Wetlands, Sherwood Park, Alberta.

These trees were killed during a flooding event in 2008. Photo by Brian Eaton, March 29, 2014.

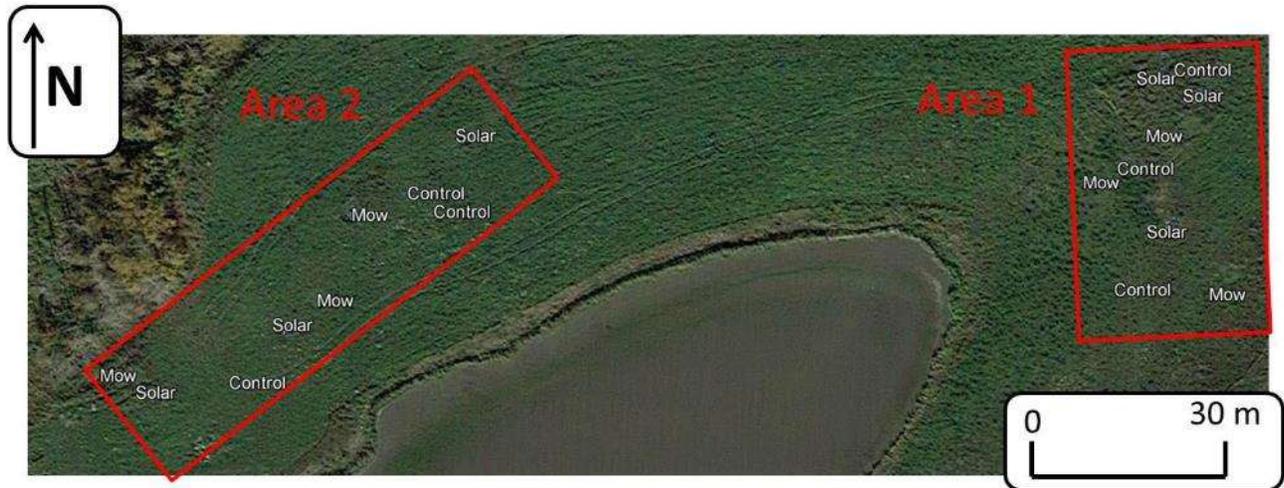
Figure 6. Approximate distribution of weed control trial plots.

The label for each plot type is centred on the plot location; there are 3 replicates of each plot type in each Area. Plot types: Control = no treatment; Mow = mowed to ground level; Solar = solarisation - mowed to ground level and covered with black plastic. Image modified from Google Earth, version 7.1.7.2606; image dated September 29, 2015.

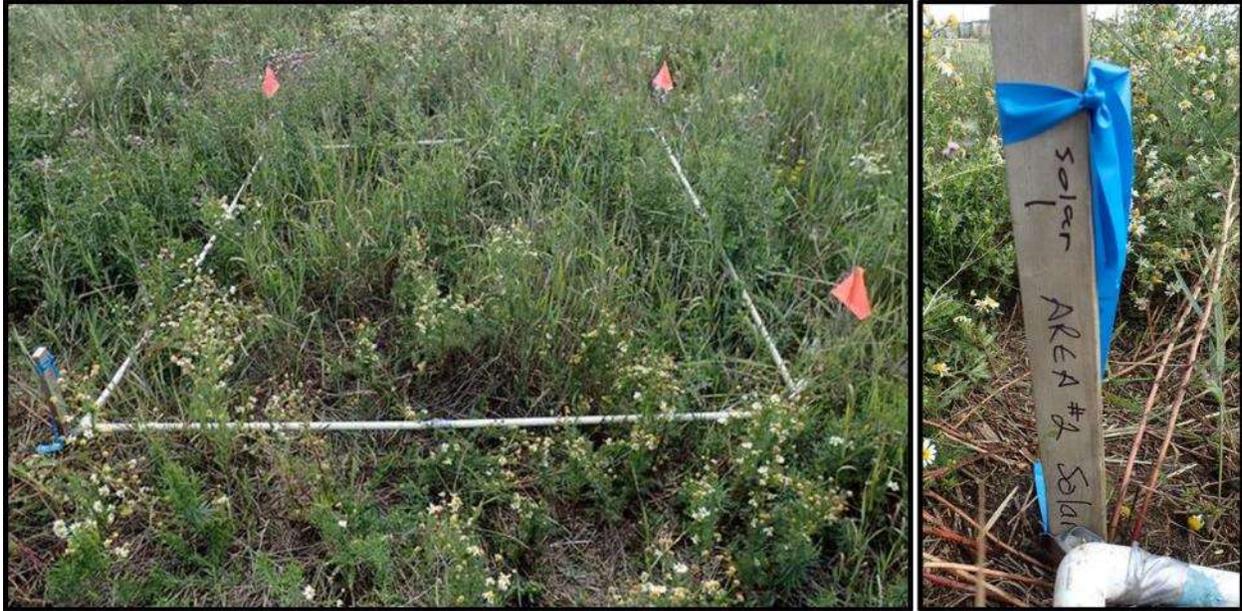
Figure 7. Setting up the weed control and treatment plots.

Left panel: A PVC plot frame (2 m x 2 m) in use while setting up a plant sampling plot. Note the flags used to mark three of the plot corners, and the wooden stake used to mark the fourth. Right panel: close-up of wooden stake showing labelling for Area 2, Solarization plot 1.

Initial plot sampling was done using a 2 m x 2 m plot frame constructed from PVC pipe (Figure 7). This was placed on each plot so that the corners of the frame aligned with the corner markers, and the relative canopy cover of each plant species - not just weedy species - was visually estimated, as was percentage of plot area covered by bare soil and plant litter (e.g. dead plant material, etc.). All cover estimates were done by the same person (Kiley Marchuk, who has a background in environmental monitoring and plant identification) throughout the project. Cover estimates were made to the nearest 5%; where a species covered less than 5%

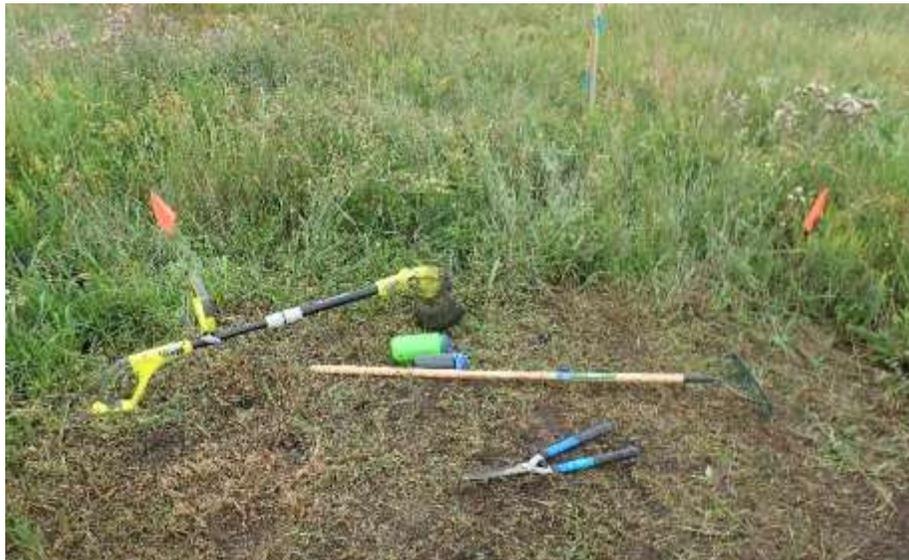
Figure 8. Tools used to remove plant material on the mow and solarisation plots. The cordless whipper-snipper was an essential tool in making this process efficient.

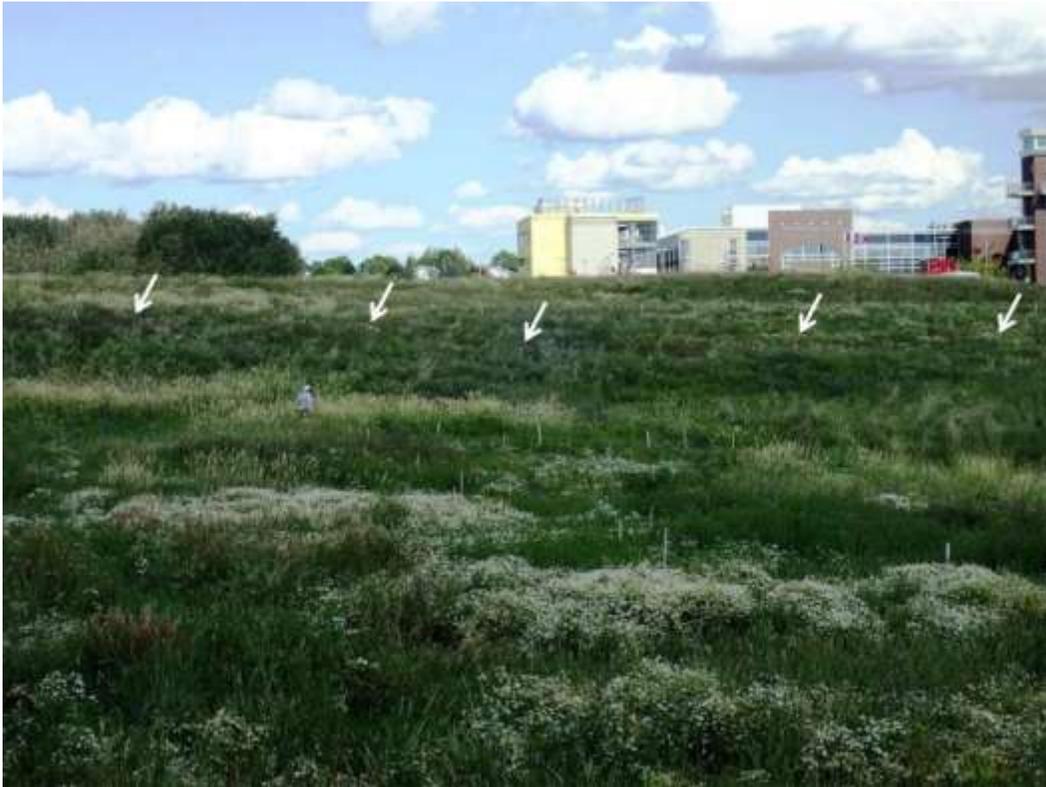
Figure 12. This view is looking east toward the Area 1 weed plot, and number of which are indicated by the white arrows. The white flowers are scentless chamomile, the dominant weed species in the area.

This image also shows that the wetland is not far from the urban areas of Sherwood Park; the local fire station is clearly visible to the upper right of image (the brown building). My wife is visible in the middle ground, in the left of the image, and provides a sense of scale.

Initial plot surveys identified a total of 28 species across all 18 plots (Table 3). Six of these species were weeds, accounting for an average 39% of the plot area, with scentless chamomile and Canada thistle forming the bulk of the weedy coverage overall (Figure 10). There was considerable variation across the individual plots, with some supporting very few weeds, and others approaching 90% weedy cover (Figure 11). Overall, the area around the restored wetland was dominated by extensive stands of scentless chamomile (Figure 12).

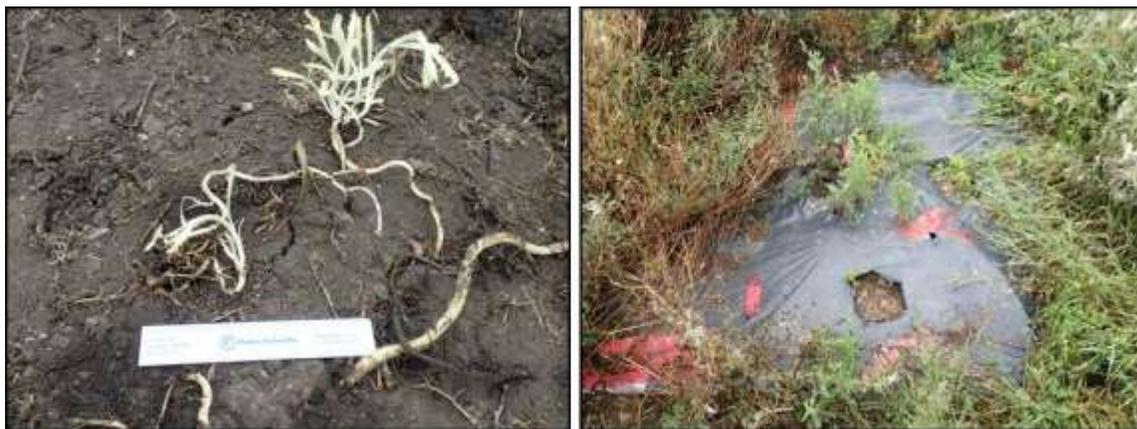
Figure 15. Plants growing in solarization plots.

Left panel: plants growing under plastic sheeting; right panel: weeds growing from holes in plastic sheeting.

The solarization plots supported few plants, and those that did grow under the plastic sheeting were typically linked to other individuals who supported them via root systems or rhizomes (Figure 15). Other individuals took advantage of rents in the plastic to grow with little immediate competition (Figure 15). Species diversity was low across all the solarization plots.
