***Grosbeak Creek:
Use of Bioengineering Techniques in the Restoration of an
Agricultural Ditch at 1020 Beckwith Avenue, Saanich, B.C.***

ER390 | Environmental Restoration Project

University of Victoria | 2016

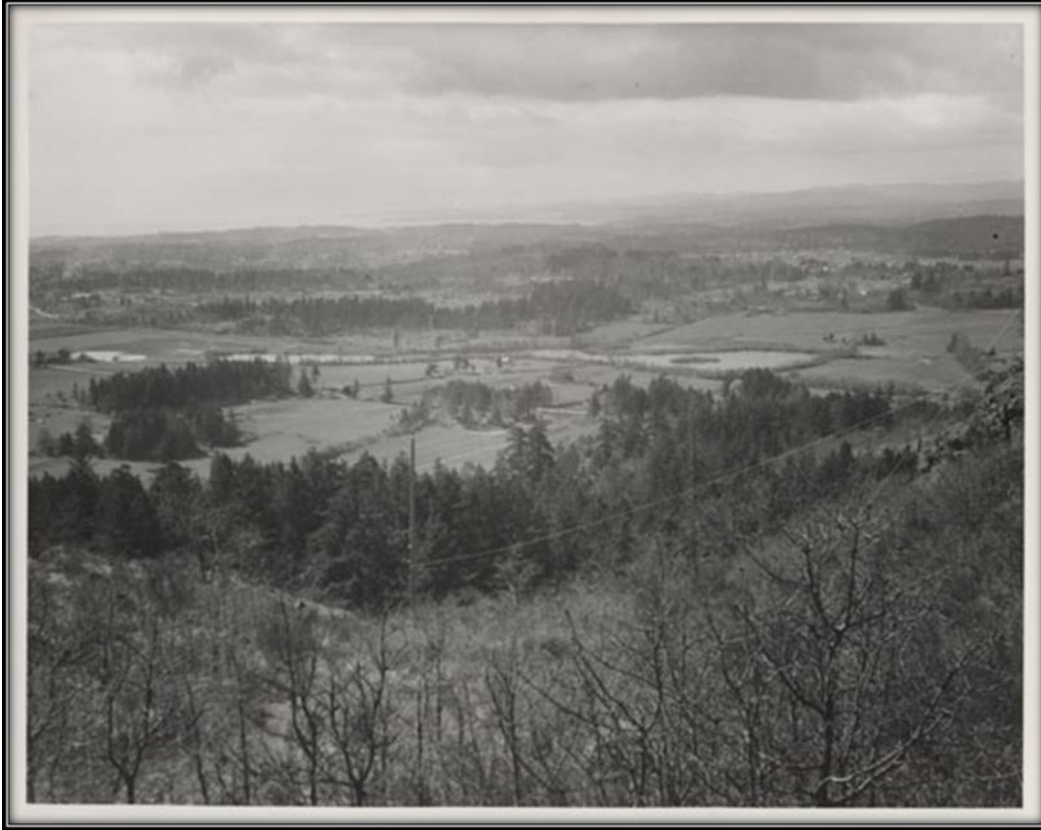
FIGURE 5. VIEW FROM THE SUMMIT OF MOUNT DOUGLAS LOOKING SOUTH WEST OVER THE VALLEY, GROSBEEK CREEK IS VISABLE AS A FAINT DARKER LINE. RETRIEVED FROM SAANICH ARCHIVES AUGUST 29, 2015

Since 1975 the Blenkinsop Valley has been protected as farmland by the Agricultural Land Act (Ministry of Agriculture, 2016). A photograph (Figure 5) taken from Mt. Douglas looking Southwest gives visual information about the agricultural use of the valley in 1905 (Saanich Archives, 2016). In this photo we see the project site in the mid to upper right quarter.

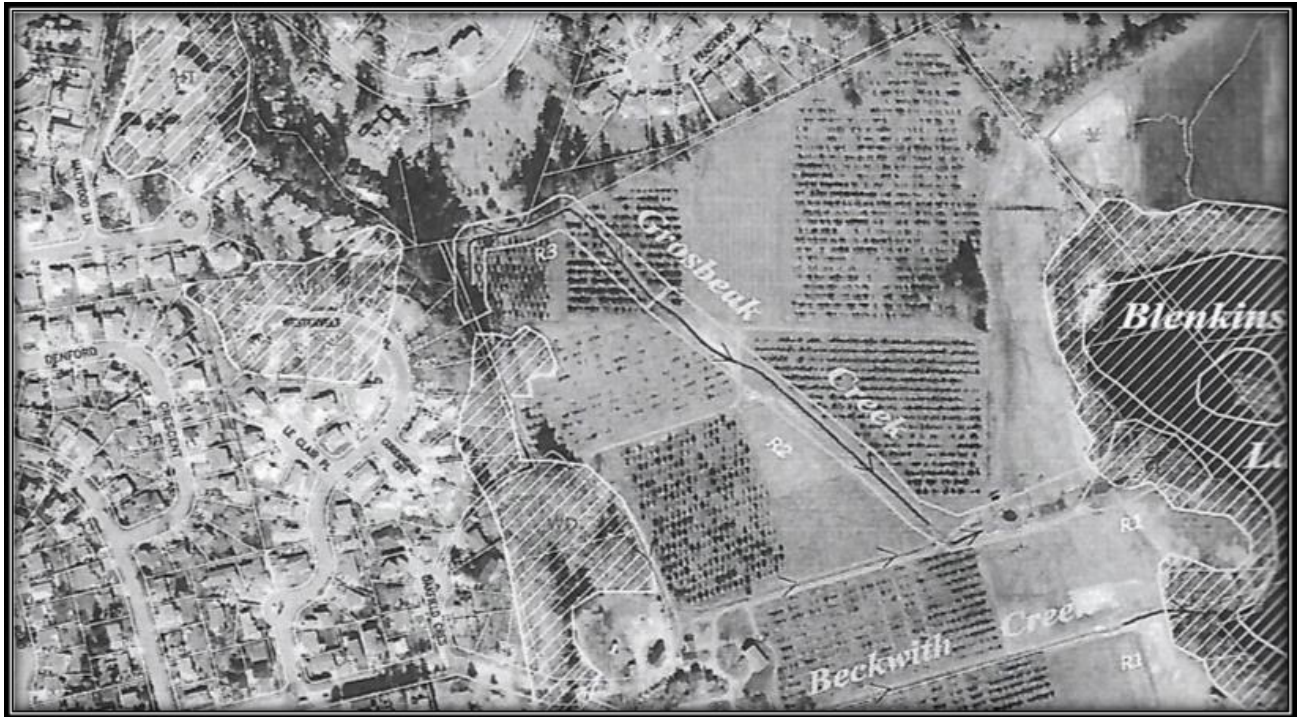
FIGURE 6. FIRST KNOWN MAP TO NAME GROSBEAK AND ASSIGN REACHES. THE CORPORATION OF THE DISTRICT OF SAANICH, ESAI MAP NO. 27, 1998.

In personal conversation Adriane Pollard (Manager, Environmental Services, Planning Department, District of Saanich) recalls Grosbeak Creek being named name when the ground work was done for the Environmentally Significant Areas Inventory (ESAI) in 1998. This name was chosen because of the Grosbeak bird community known to reside in the riparian areas of Blenkinsop Lake. At this time the creek was assigned three reaches, defined in Figure 7. The project area is in reach three.

The Creek has five to six clear dividing areas and restoration will be divided into stages, one per year. The ESAI has labelled the creek into three reaches (Figure 6), stage one of the project starts with the area designated reach three at the forty-one meter elevation, beginning at the West property line where the creek enters from Vailwood Park.

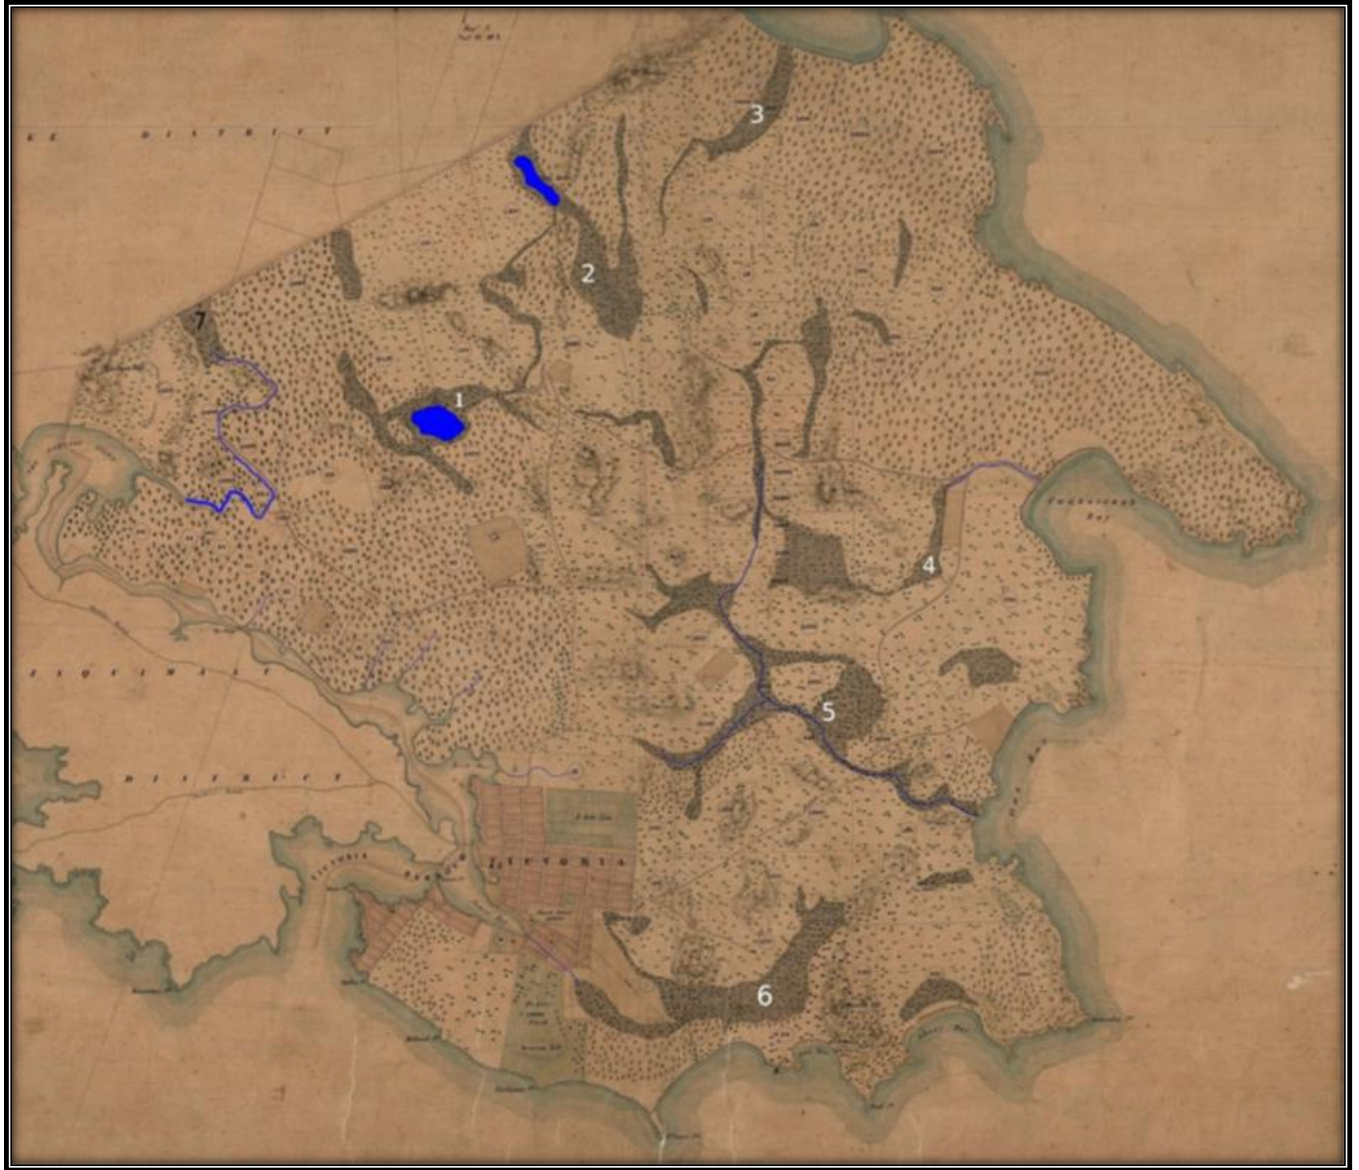
FIGURE 7. VICTORIA DISTRICT OFFICIAL MAP, 1858. FROM TOWNSEND (2009). DEFINING NUMEROUS WETLANDS AND RIPARIAN CORRIDORS IN THE VICTORIA DISTRICT, AREA 1- SWAN LAKE, 2- SWAMPY AREAS AROUND BLENKINSOP LAKE AND OAK SAVANNAH ON WEST SIDE OF LAKE, 3- DOUGLAS CREEK.

None of these maps indicate any streams flowing into or out of Blenkinsop Lake. Figures 7 and 8 show how the surveyors used different marks to indicate coniferous from deciduous trees. The other maps are viewable in the appendix. Townsend (2009) numbered the map facilitating the search for familiar waterways and interpreting surveyor's notes from the Victoria District Official Map, 1858 (Figure 7); they describe the project area as Oak Savannah and mark out wetlands and riparian cover, coniferous trees are represented by stars and deciduous trees marked as cloud like circles. Swampy wet areas with riparian vegetation are defined by gray- green, waterways by blue. These maps provided valuable information when piecing together what the hydrological patterns were in the valley.

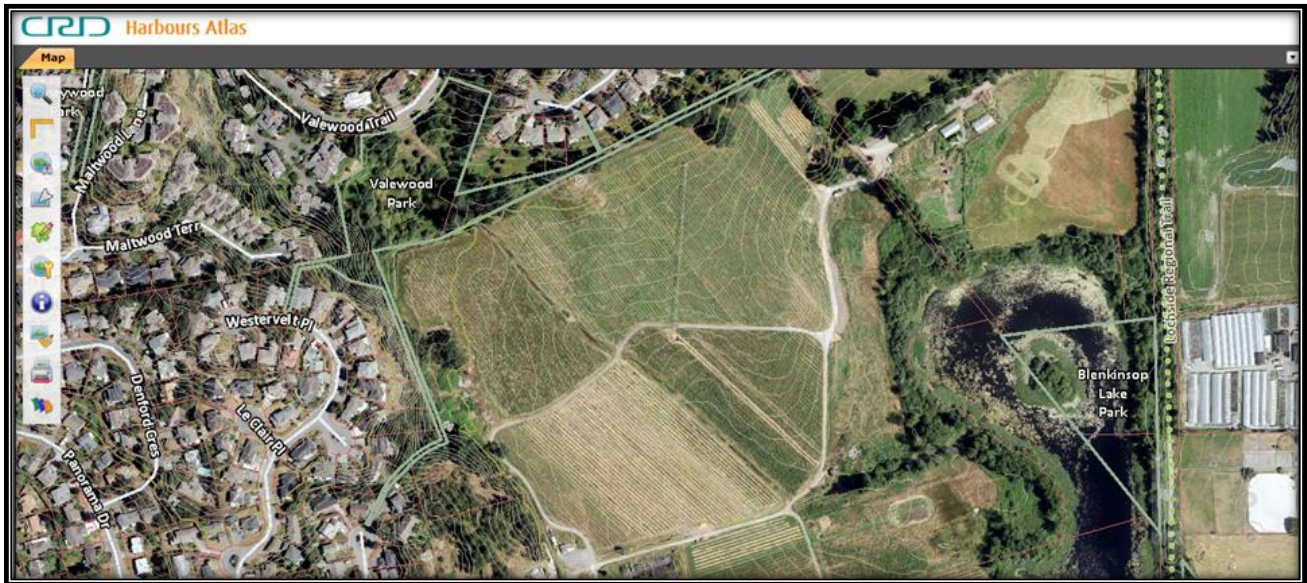
The topography lines are visible in Figure 9; each line represents a one meter drop in elevation and shows the elevational gradient directing rainwater into the creek.

FIGURE 9. CRD ATLAS TOPOGRAPHICAL MAP OF PROJECT AREA, THE WHITE LINES INDICATE A ONE METER DROP IN ELEVATION. MAP CREATED JANUARY 4, 2016.

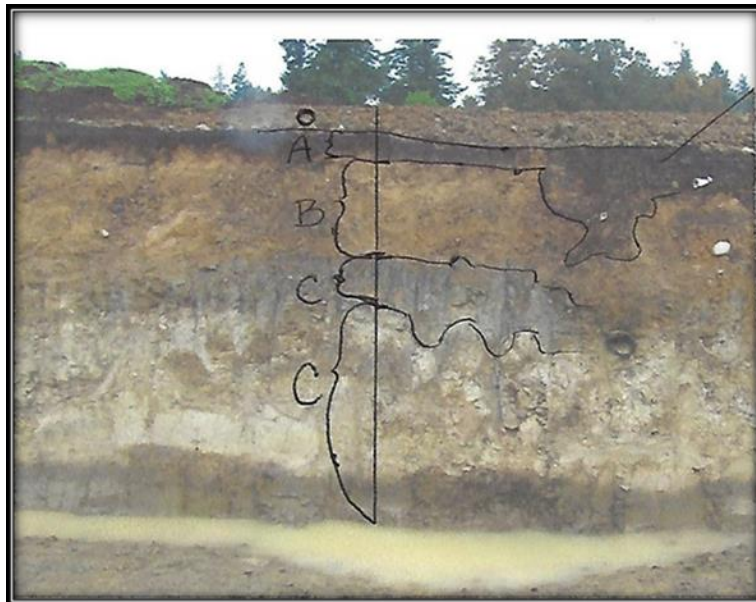
FIGURE 11. FOUNDATION EXCAVATION LOCATED 50M FROM RESTORTION SITE GIVES VISUAL OF C HORIZON.

Approximately fifty meters from the project area a house construction is beginning, the foundation excavation (Figure 11) gives visual detail of what is lying under the restoration area. Compass reading for this excavation is 48 29'5"N, 123 22'6"W and elevation is 40m.

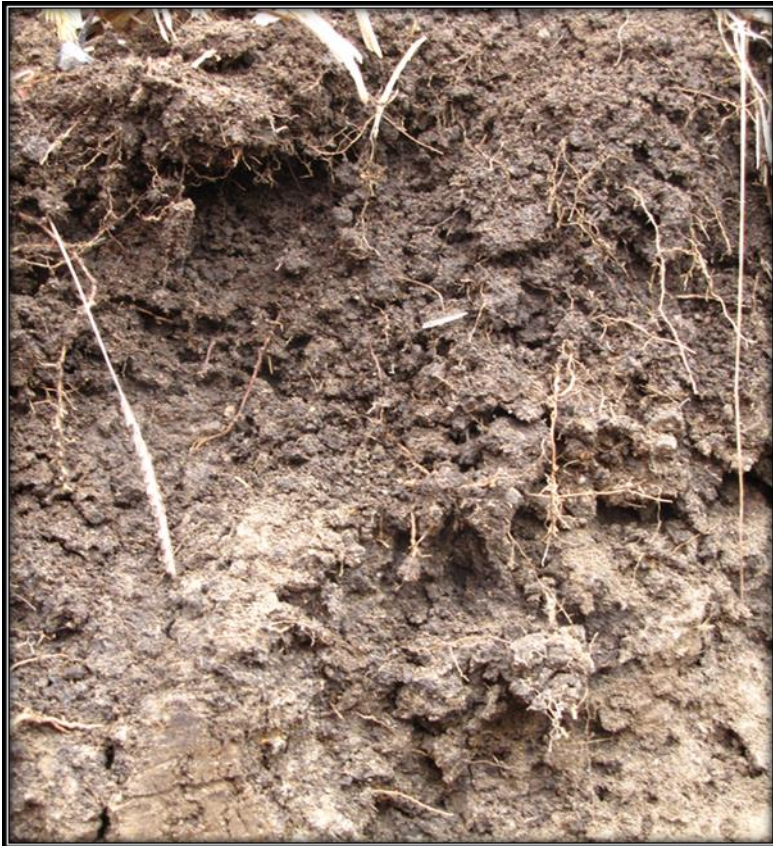
FIGURE 15. SOIL HORIZON LAYERS A AND B FOR CREEK BANK.

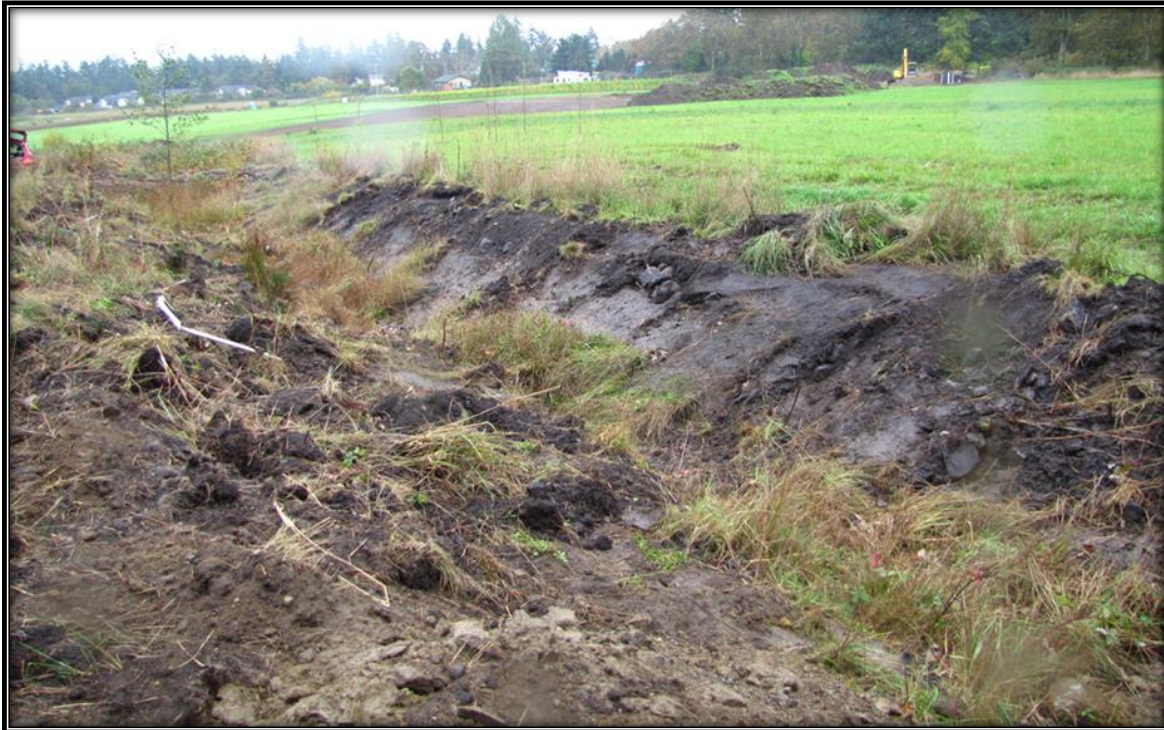
FIGURE 17. BLACKBERRY REMOVAL COMPLETE SEPTEMBER 2015.

Through August and September Blackberry (*Rubus armeniacus*) bushes were removed from the project area (Figure 17), it was important to dig them out as they are tenacious and will easily regenerate. An excavator was used to scrape the bank edges and then removed the brambles and root balls to a compost pile.

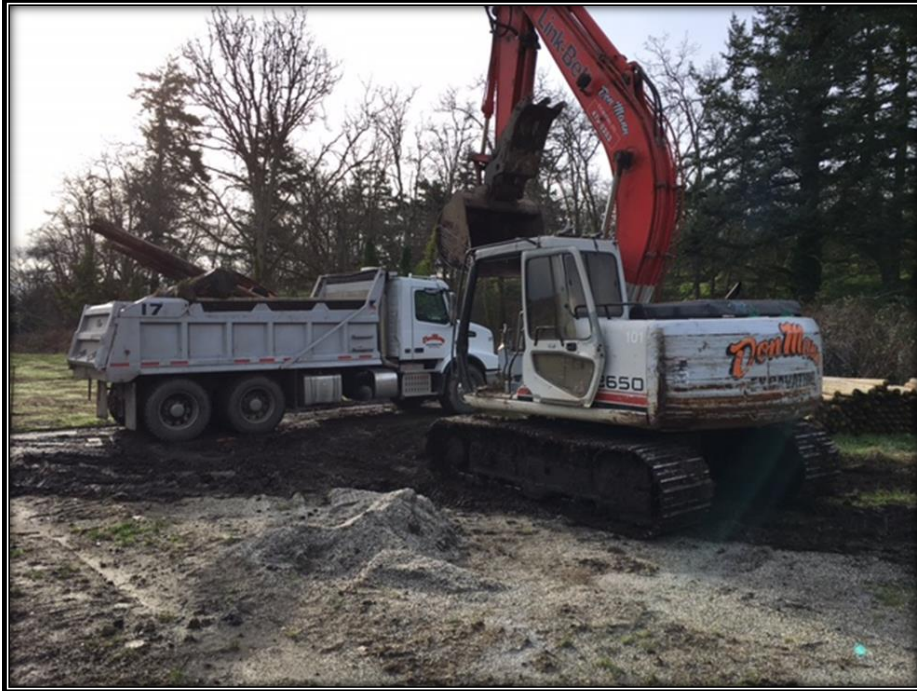
FIGURE 18. TANDEM AND EXCAVATOR USED IN THIS RESTORATION.

Tools used in this restoration were; Excavator, Tandem (Figure 18), Loppers, Pruning saw, Secateurs (Figure 19), Shovel, and Chain Saw.

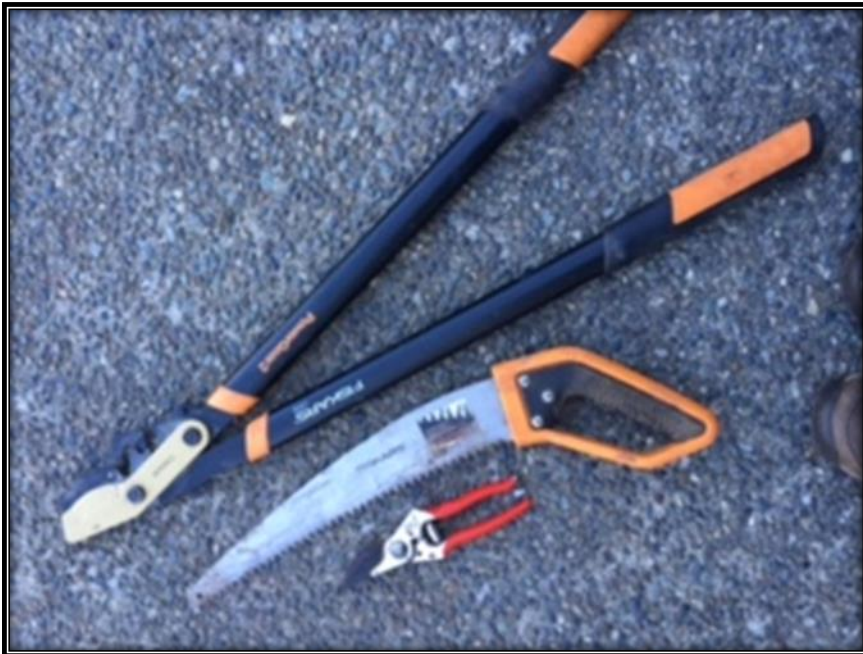
FIGURE 19. LOPERS, PRUNING SAW AND SECATEURS USED IN THIS RESTORATION.

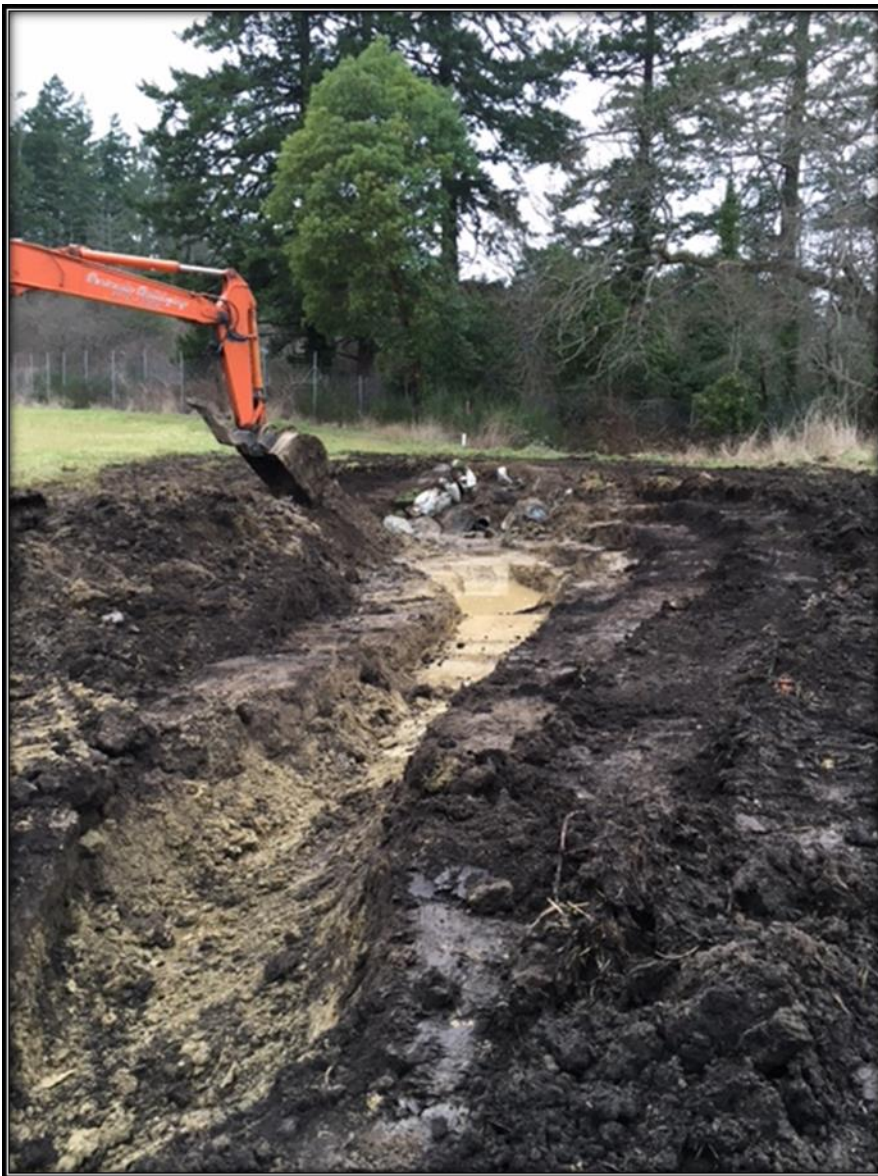
The restoration extends thirty-five meters along the creek and planting extends approximately fifteen meters wide along that length. January 8, 2016, the creek was reshaped. Figure 20 shows the end of the first day of reshaping.

FIGURE 20. FIRST DAY OF RESHAPING ACCOMPLISHED BY MEANS OF AN EXCAVATOR.

The existing ditch was reshaped to include a pool; shelves carved along the steep banks have created more accessibility. The creek has been gradually directed North for seven meters then bends sharply to the West forming an elbow. 75mm minus round stone placed along the creek bed will dissipate storm water velocity and stabilize the stream bed. Larger rock and small boulders have been placed in the stream to create riffles.

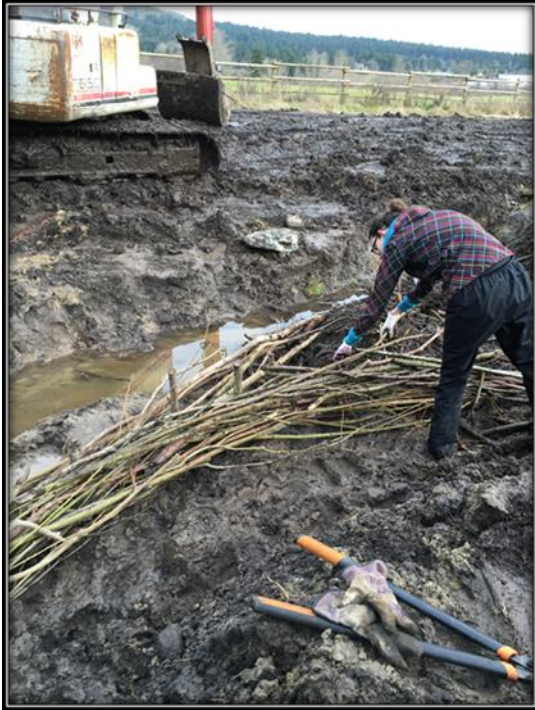
FIGURE 21. BUILDING A WATTLE ON THE SOUTH BANK.

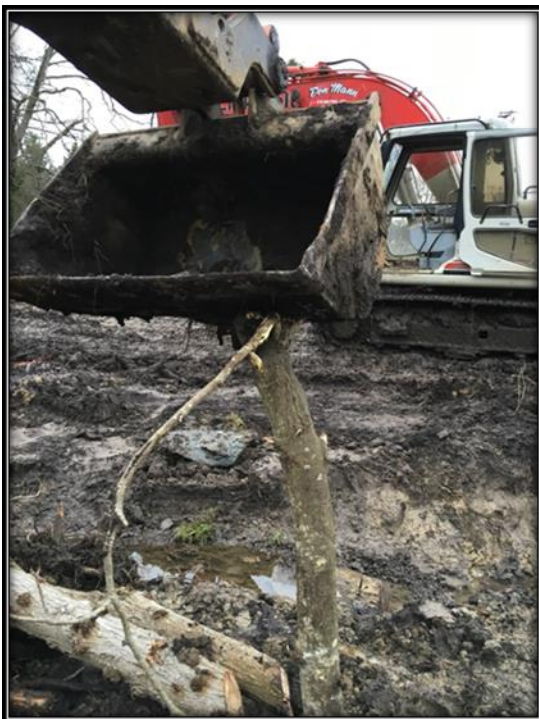
FIGURE 22. COTTONWOOD STAKES ARE BEING INSERTED BY THE EXCAVATOR BUCKET EXERTING GENTLE PRESURE.

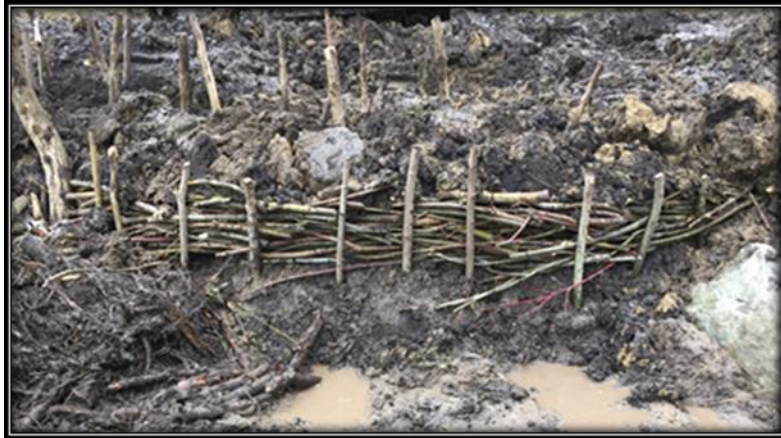
Through January and February bioengineering took place. To keep the stake material viable, stakes were cut in the morning and staked into the project area in the afternoon. Four wattle sets were built, three on the South bank and one on the North bank. Figure 21 depicts a wattle being constructed. Long straight branches were sought. They were cut where their diameter was 10 to 15 centimeters, and then divided along their length into one meter segments. The upper thinner ends were used horizontally in wattle building. The excavator was used to help insert the cuttings three quarters of their length into the ground (Figure 22). With each rain event the mud became deeper and began to hinder progress. Figure 23 shows a completed wattle.

FIGURE 23. A FINISHED WATTLE, FEBRUARY, 2016.

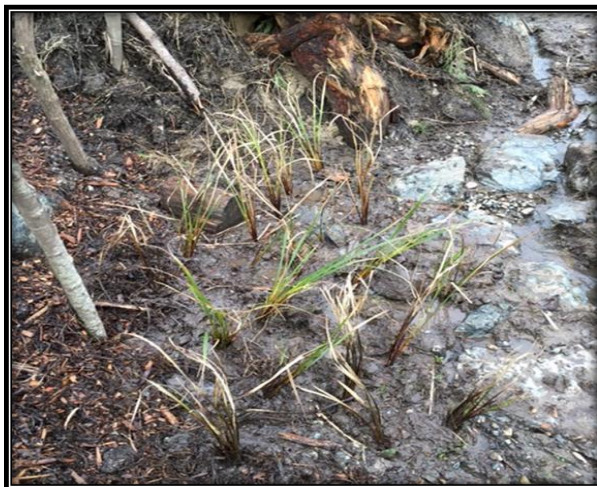
FIGURE 24. CAREX SITCHENSIS PLANTED ALONG THE WATER'S EDGE.

Forty five Red Alder (*Alnus rubra*) seedlings were dug from a donor site and transplanted along the upper banks in mid-February. In March *Carex sitchensis* were rescued from a job site where they were about to be buried in fill and placed in pockets along the water's edge (Figure 24).

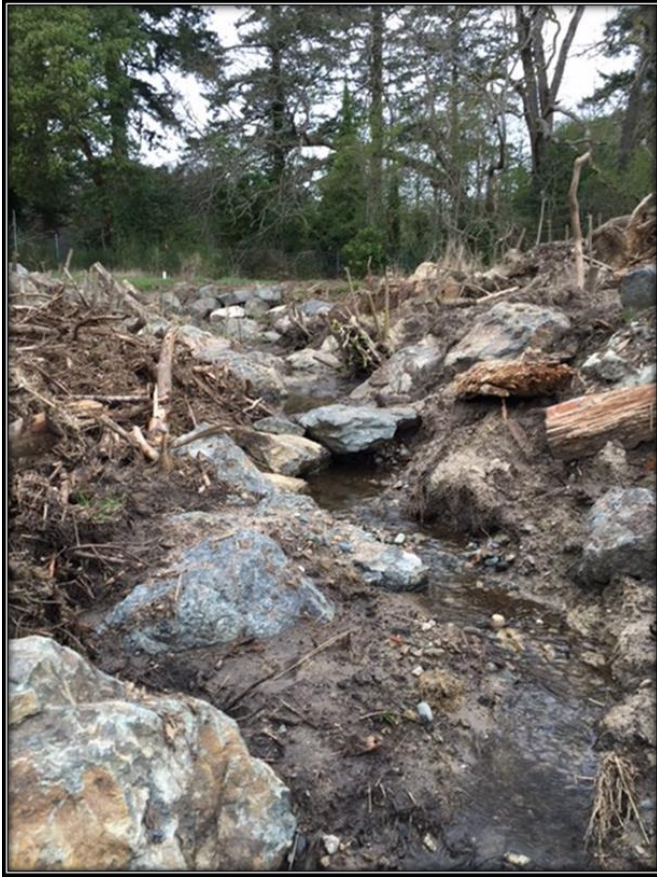
FIGURE 25. RECONSTRUCTION COMPLETE.

Figure 25 shows the restoration complete and ready for mulch. In May 2016 the project area had dried out enough to be able to move mulch onto the site. This last stage of restoration was to spread mulch to protect the bare soils. Six tandem loads of wood chippings were spread approximately eight centimeters thick.

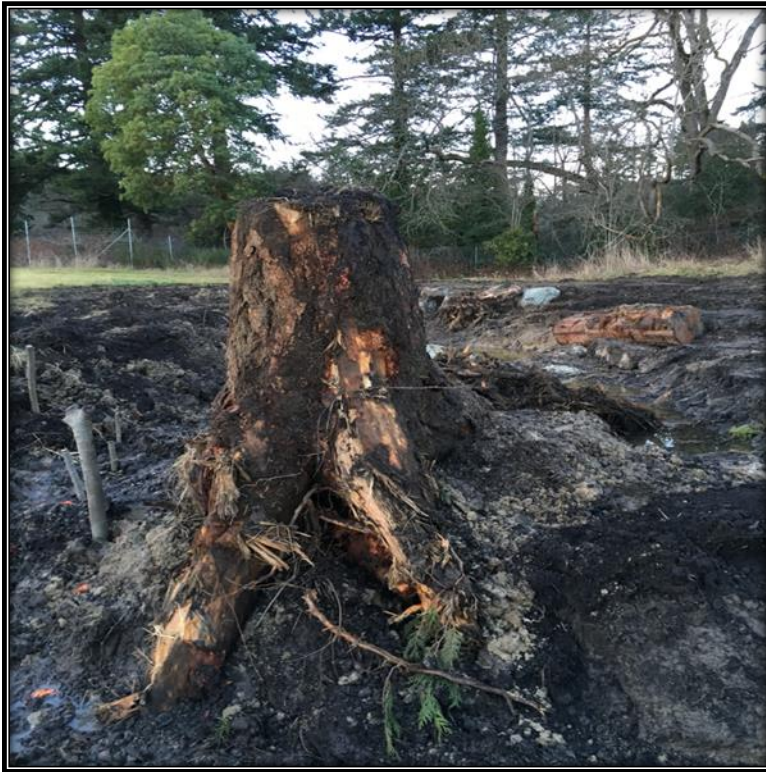
FIGURE 26. A LARGE STUMP PLACED IN RESTORATION.

Four loads of boulders were placed along the creek bed and within the restoration area. The stump in Figure 26 was rescued from a construction site.

As the creek was reshaped the excavated excess soil was placed to the West, building a mound where the large stump now sits (Figure 26) and the Cottonwood stakes were placed, this area was much easier to stake as the soil was loose. Soil became highly compacted where excavator moved alongside the creek to enable reaching across the span when shaping the creek, placing boulders and CWD. Compaction here made staking more difficult. Future monitoring will assess the vegetation survival rate between the loose and compacted soil.

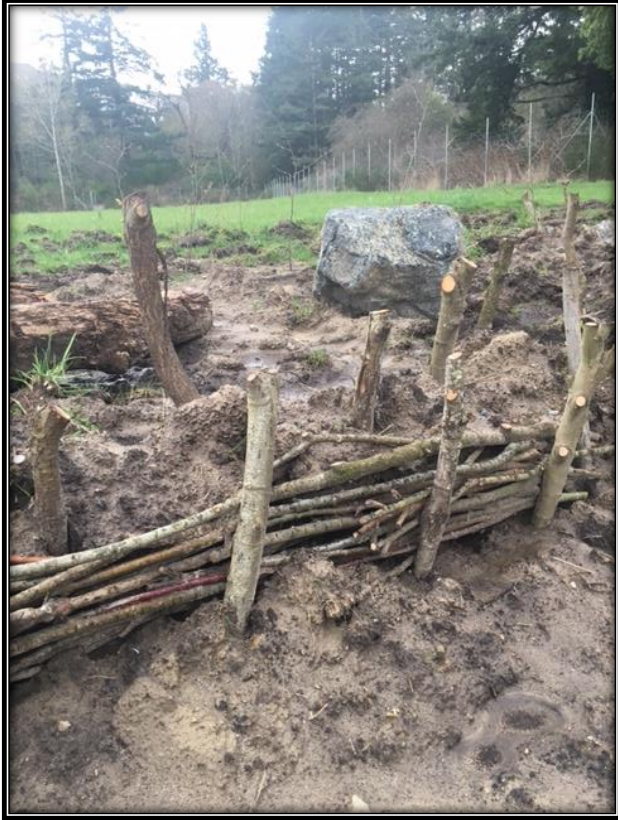
FIGURE 27. AFTER A HARD RAIN CLAY BEGAN TO OOZE UNDER AND THROUGH THE WATTLE.

Figure 27 is a picture of the clay oozing through one of the wattles. With each rain event the clay became more liquid, four of the stakes in this wattle became unseated and fell toward the creek 45 degrees, but the stakes have now rooted and put out leaves (Figure 28), as they continue to grow they will become more stable. Winter rains transformed the heavy clay to a semi liquid form making it difficult to maneuver through the site.

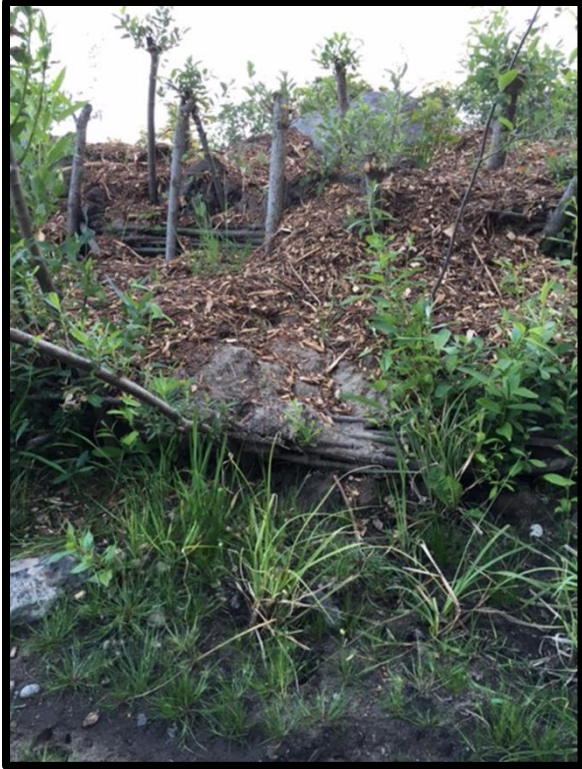
FIGURE 28. WILLOWS HAVE LEAFED OUT AROUND THE DAMAGE FROM OOZING WET CLAY.

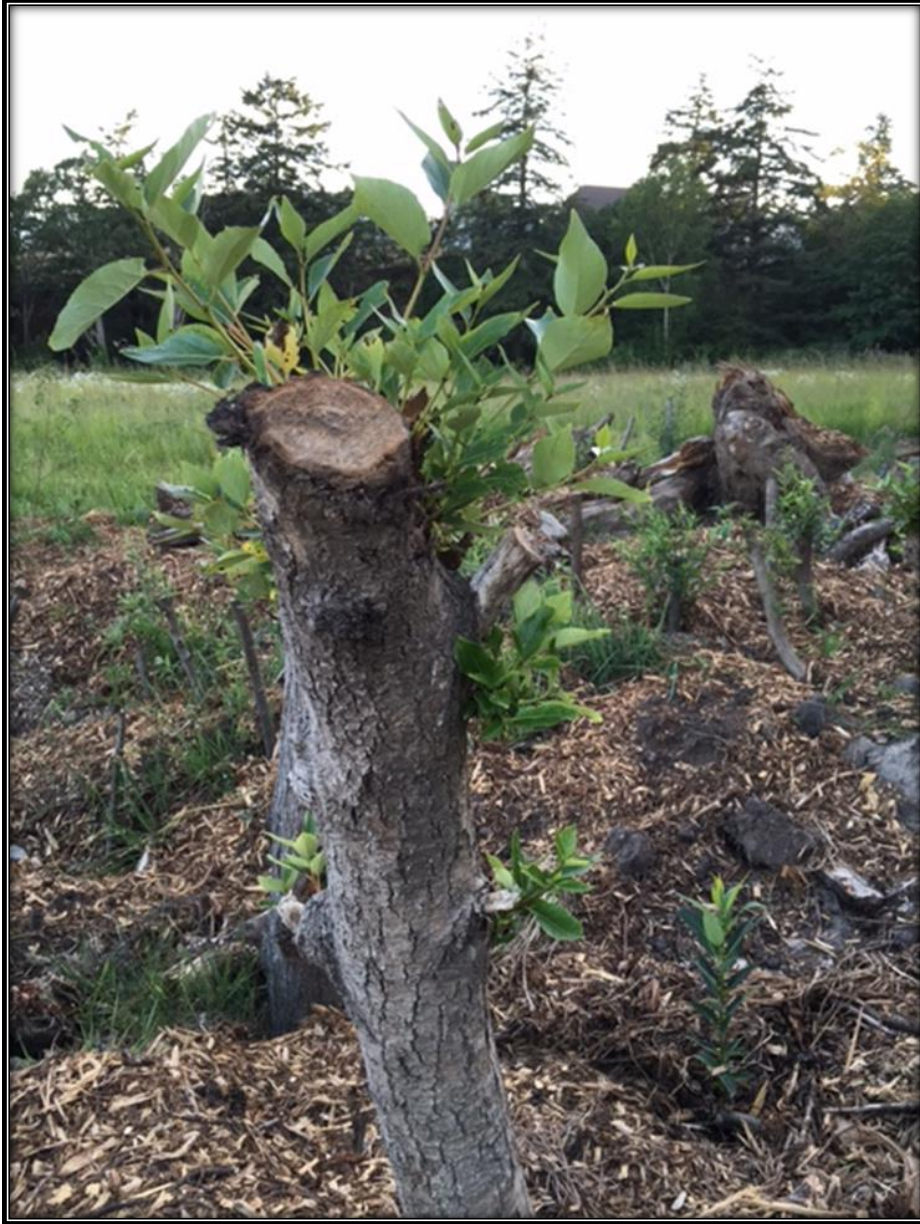
FIGURE 29. COTTONWOOD STAKE WITH NEW GROWTH EMERGING.

Cottonwoods (*Populus trichocarpa*) are large trees and will eventually reach a height of 50 meters (Pojar & MacKinnon, 1994). Figure 29 shows emerging new growth on a Cottonwood. Figure 30 shows the half meter growth on the willow stakes as of May, 2016.

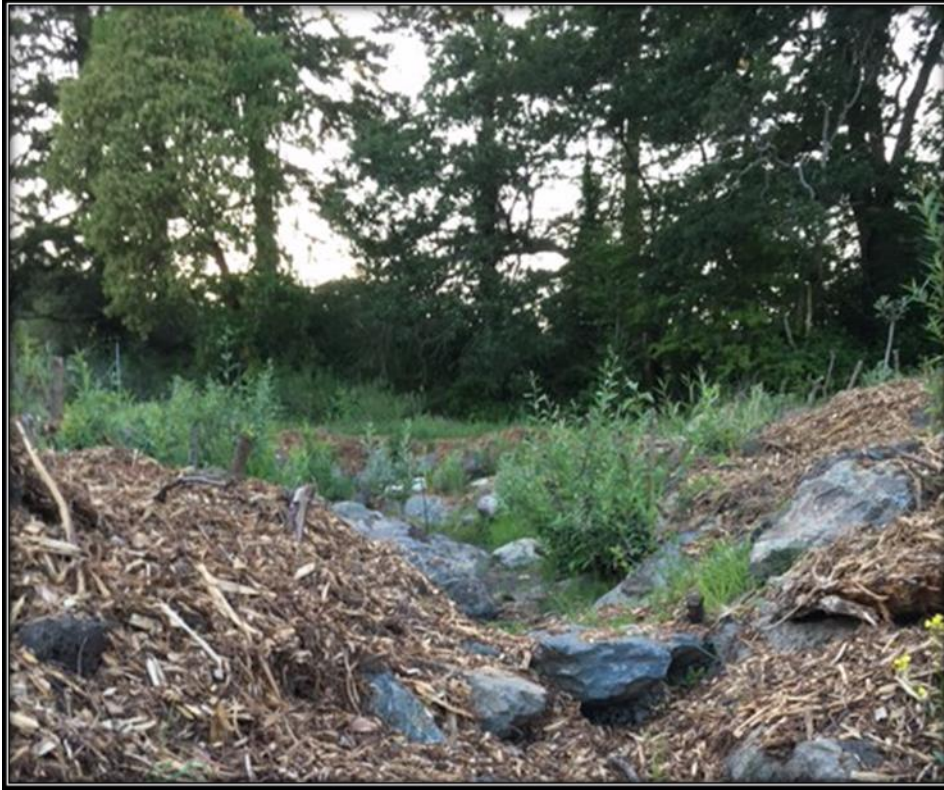
FIGURE 30. STAKES HAVE PUT OUT HALF A METER OF NEW GROWTH, MAY 2016.
