**Riparian restoration of 32E Greenbelt, along Quibble
Creek, to enhance canopy cover and limit urban
impacts within the wildlife corridor**

Prepared for the Restoration of Natural Systems Program, University of Victoria
Written by Cassidy Patton
In Partnership with the City of Surrey
April 2020

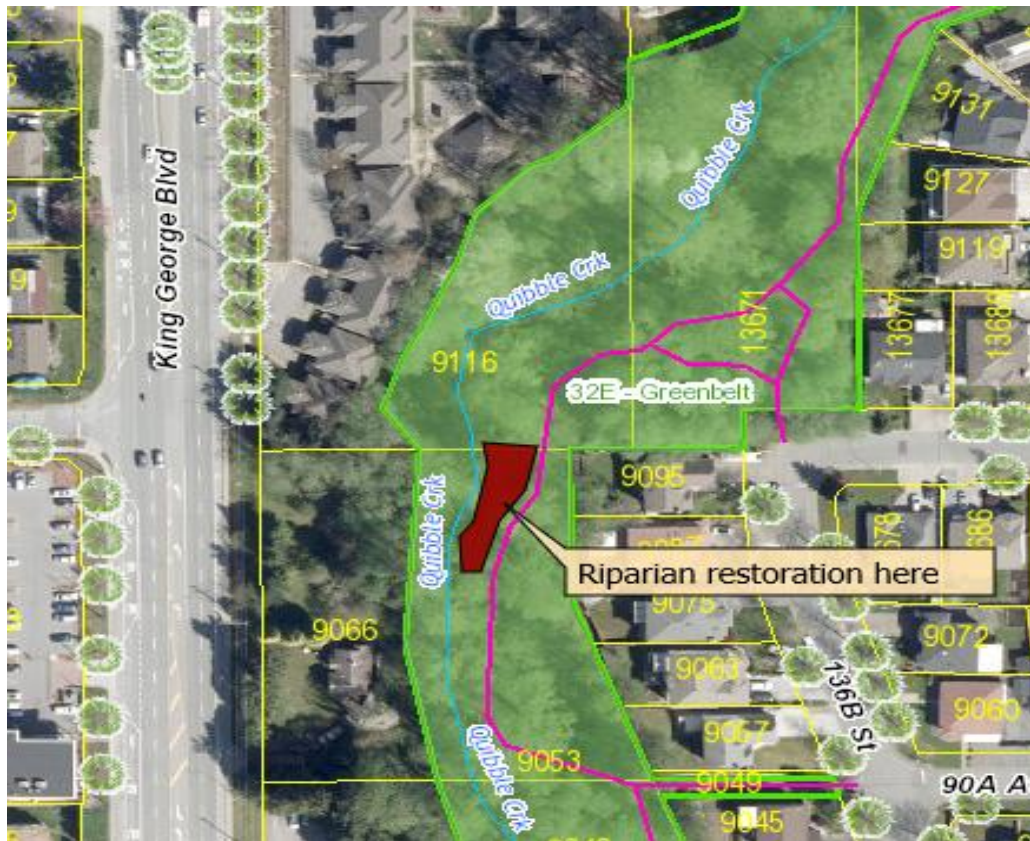
Figure 2: COSMOS map

The riparian restoration site is highlighted in red and is found on the eastern bank of Quibble Creek within 32E Greenbelt. Map created through COSMOS and provided by the City of Surrey.

The ~325 m² restoration area is located on the eastern bank of Quibble Creek within 32E Greenbelt (Fig. 2). Although the majority of the creek's banks are covered in Himalayan blackberry (*Rubus armeniacus*), this specific site was chosen as it was located under a large gap in the tree canopy. The direct sunlight had allowed the Himalayan blackberry to reach ~1.5 m in height. Its dense monoculture growth suggests that it has competitively excluded the native shrubs that may have been in the area. To access the site, trailheads are found at 136B St. and 90A Ave., or at 136B St. and 91 Ave (as seen as the pink lines in Fig. 2).

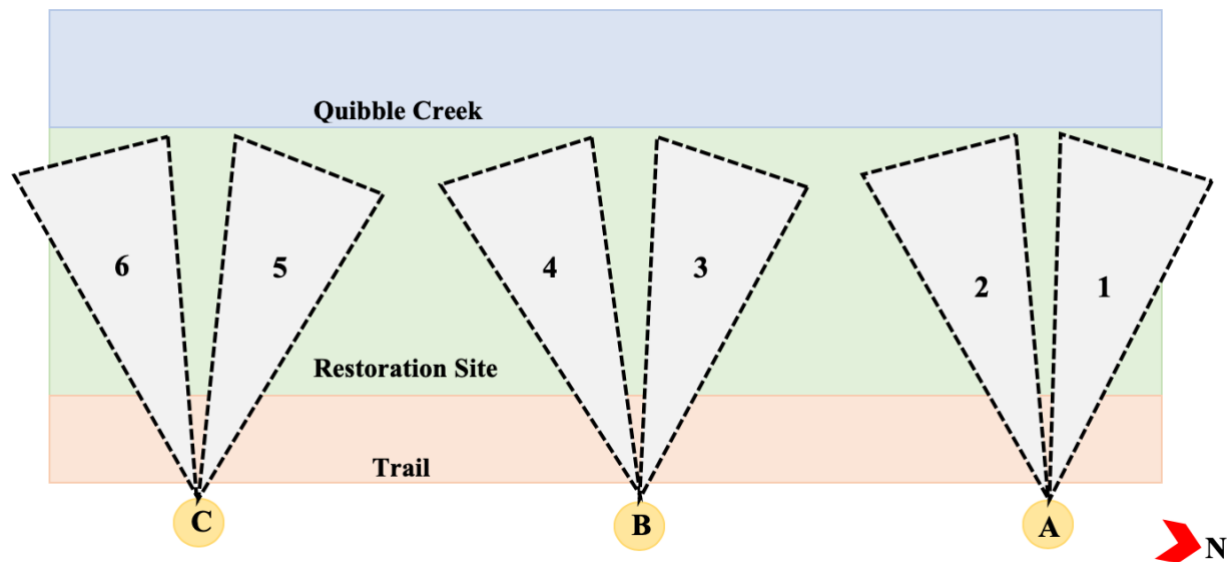
Figure 5: Photo-point monitoring set-up

Set up for photo-point monitoring at 32E Greenbelt. A, B and C indicated the three locations where the camera was placed. Numbers 1 through 6 indicate the field of view of the pictures taken.

The pictures were taken from the eastern edge of the trail, facing the restoration site along the bank of Quibble Creek. As seen in Figure 5, the restoration site was photographed from three locations (A, B and C). At each location, two pictures were taken at different angles so that the photo-point monitoring captured the entire restoration site (Fig. 5). Location A is found on the eastern side of the trail at 49°10'05"N, 122°50'40"W, 0.6 m west of a large black cottonwood (*Populus trichocarpa*) tree that has been flagged with orange flagging tape at breast height. Location B is found on the eastern side of the trail at 49°10'03"N, 122°50'40"W, 0.3 m west of a black cottonwood (*Populus trichocarpa*) tree that has been flagged with orange flagging tape at breast height. Location C is

found on the eastern side of the trail at 49°10'02"N, 122°50'40"W, 0.3 m west of the orange flagging tape found at breast height on a thicket of Himalayan blackberry (*Rubus armeniacus*). Overall, pictures were taken over an 8-month period, from August 2019 to March 2020, as a part of the photo-point monitoring activity (Appendix B).
