Coastal Douglas-fir Forest Restoration and Liner Wetland Construction

At the Millard Learning Centre on Galiano Island

UNIVERSITY OF VICTORIA RESTORATION OF NATURAL SYSTEMS
GALIANO CONSERVANCY ASSOCIATION

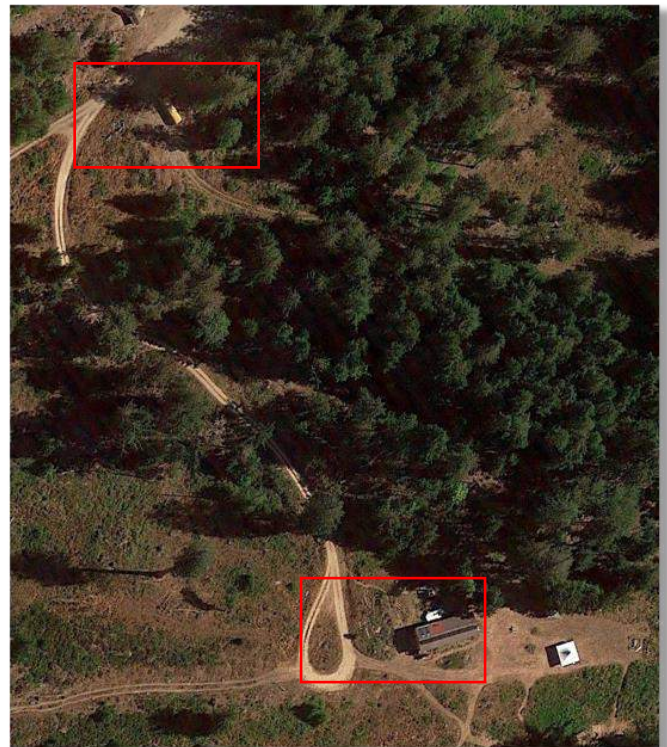
Figure 3: The rectangles represent the two main buildings at the MLC. The top rectangle is the location of the Program Centre, and the lower one is the location of the classroom building. Aerial photo: Google Earth Pro

Two main structures used by the GCA exist at the MLC (Figure 3). At the top of the property, near the entrance from Porlier Pass Road, sits the Program Centre, a building that houses offices and meeting rooms and is considered to be the GCA and MLC headquarters. This building was completed last year and includes a native plant garden and native plant nursery annex for the sale of locally propagated plants to the public. At the bottom of the main road (approximately 200m away), there is the classroom building. This building houses a space for school children and university students alike, and contains an industrial kitchen, as well as bathroom and shower facilities. A campground fit with tent pads

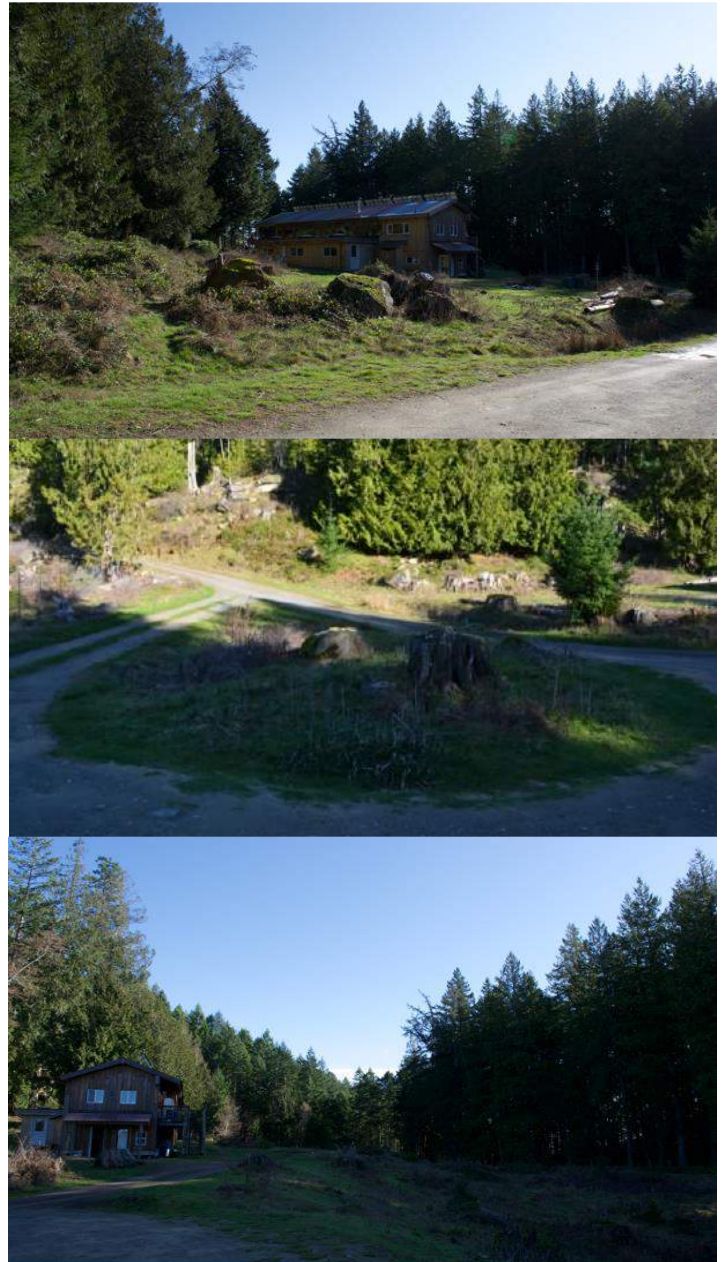
The images below show the state of each polygon prior to intervention. (Order: Green, Yellow, Blue+Red)

that edge by a fairly healthy and natural mature redcedar forest. The goal in this polygon was to advance that line as much as possible, reclaiming this area to the forest it should be. This area was mechanically decompacted with an excavator, the operator being careful not to uproot the existing saplings and planted with the trees mentioned above. These trees were all caged after planting to help ensure establishment without the stresses and pressures of ungulates. The establishment and growth of these planted and already-present trees will help control the invasive species as well, as they will serve to shade them out.

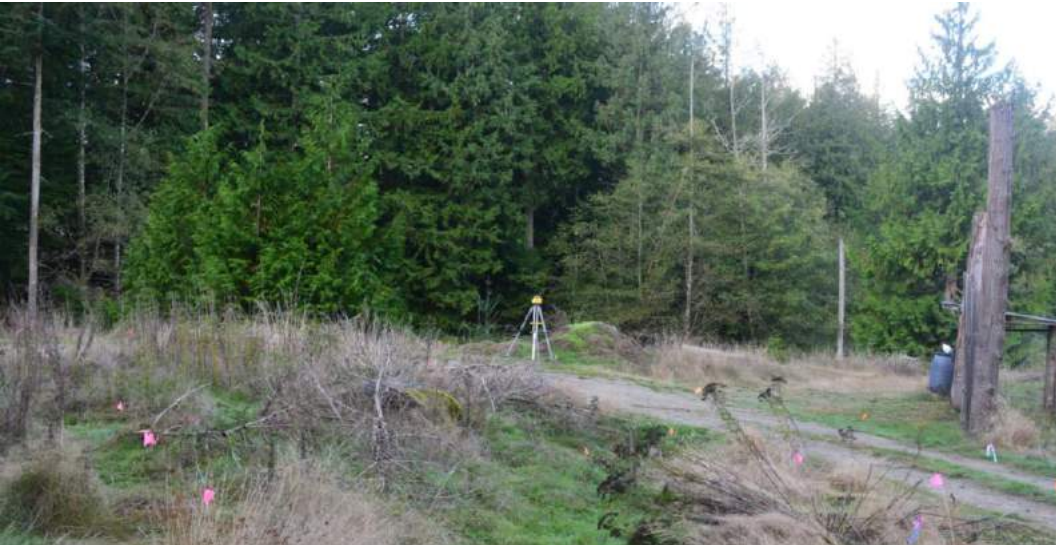
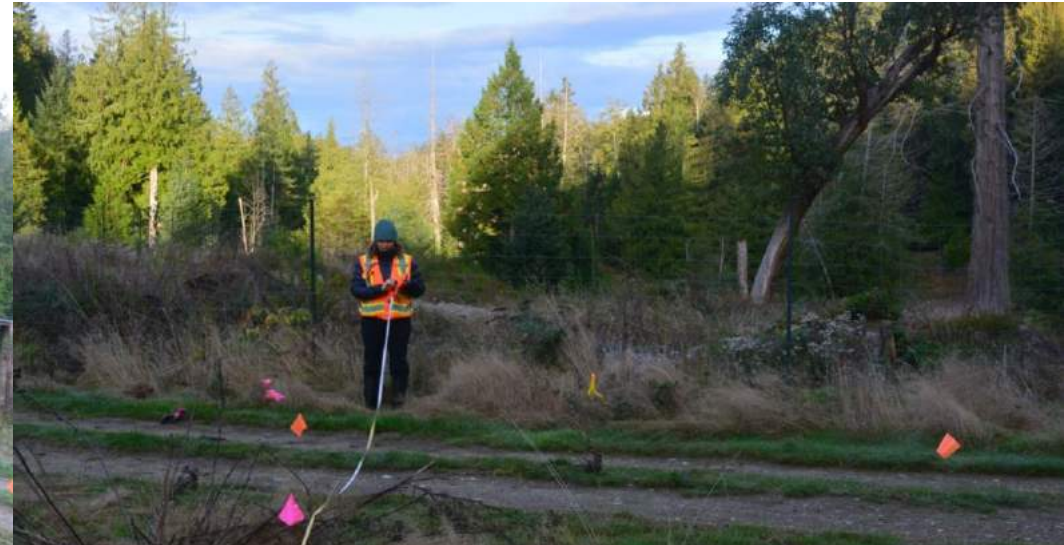
Upper left: laser level and marking flags.
Lower left: excavator preparing wetland area.

Upper right: measuring distances from wetland centre to edge.
Lower right: dig, measure, dig, measure, dig
