University of Victoria – UVIC
Department of Continuing Studies
Restoration of Natural Systems

**ER 390 Report: Hydrological Assessment and Restoration of Water Resources in an
Aluminum Industry**

Student: Davi Teixeira
ID: V00020675
Instructor: Dr Valentin Schaefer

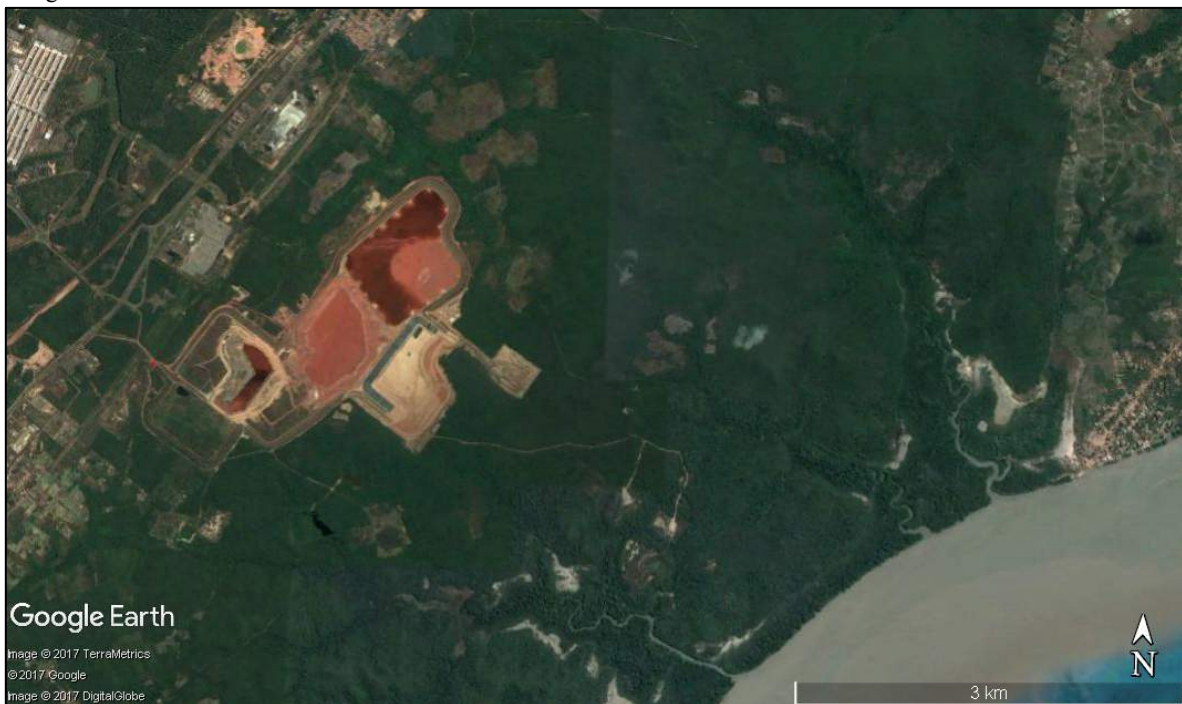
Image 1: RSA area

At the south of the Island is located a major Aluminum industry that occupies an area where occurs three types of ecosystems in general: mangrove at the west part, where the port facility was built to receive the main raw material bauxite, dry land with secondary growth bush and a great number of scattered water courses. These systems to the north and east make up a buffer zone of approximately 3,400 hectares. To the east there are artificial lakes for the disposal of bauxite residue called Residue Storage Areas - RSA's (Figure 1).

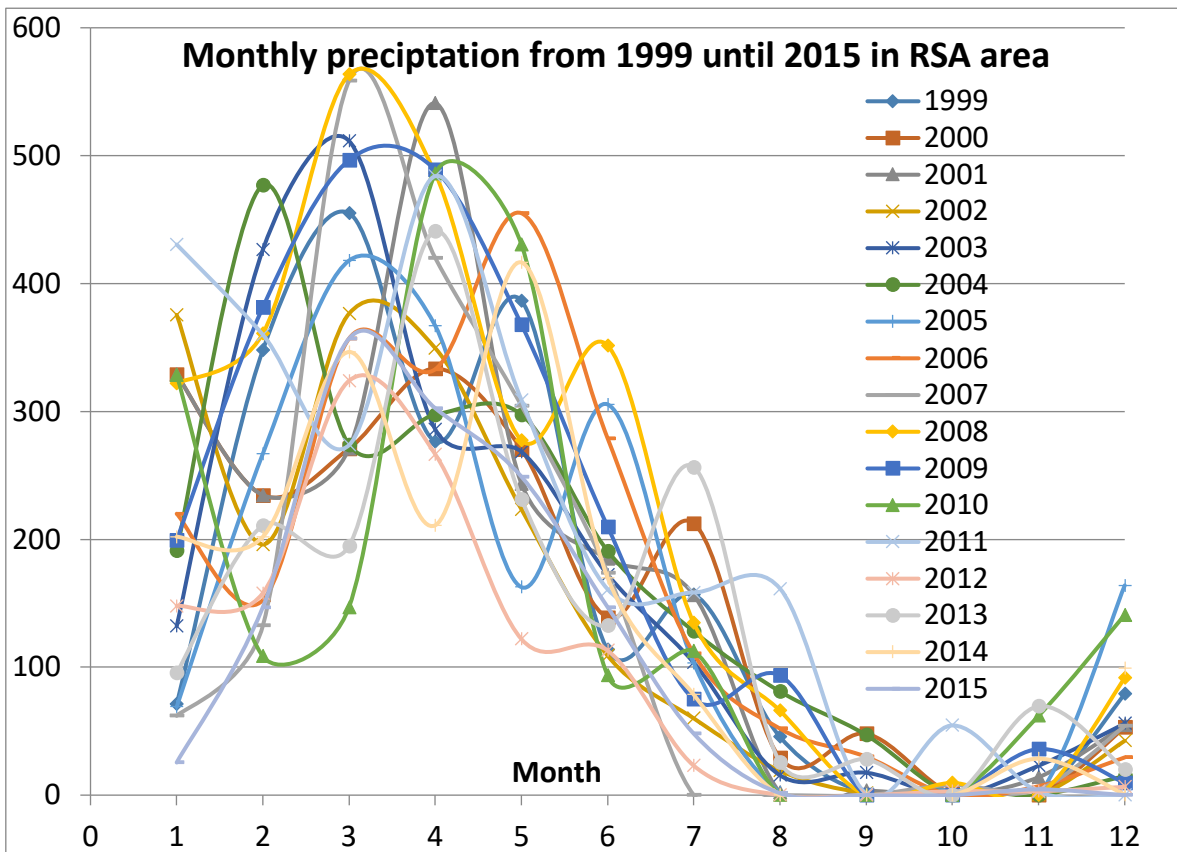
Graphic 1. Background precipitation.

During RSA construction period, it is very important to adopt mechanisms that can protect the surrounding native vegetation, during heavy rainfall period (from February until May with rain peak in March – Graphic 1).

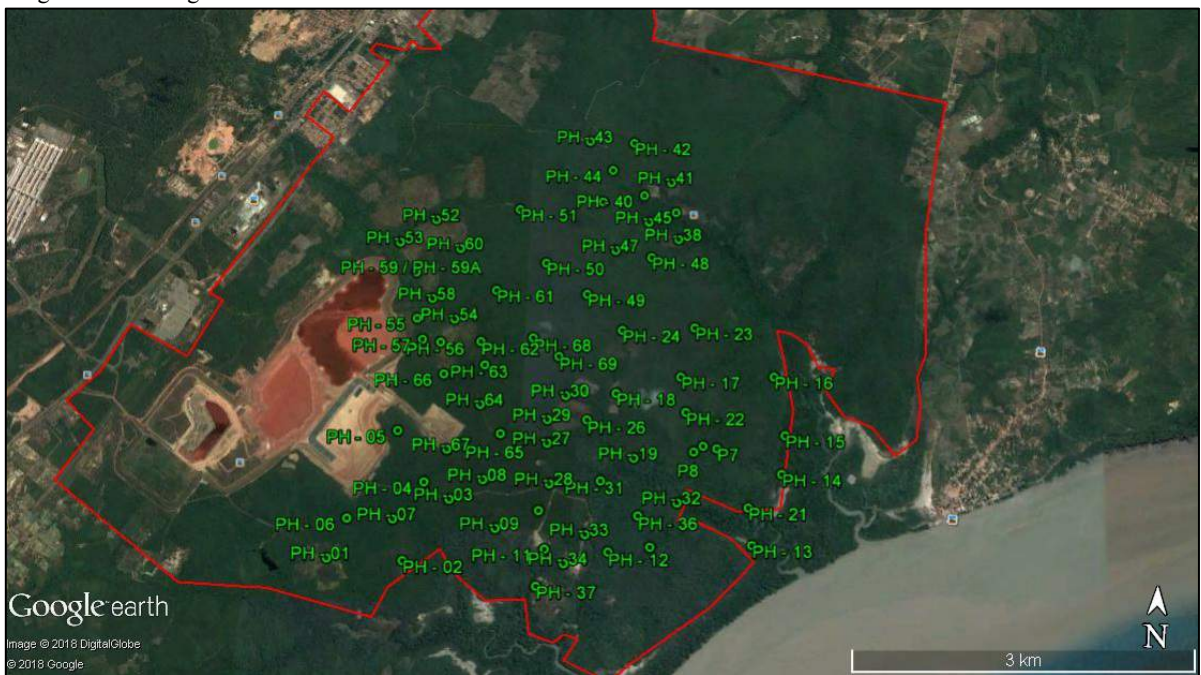
Image 2. Monitoring wells locations

The first wells were set in early April, based on technical knowledge of drilling execution by specialist Geologist who established the location of the drilling points with support of local expert who provided the coordinates of all the 69 wells across the 3.400 hectares site (Image 2) Safety equipment was utilized to perform the trails, as the company safety procedures.

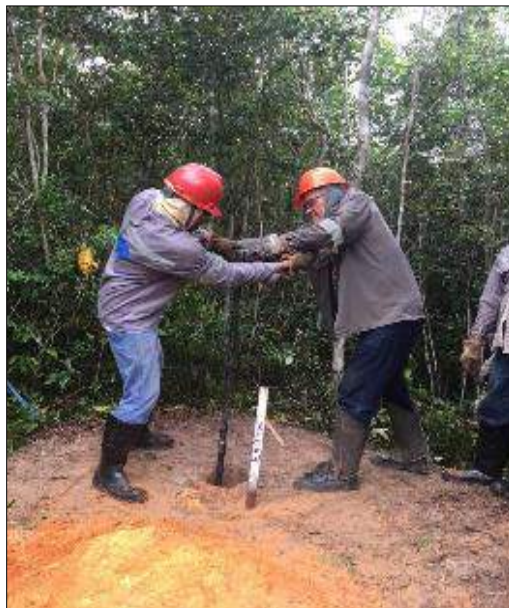
Picture 1. Auger drilling

- Auger drilling (picture 1) at 6 "diameter until the water level is reached;
- In another step, coat the well with steel tubes and continue the drilling with valves tubes, at enough depth to locate the top of the filter 2 m below the static level;

While the first wells were being located, the drilling activity was taken place in parallel, to optimize time. In total, 3 teams of 5 employees took over the drilling activities, coordinated by 1 foreman, under technical orientations, as picture 1 below.

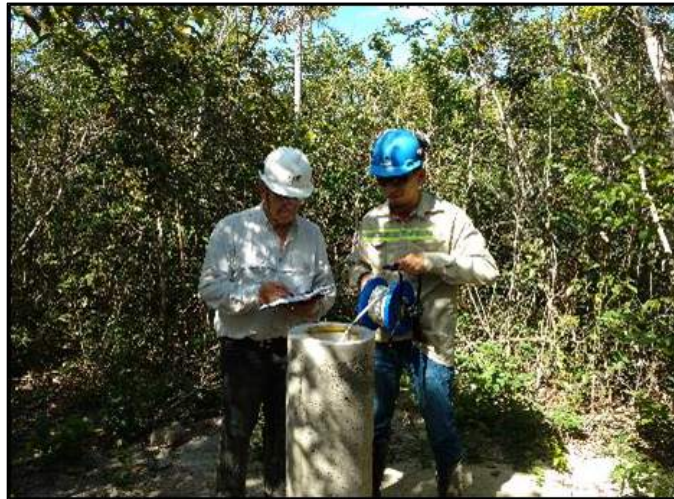
Picture 2: Water level measuring

The readings were done with the support of equipment water level measuring (picture 2) with electric sensor, flat double cable with steel core and with centimetric marking. To get to the monitoring wells it was necessary to use a tracked? vehicle and a field GPS, by the support of a contractor company in which was trained in how to use the water level measuring before the beginning of the campaign.

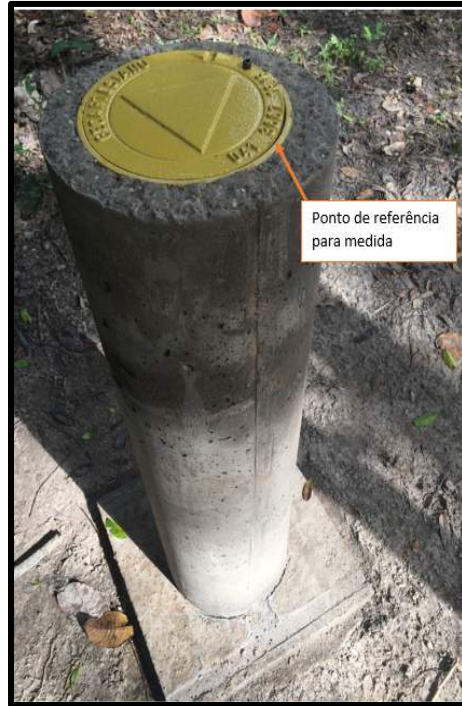
Picture 3: Monitoring well

As a reference for the measurements, the inner part of the ring of the metal cover is used as indicated in the photo below.

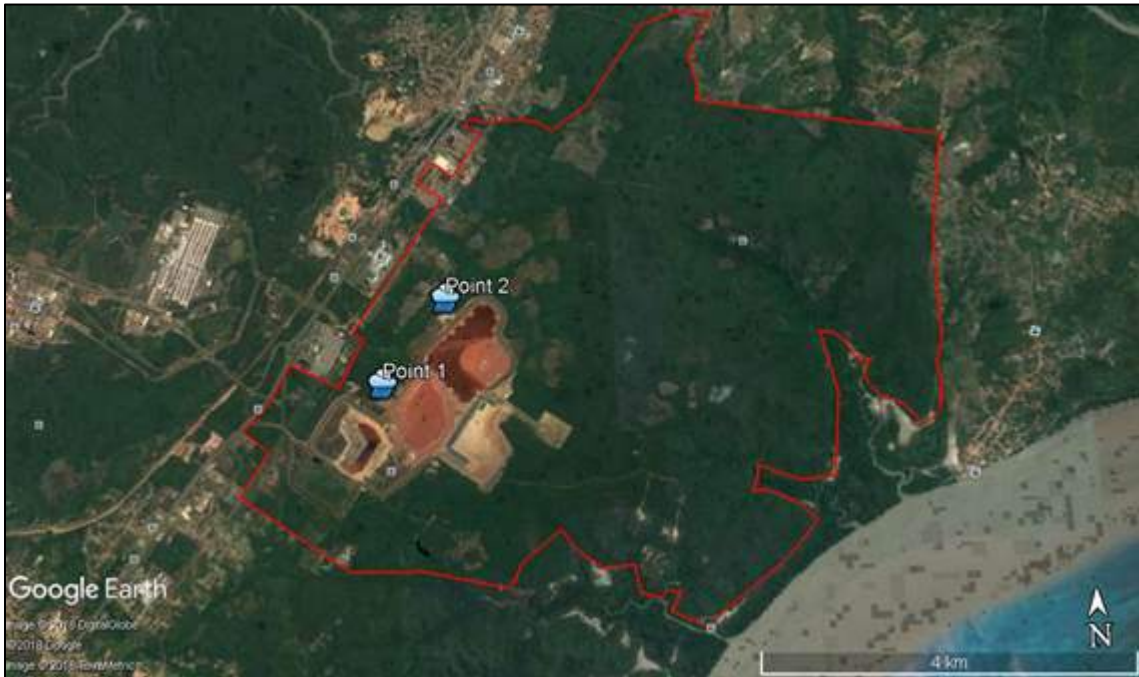
Image 3: Rain data collection points

In parallel to the installation of the piezometers, monitoring of hydrological parameters were carried out approaching firstly rainfall data collection through 2 rain gauges installed in early 2017 for acquisition of data including wet and dry seasons from January 2017 until December 2017. The points regard to the area of the field office (1) and main office (2) since image below:

These devices of easy utilization could attend with no discrepant data, so that the distance between the points was just 1.15 Km thus it was normal to have small variations and, overall, the rain gauge in point 2 have registered a higher water column (mm) compared to point 1 throughout the project time line.

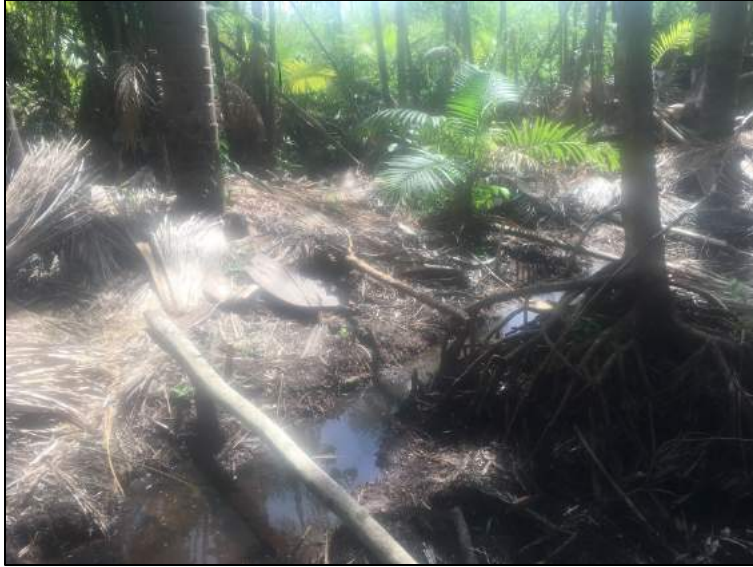
Picture 4: *Aracaua*

Below are some pictures that represent 3 stream flow measuring points. They were taken in September 2017.

The method used to measure the flows was that of the floating method, due to the characteristics of water bodies with low velocity in the water course. A 600ml plastic bottle was used as standard float and field methodological procedure were followed as per below consulting recommendations for stream flow measurements:

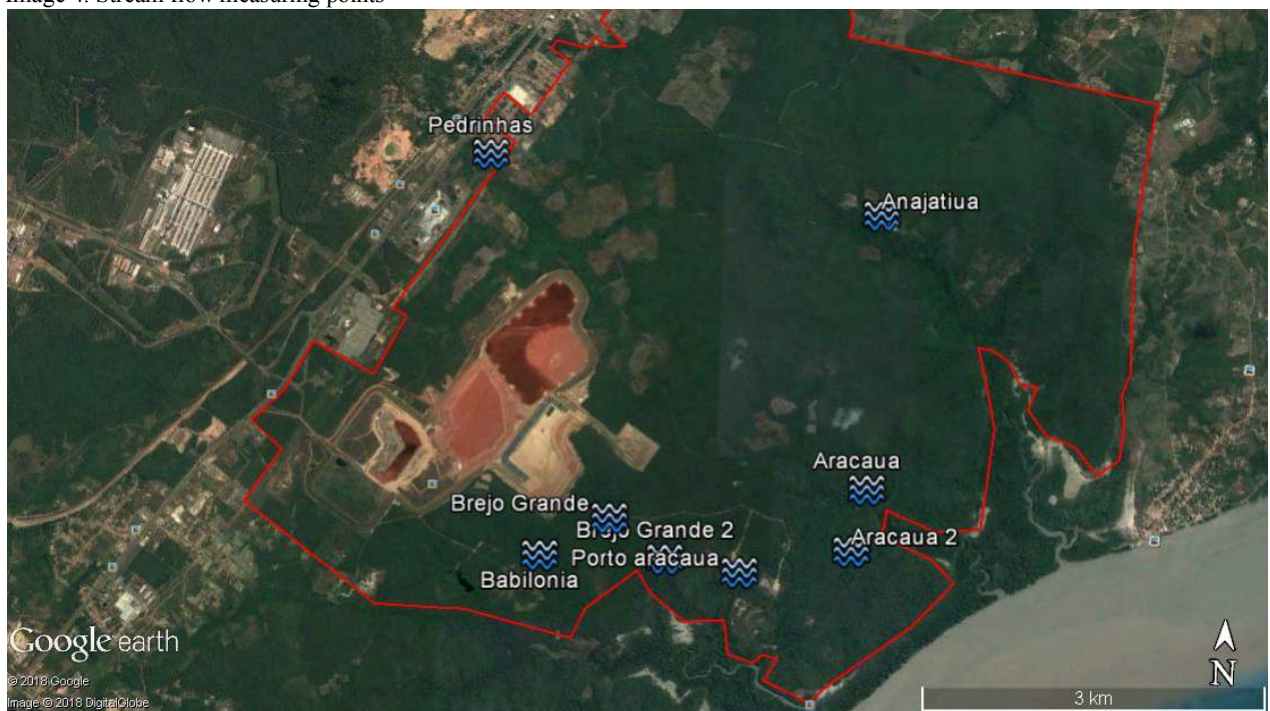
Image 4: Stream flow measuring points

The location of all the 8 sections in Google Earth 2017 map is represented in the image below.

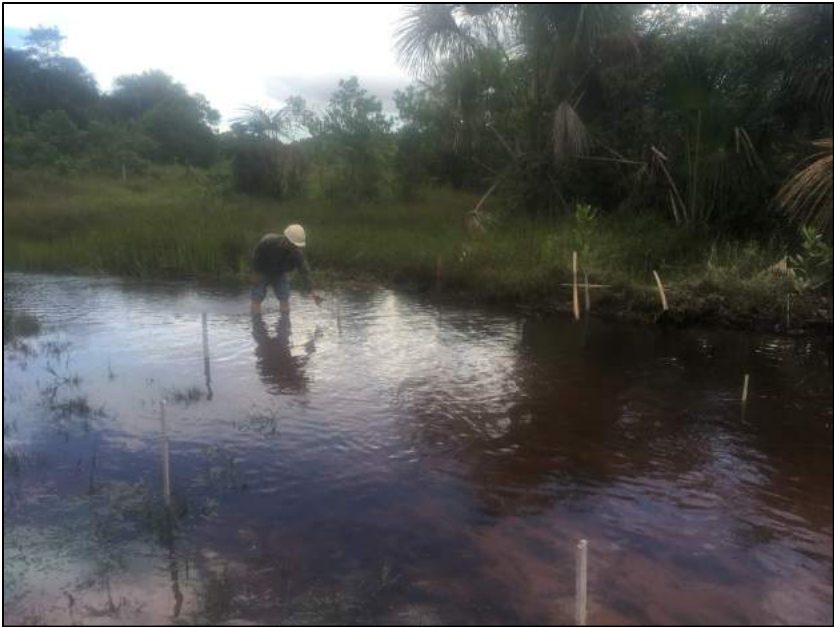
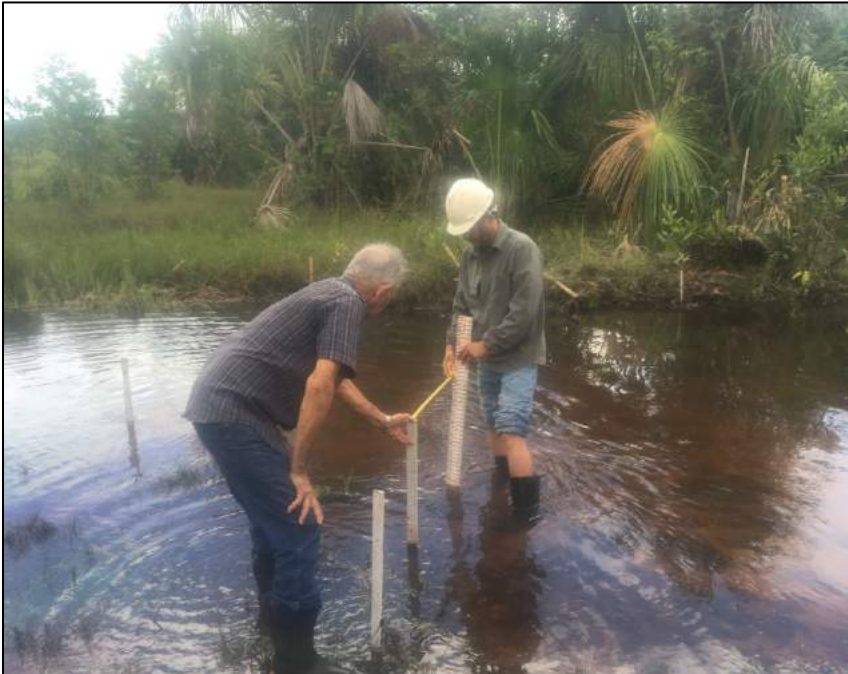
Picture 7: Section demarcation

Once in the field, it was set a 6 meters length cross section and 5 subsections within it. So the 5 subsections had their respective depths measured by a fluviometric ruler as well as their width (measuring tape). In the end a plastic bottle filled with water at one third of its total volume was utilized to measure the total time spent by the float to run the cross-section length. Some of the sections are shown in the pictures below. This method requires a minimum of 3 repetitions to measure time (PALHARES et al 2007).

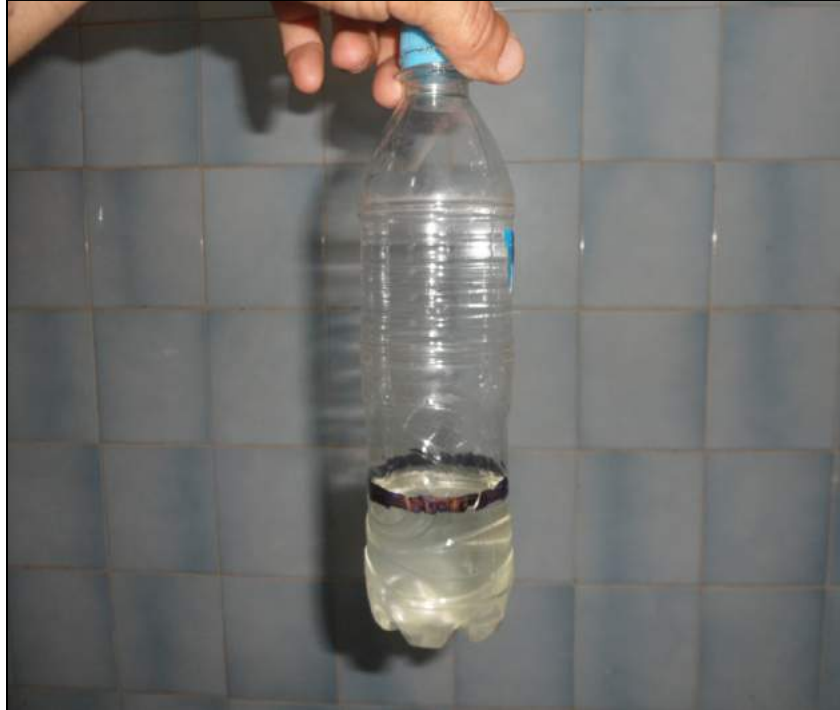
Picture 9: Float utilized

- Empty plastic bottle of 600ml in the first step and in a second step the same bottle with one third of water;
- Fluviometric meter for depth measurement at the 3 points fixed of the gutter;
- Tread for measuring the widths at the 3 points of the gutter;
- Timer to determine float travel time between start and end points

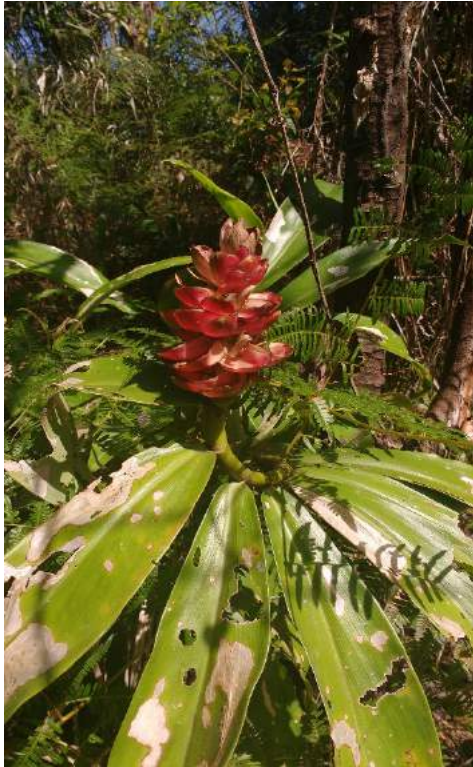
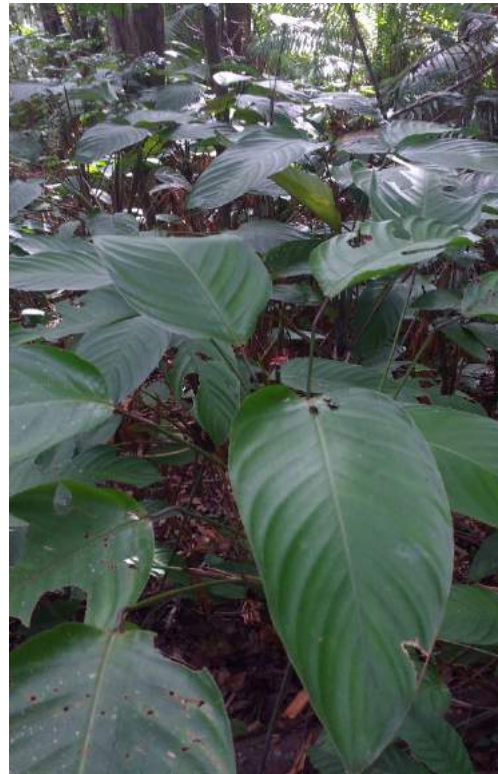
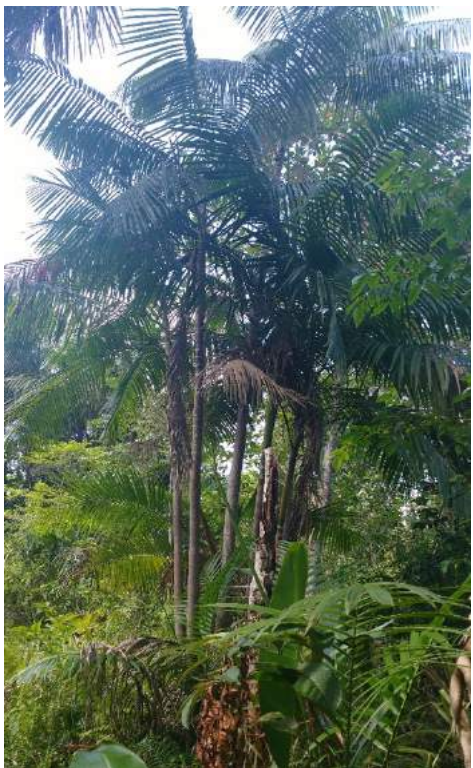
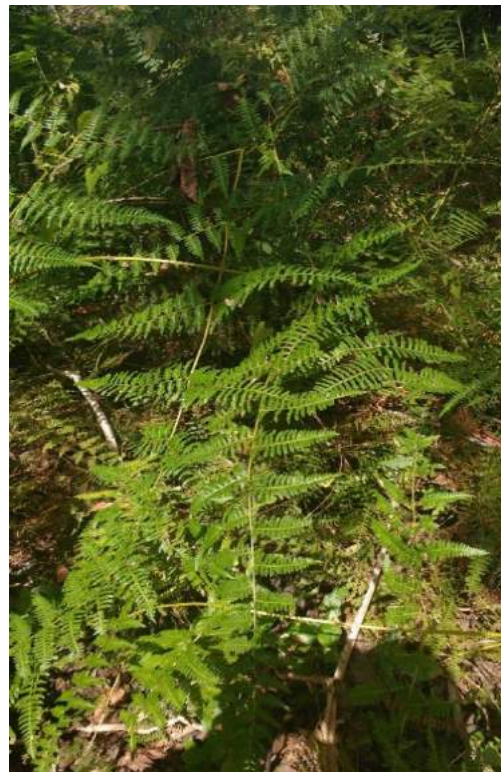
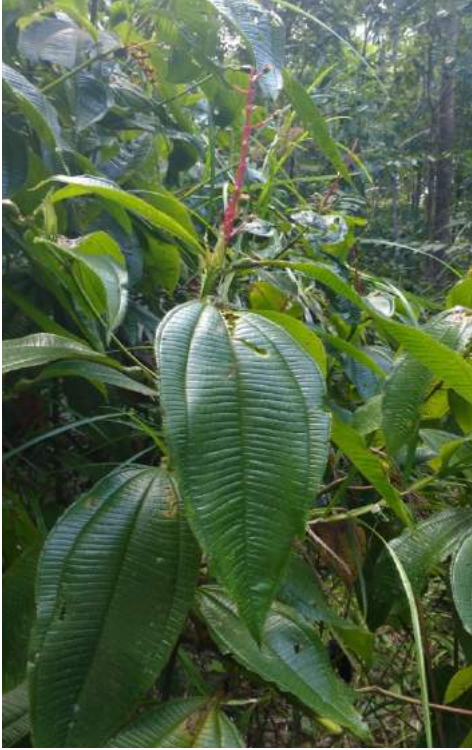
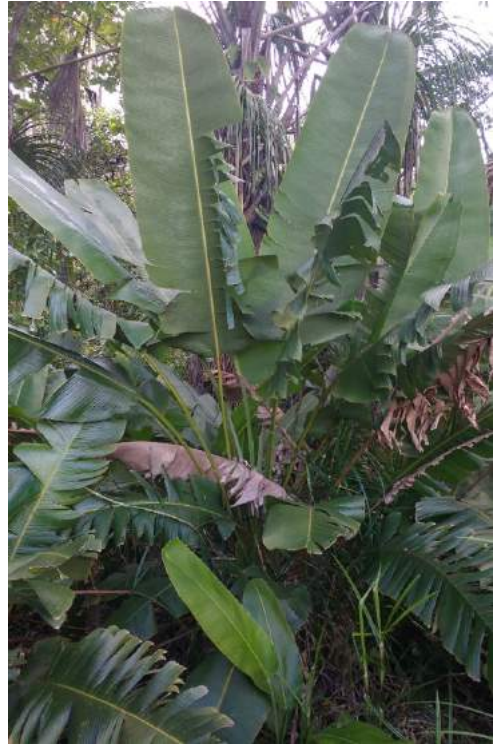
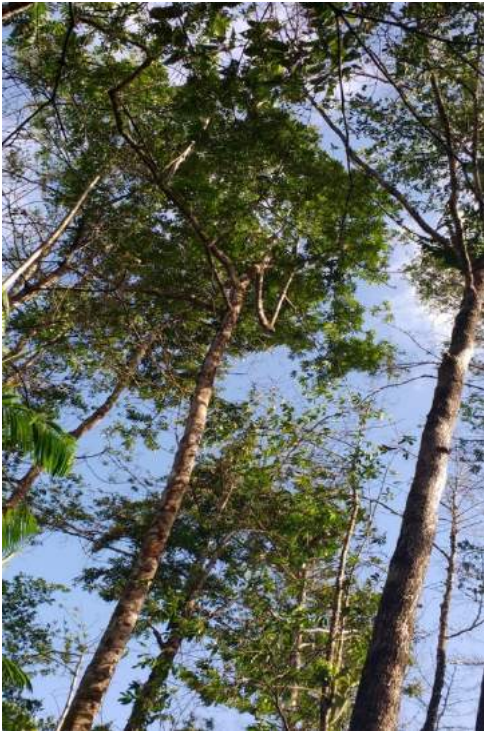
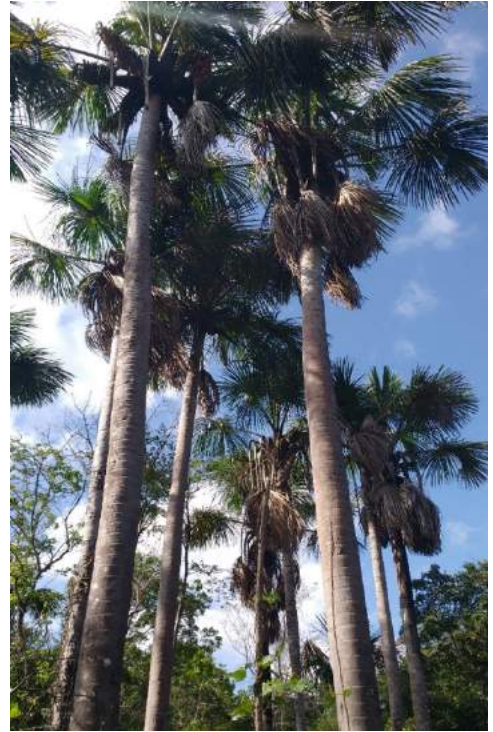
Picture 10: Wet species indicator plants with common name

Once in field, at first it was adopted the biological factor - wet species indicators (picture 10 below) which demonstrate the occurrence of a water course or parched water table in that environment and, since preliminary observation, it was confirmed water courses ecosystems as the majority identified with springs and streams.

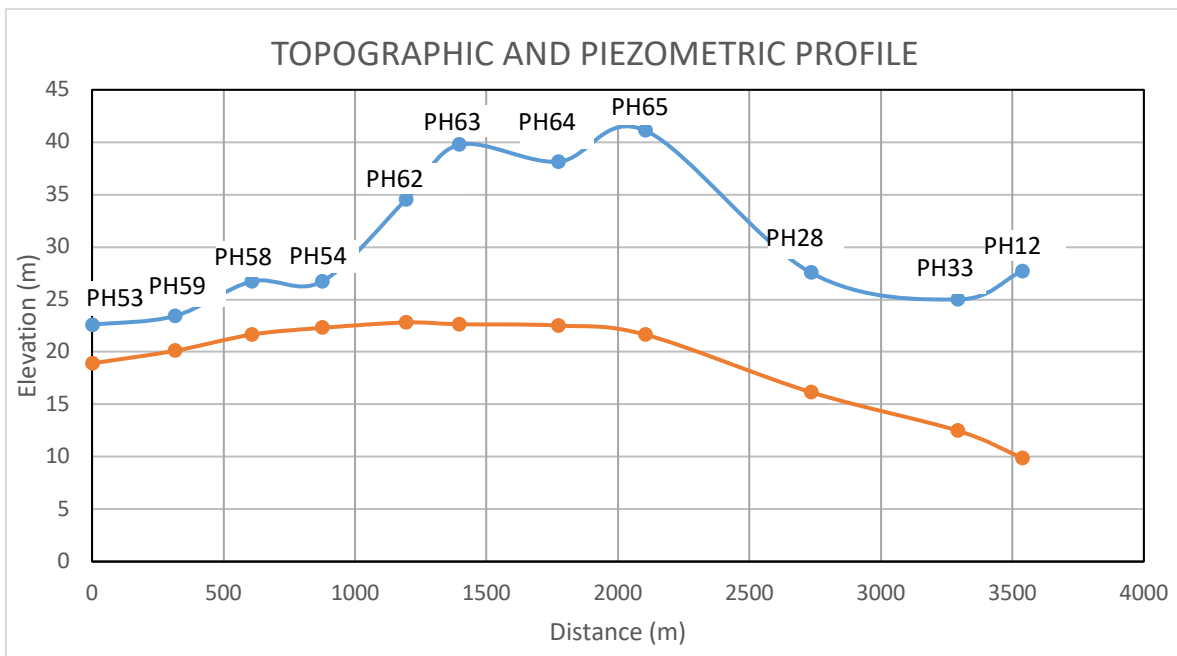
Graphic2: Topography x Piezometry

The local topography follows the elevation so that higher elevations, overall, means a higher water level in the groundwater system.

At first, it was verified an increase in ground water level due to the topographic level variation, so that the local topography follows the water level. The relationship water level x topography variation is presented in the image (yellow line reference), table and graphic below, indicates the behavior of the water level in the monitoring wells from PH 53 to PH 12, as an example of these aspects.

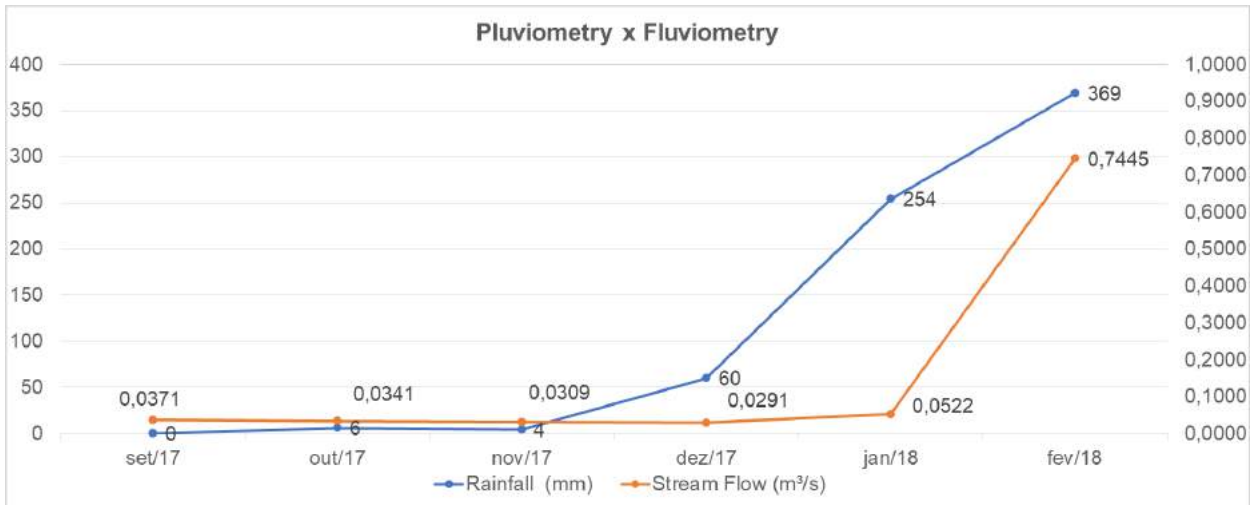
Graphic 4: Pluviometry x fluviometry

Concerning Pedrinhas, the floating methodology adopted and the collected pluviometry data indicated the graphic below, where it was certainly possible to observe an increase of the values throughout the months of field monitoring with rainfalls. It is clearly shown the abrupt change considering the dry months and January/February with the beginning of rainfalls.

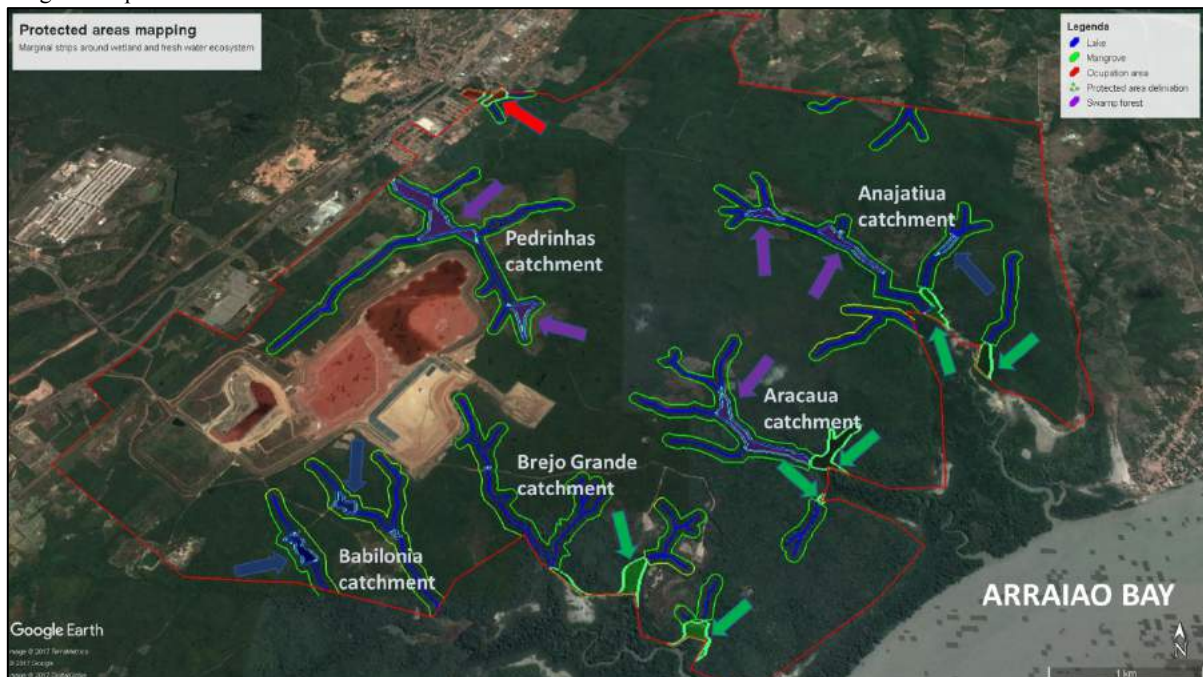
Image 6: Map of terrestrial water bodies

Image 6 below identifies the occurrence of the ecosystems within its protected area limits. Arrows of different colours indicate each ecosystem's location: purple arrow - swamp forest, green arrow - mangrove, blue arrow - natural and artificial lakes and red arrow - occupation area (small pig farming). The red line surrounding the RSA area represents the property limit established for the plant in accordance to the State Decree 7646 from 1980 in which has created the SLID (Sao Luis Industrial District).

Springs and streams are inserted within the green contour represented by the permanent preservation area strip. The round shape corresponds to the spring location with a ratio of 50 m as extension strip to be protected and the parallel line (cannot be seen) corresponds to the water course/stream surficial drainage, adopting the same protection distance of 50m.

It was observed during the field diagnosis, which can be observed in the map of the area, that the microbasins of *Anajatiua*, *Aracaua* and *Brejo Grande* have their extension located within the limits of the property of the plant, being its mouth located in the mangroves from *Arraiao* bay. The micro basin of Babylon, despite being a contributor to the Bay of *Arraiao*, has its mouth beyond the limits of the plant's property. The micro basin of *Pedrinhas* also has its mouth out of the property boundaries, advancing towards BR-135 highway.

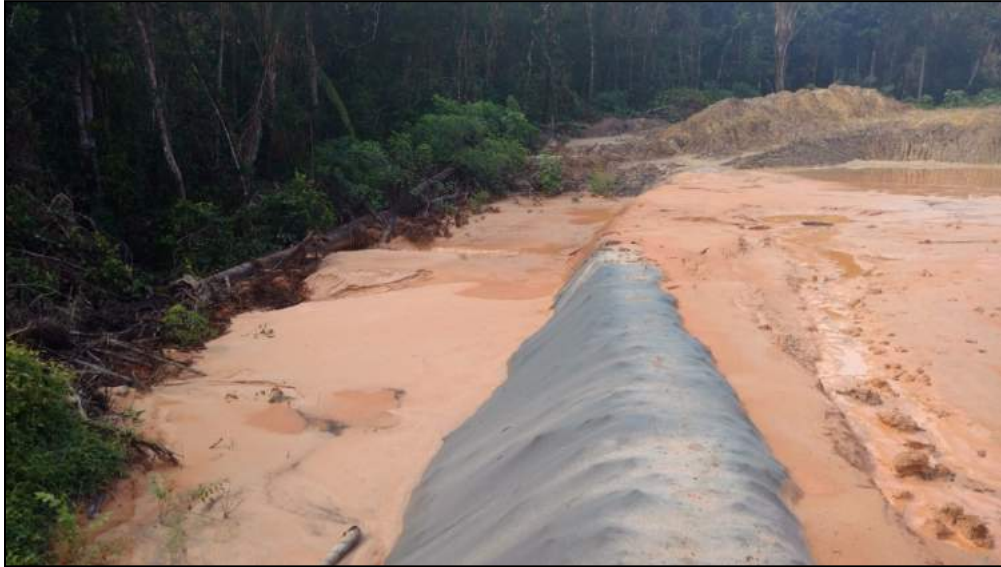
Picture 11. Overtopping event

As a result of the strong rainfall occurred on March 15 2017, the overtopping of the sedimentation basin number 03 (Picture 11) caused by a sediments wash off in a slope unprotected area from the Residue Storage Area 06 has occurred, causing the silting of the stream the Brejo Grande within a protected area.

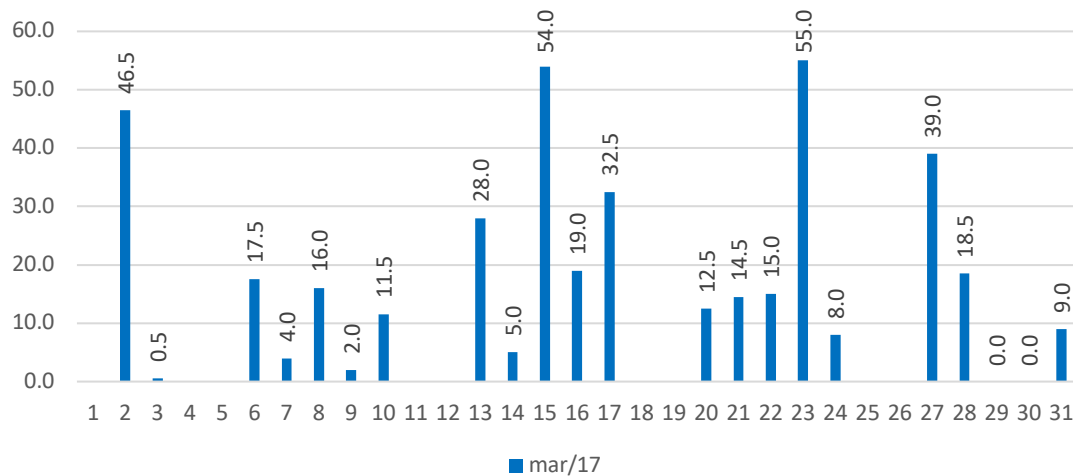
Graphic 6: March Daily precipitation

On that day alone it rained more than 50 mm in 60 minutes which has caused the event above. Figure 17 below represents the precipitation of March as the wettest month in 2017 with 400mm.

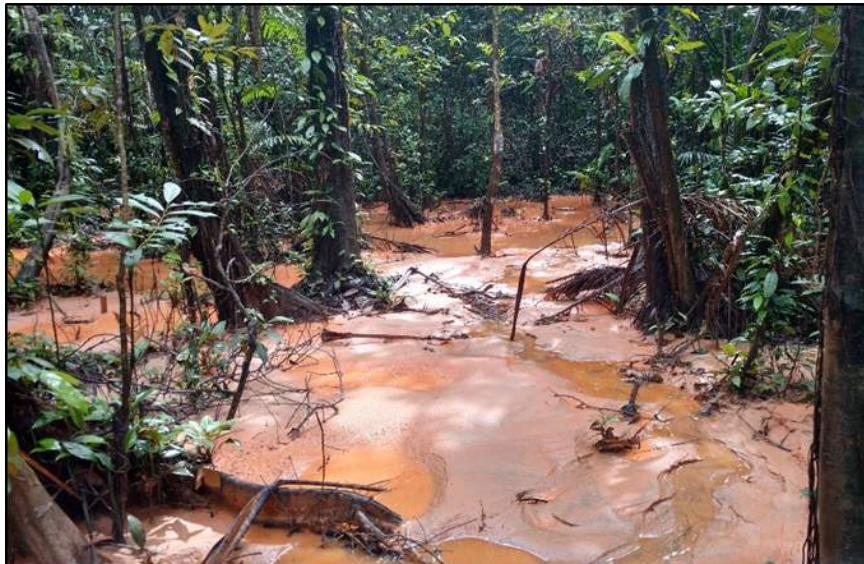
Picture 12. Sediments accumulation

The overall environmental impacts are listed in below. Picture 12 represent the visual impact

- Aggravation of siltation in approximately 19,000 m² of the protected area;
- Estimated 6000 m³ of sediments accumulation;
- Permanent damage to some Fauna and Flora;
- Turbidity analysis above the limit (> 1101 ntu). Environmental limit: 100 NTU - CONAMA 356;
- Sedimentable materials analyses above the legal standard 1ml / l / hour - CONAMA 430;
- Part of the Stream bed totally silted.

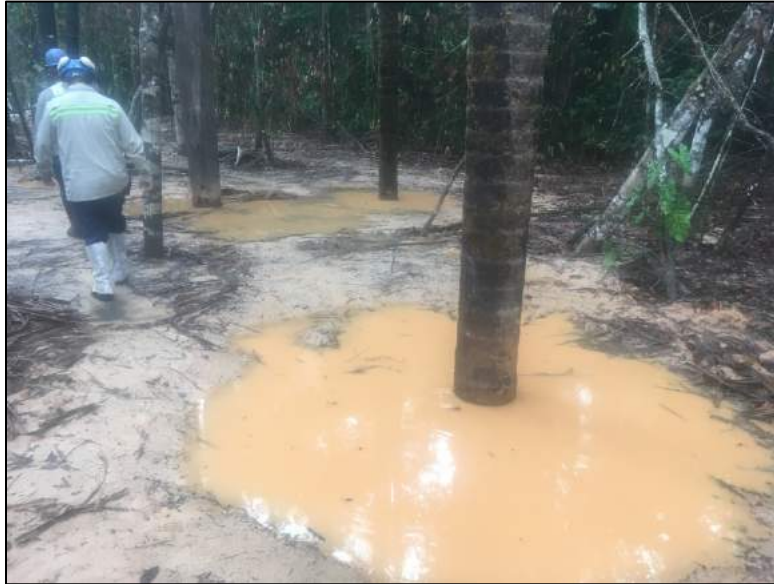
Picture 14. sediments removal results

Action 6 and 7 were also carried out in the period from October to December 2017, being developed within the disturbed ecosystem. In this period, the impacted stream had its bed totally harden as the pictures in below:

So that action 6 aimed to remove sediments banks on the foot of the remaining trees aiming to conserve the remaining individuals and action 7 adopted a contentment dike and 2 tube as

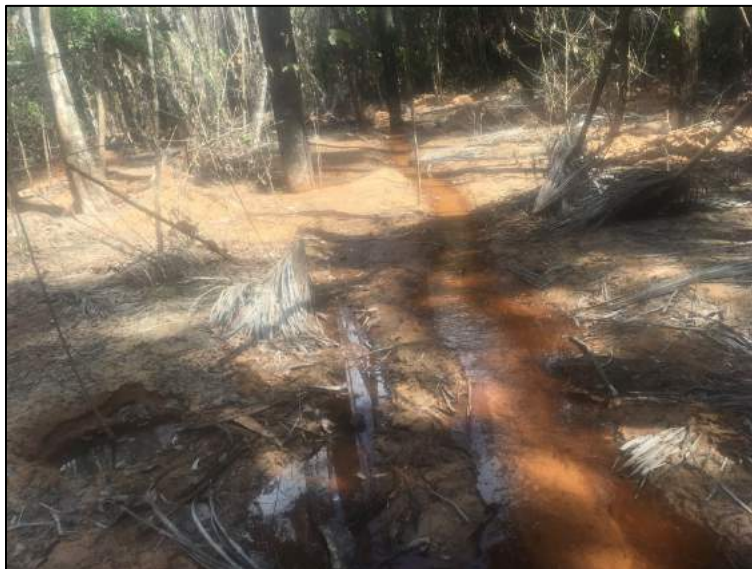
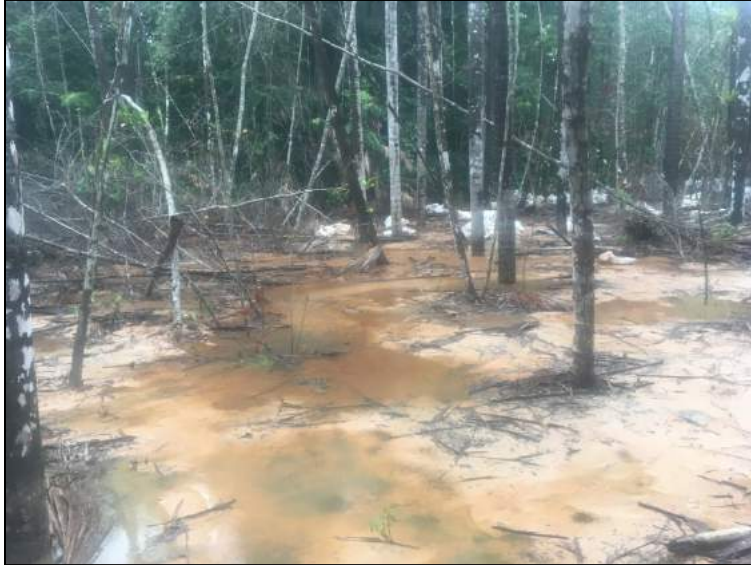
Picture 16 Water course.

The images below represent the result of those 2 actions combined, where there are small water courses recently formed along with some ponds. Hence there was a significant increase in water availability.

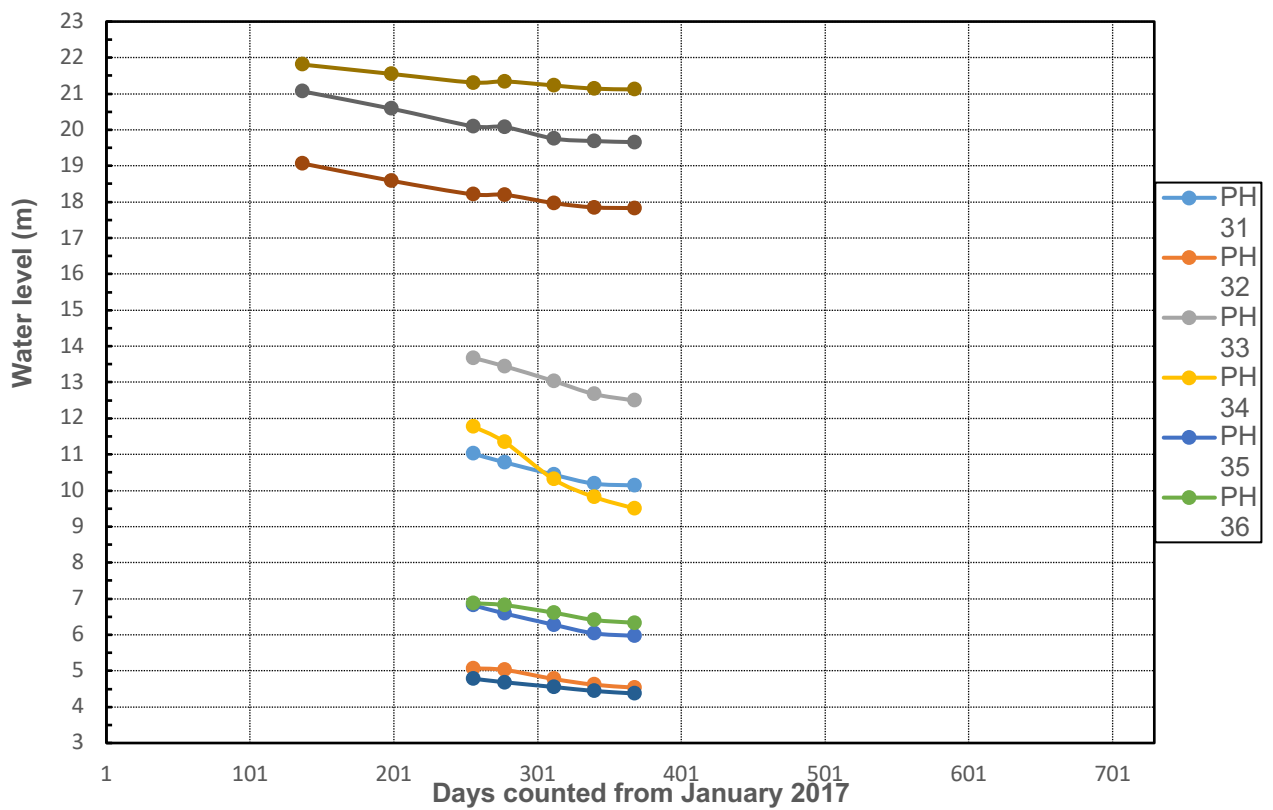
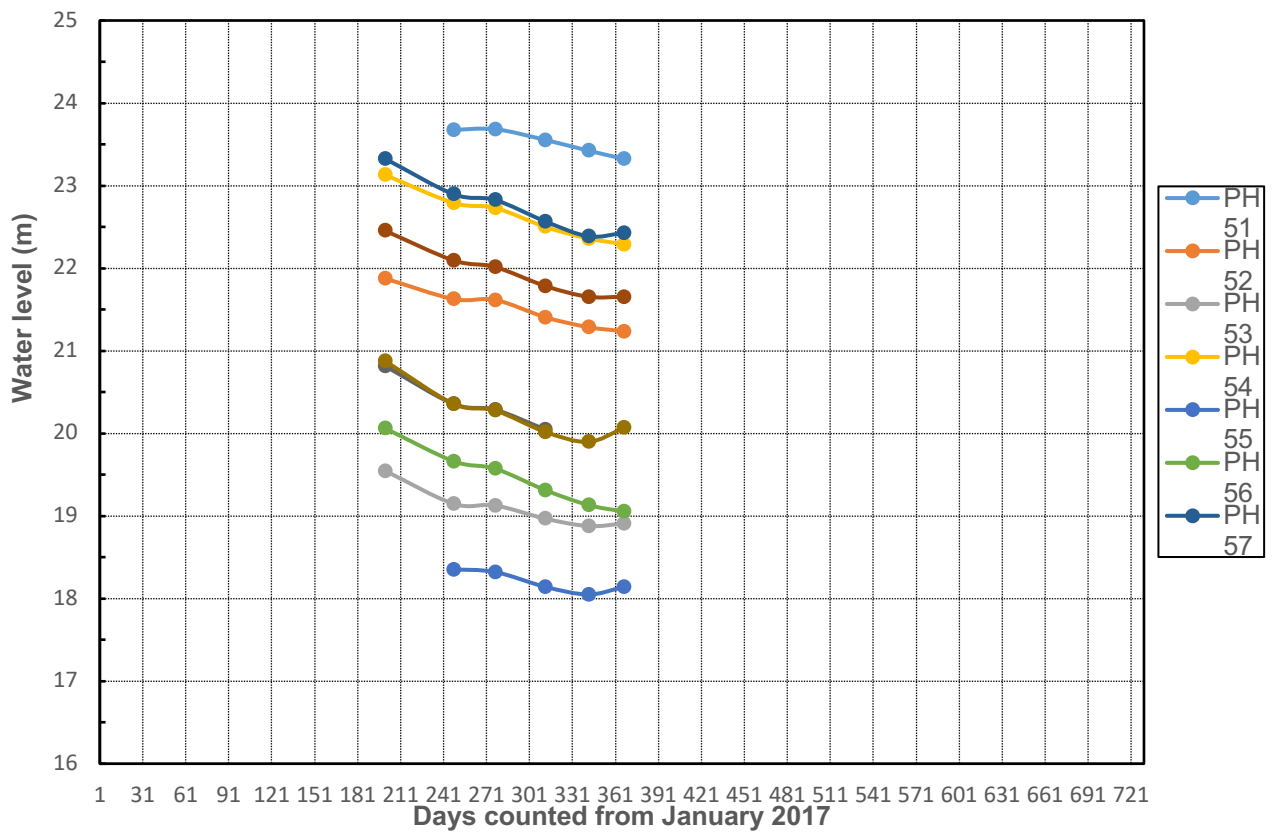
GROUND WATER FLUCTUATION

Also, the results in Appendix 1 present slight decreases for mostly of the monitoring wells, which is an extremely important factor indicating a very strong hydrogeological system capable in storing a significant water volume regardless the seasonal period in question. In this case it was decided to present the behavior of the levels in period of change of season from the driest month to the first rainy months.

The graphics in Appendix 1 have in the abscissa the number of days between the reading date and February 2017.
