ER 390

The Remediation of Rock Bay, Victoria B.C.

By: Kurtis Sanderson

DUE April 4th 2016

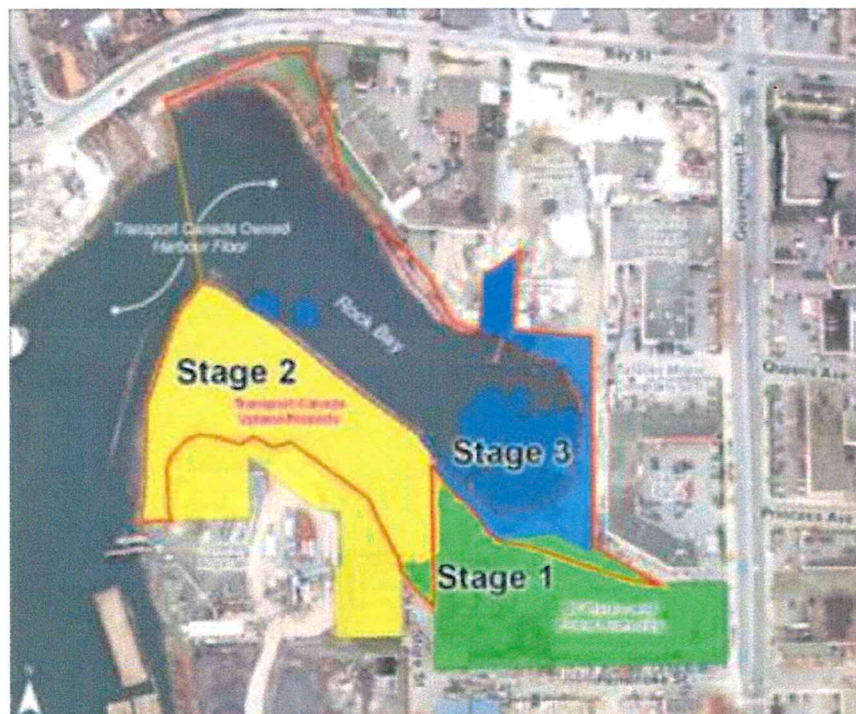
Figure 3: Location and Stage of remediation areas (Sourced from: Design/Build – Rock Bay Restoration Project Stage 3)

As shown in figure 3, the Rock Bay remediation has occurred in multiple stages throughout the past decade to slowly account for the century's worth of contamination. Stage one of the remediation was completed by BC Hydro on the lands they historically used as a PCB storage facility. Throughout the time that they utilized the grounds there was continuous underground leakage and contamination of PCB's into the soils and sediments. Their remediation consisted of removing the contaminated material and backfilling the cavity with sand as a bulk modulus. Stage two of the remediation was completed via the partnership of B.C. Hydro and Transport Canada in which they continued to remove PCB and hydrocarbon contamination. This second stage focused on the southwestern shore of the Rock Bay and resulted in a combined total of 200,000 tons of contaminated material being removed (Hazmat Management)(Rock Bay Remediation Project Review - Stage 2 and 3). Currently the final stage of the Rock Bay remediation is being completed which involves removing material from the bottom and sides of the bay. Stage three of the remediation has required by far the greatest amount of work to restore and has removed over 90,000 tons of contaminated sediments from the bay (Coal Gasification Plant - Stopping the Spread). The various stages of the bays remediation can be seen in the map below.

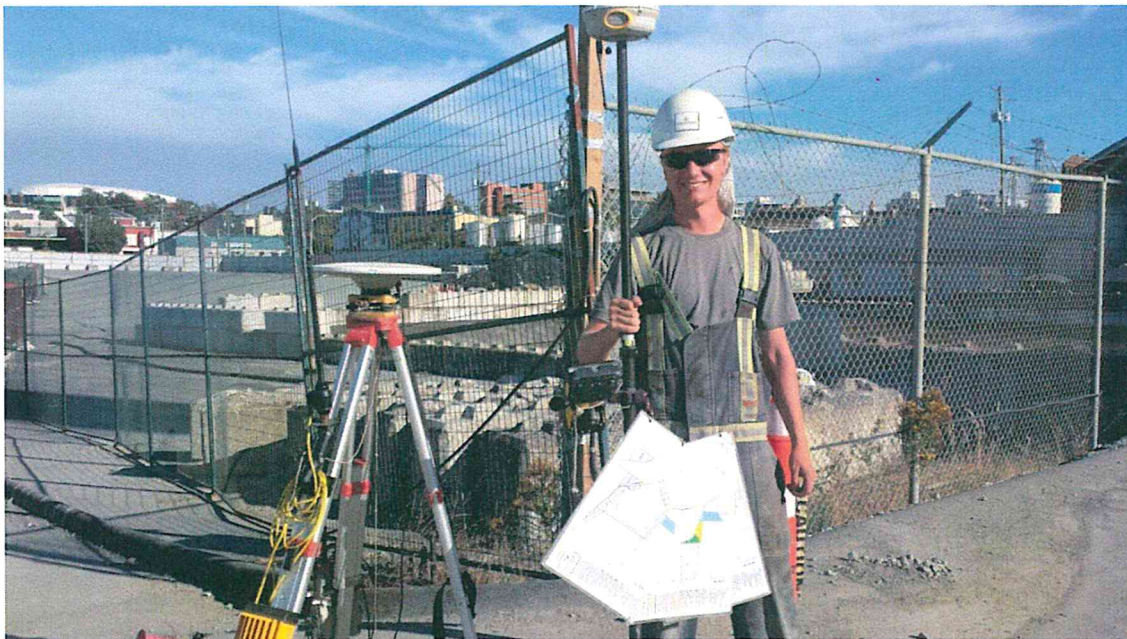
Figure 4: Trimble SPS GPS system and layer maps

These excavators would work in coordination with a laborer equipped with a Trimble SPS GPS unit to determine the depth and position of the excavation. The Trimble unit had the zones of contamination loaded onto its interface so that the team could coordinate where and how deep to dig. In addition the consultants observing the process used surveying equipment to verify the depth of excavation with further accuracy. From knowing where exactly the team was excavating the operator could notify the truck drivers which class of material contamination was being excavated. The materials removed by the excavators were then loaded into trucks and hauled to the surface stockpiling area. The material would then be dumped into piles according to the level and nature of contamination based on the classifications determined by the consultants and GPS data. Each surface pile was separated from the other to prevent cross contamination of materials. To further prevent cross contamination, the trucks would be washed out whenever the grade of contaminate would change. In addition, whenever a truck would change from hauling contaminate to hauling backfill, they would be thoroughly washed out.

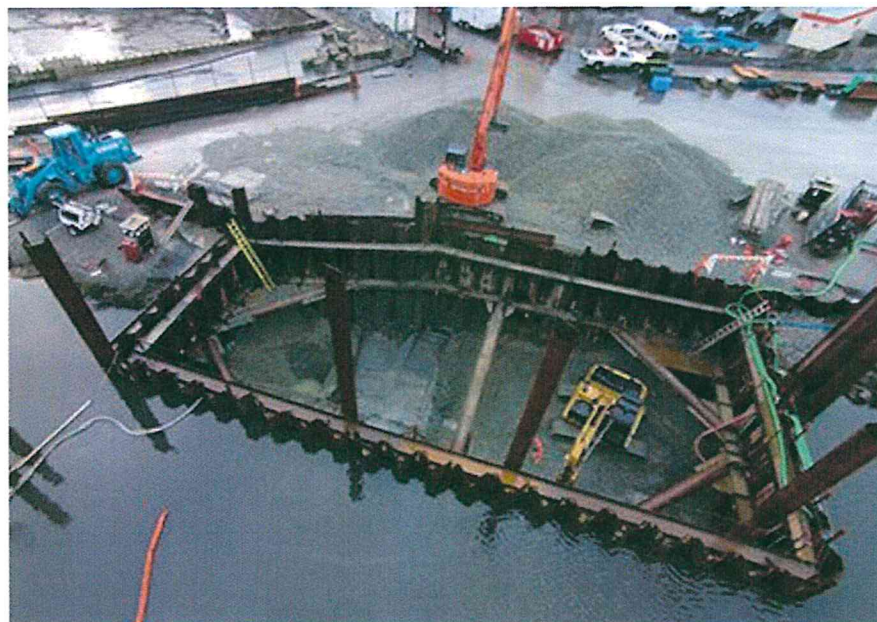
Figure 5: Cofferdam Construction (sourced from: www.qmenv.com)

After the construction of the sheet pile barrier around the perimeter of the bay, the erection of the coffer dam at the mouth of the bay commenced. The coffer dam’s dimensions were approximately 15x30x100m in order to cover the mouth of the bay to drain the bay where the remediation was taking place. Similar to the barrier erected around the bay, sheet piles were used to create boxes as a skeleton. The dam was created by erecting a series of these sheet pile boxes, after a sheet pile box was erected, it would then be backfilled with 3” rock. The 3” fill was used to increase the density of the boxes and give the dam increased strength and rigidity. Once the first box was complete the work on the second in the series could then start, and this progressed until the dam covered across the mouth of the bay. Eventually after the water in the bay was drained the dam would then be reinforced for added strength and support. The extra support was installed on the “dry” side of the coffer dam and consisted of a series of steel “H-beams” welded to the sheet pile wall in the corner regions.

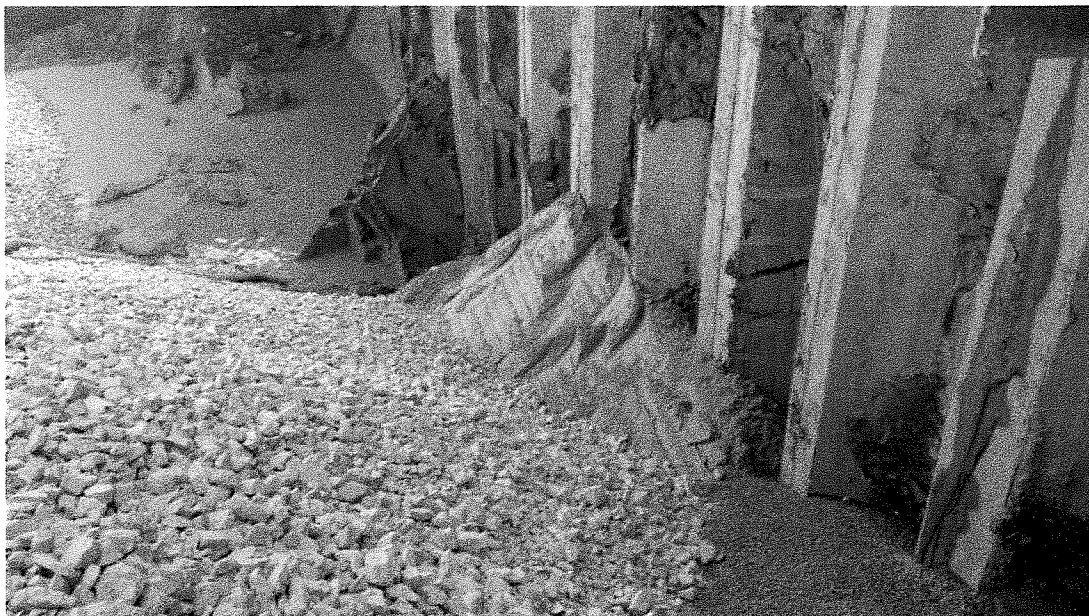
Figure 6: Grading sequence of the interface

filling on either side of the wall, if one side had three inch backfill and the other was sand, there would be the potential of the sand to migrate through the large three inch pore space. If the migration of the sand material was allowed it could have serious effects on the stability of the previously excavated area and surrounding site. To prevent the migration of sand, a grading series of increasing porosity was utilized to minimize the porosity change between substrates. The grading started with bentonite sand, then was layered outward into birds eye gravel then finally the three inch was placed. By grading in this manner of gradually increasing the pore space of the substrate there would be very little migration of the sand material. However the ground water would still be allowed to naturally flow into the bay and the hydrology could continue from the surrounding land into the bay and prevent oversaturation of the substrate.

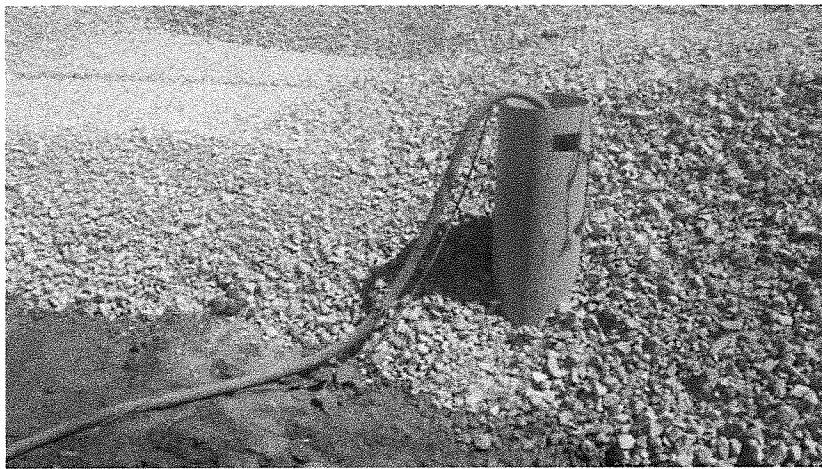
Figure 7: A Sump with a 3" Pump inserted

To begin the process, the waters at the bottom of the bay enter into one of the many water collection sumps onsite. These sumps would be located in areas of local depressions as to allow for the maximum amount of water capture. Each sump would then have a three inch pump at its base which would then move the water from the basin to the onsite water treatment facility. The pumps would have float switches attached to them as to allow for the pumps to be automatically turned on when there was water present in the sump. The multiple sump lines would then feed into a main line which would then take the waters to the surface. To prevent the water from travelling back down the line one way check-valves would be placed in the hose line to prevent backflow.

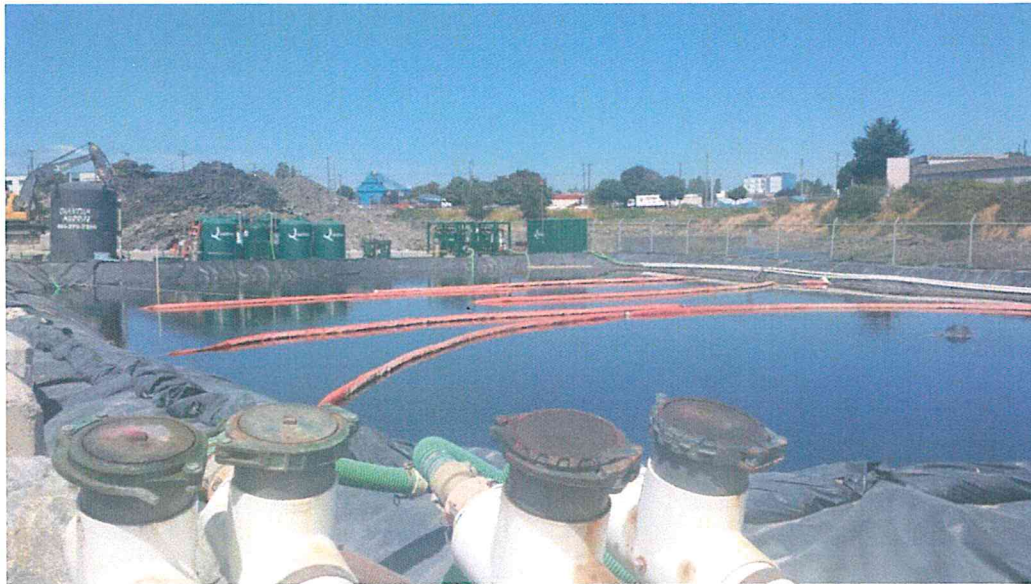
Figure 8: Settling pond and water treatment system in background

From the sediment settling tank the water travels into a Sediment pond which can hold approximately 1.5M liters. The pond contains large screens jutting out from either side of the pond perpendicular to the direction of flow. This slows the flow of the current in the pond in order to maximize the amount of sediment to fall out of solution. However at this point in the process the sediment is mainly reduced to silt and fine clays. To prevent the pond water from leaking a double layer geo-membrane has been installed above and below of an ash fault base. It should be noted that the particulate matter can contain metals and contaminates so the ultimate goal is to reduce the suspended material.
