## From Wasteland to Waterscape: Riparian Restoration of 40 Mile Landfill in Banff National Park

Prepared by Rebecca Celine Smith  
Resource Technician (EG02) Fire and Vegetation  
Parks Canada - Banff Field Unit  
ER 390/400: Project in Ecological Restoration

University  
of Victoria

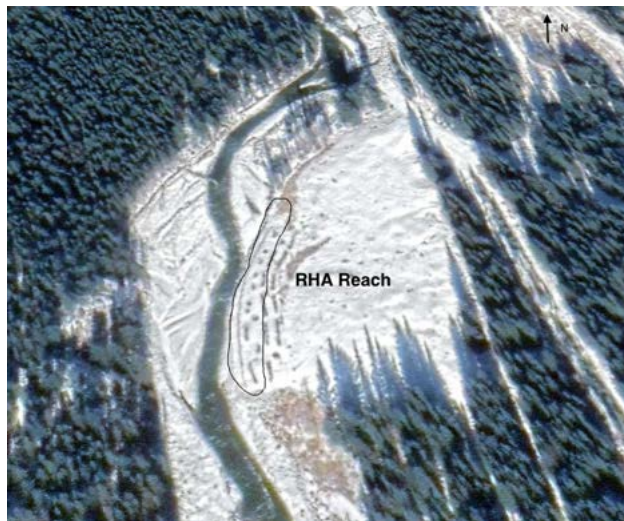
Figure 6- 40 Mile RHA reach (2019)

To characterize the riparian area, a standardized Riparian Health Assessment (RHA) was undertaken for the site through the parameters set out by Alberta Riparian Habitat Management Society, comprising 13 scoring methods with visual survey techniques (Fitch, Adams and Hale, 2009). The assessment was completed in July when plants were in the active aerial growth phase for identification and flow conditions were close to average. Following their definitions of small streams, I evaluated up to bankfull width, or twice the depth of existing high water, along a ~125 m stretch of streambank, determined by pacing (Fig 6). Only the east side was assessed.

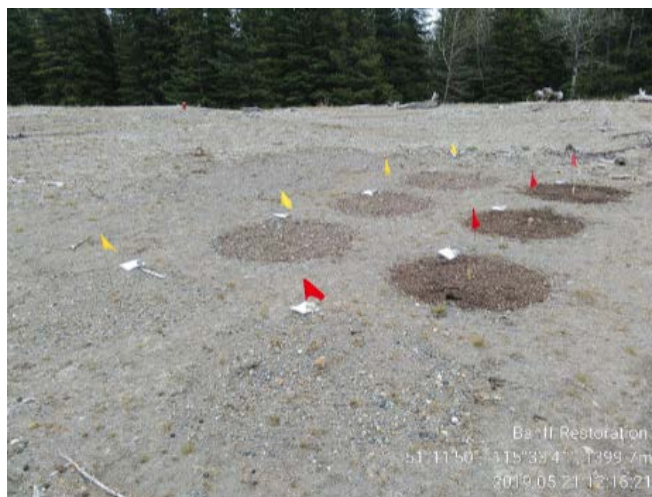
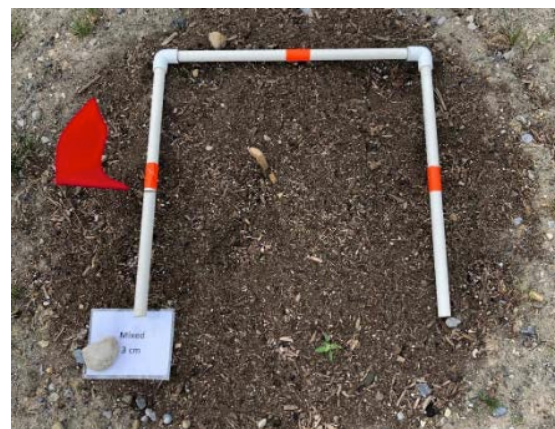
Figure 8- Soil Amendment Test Plots 2019

Eight plot diameters (1.14 m) were drawn into the soil surface using a string (0.57 m) attached to a wooden stake. In the middle of each plot the wooden stake was secured into place, the string was pulled taught and a circle was made by walking around the stake, creating a plot perimeter. Soil depth was then measured with a ruler in each plot and dug with a spade to the appropriate depth, the soil exhumed was placed to the side for mixing. In unmixed soil plots, soil was placed back in to plots and measured to ensure proper depth. In mixed soil plots, soil was placed in a bucket where Nutrilam was added at a ratio of 1:1, the combination was thoroughly mixed, placed back into plots, and depth measured. A seeding rate of 25 kg/ha was predetermined and 13 grams of seed was hand broadcast on the soil surface of each plot and raked in (Fig 8).

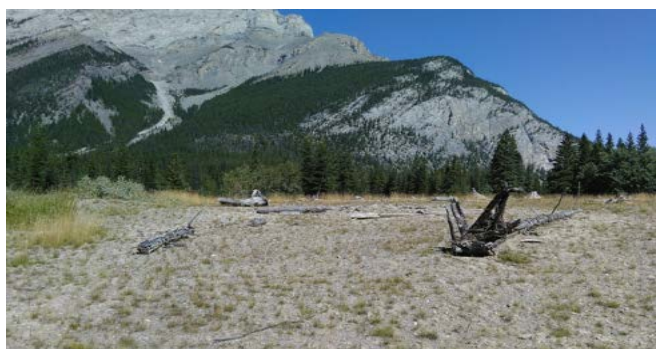
Figure 10- Typical biotic conditions at uplands

In line with the nature of the site as a novel system, 40 Mile soil/overburden is characterized by high proportions of silt and sandy gravel (Fig 9) which reflects in vegetation groupings characteristic of poor soils – i.e. nitrogen fixing and disturbance dependant species such as Alfalfa (*Medicago sativa*) and Locoweeds (*Oxytropis spp*), and limited growth of previously hydroseeded bunchgrasses and trial plantings from prior restoration, with predominantly weedy ruderal species (Fig 10).

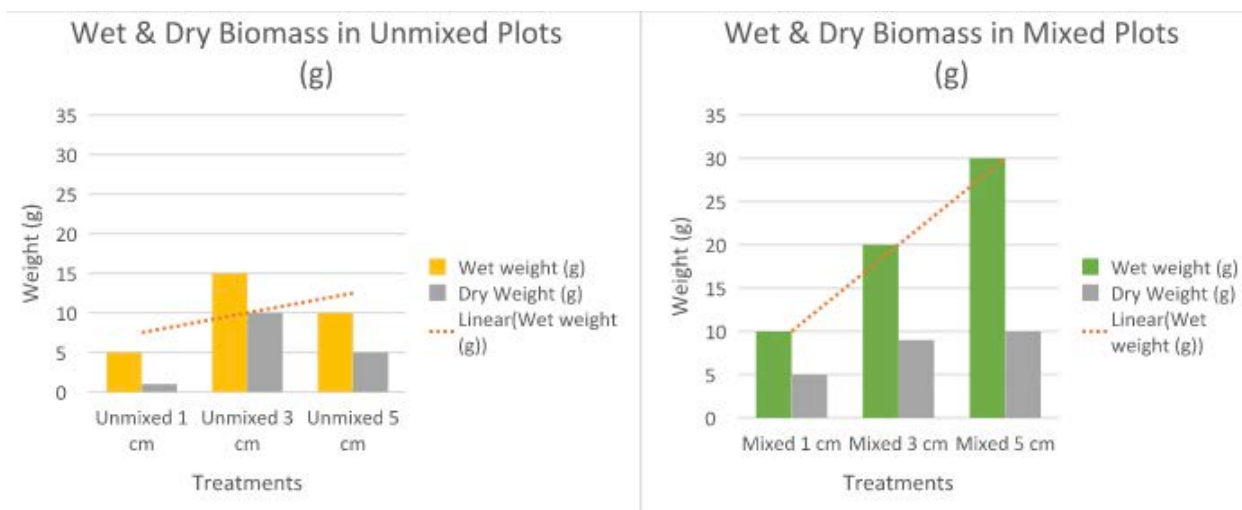
Figure 11- Biomass Results for 40 Mile Amendment Trial Plots

The soil amendment plot study demonstrated that grass plants found within the control (non-amended) plots were stunted, with a marked increase in the above ground biomass in amended plots (Fig 11). In addition, more growth was observed in the plants adjacent to and in the area surrounding of the test plots, which could be a response to the increase of nutrients from the amendment and the loosening of soil allowing moisture to infiltrate into the substrate.

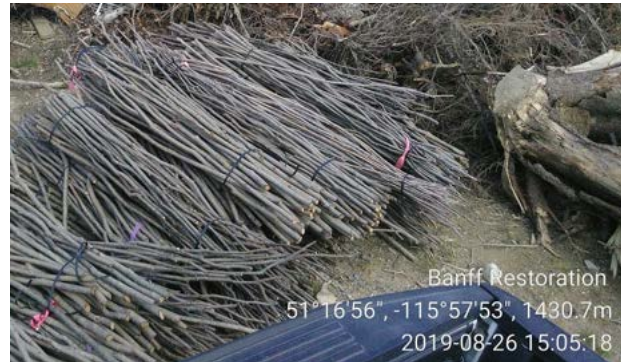
Figure 12- Live willows and poplars bundled for use on site

The objective for riparian restoration in 2019 was to stabilize and enhance the functioning of streambank and riparian reach using a living wall. There is a need to move beyond conservative factors promoted by traditional engineering for flood mitigation in Alberta, and the narrative of ‘biological uncertainties’ used to minimize the validity of using live materials vs. hard elements- in fact, bioengineering treatments can be integrated with geotechnical treatments to provide effective, affordable and sound bank stabilization (Barrett et al., 2006). The mechanical contribution to the soil stabilization of mature willows (*Salix spp*) and balsam poplars (*Populus balsamifera*) can increase soil cohesion up to around 0.3 m deep (Ishii, 2019). We used live willow (*Salix spp.*) and Balsam Poplar (*Populus balsamifera*) contributed via materials collected for a BFU Aquatics project (Fig 12).

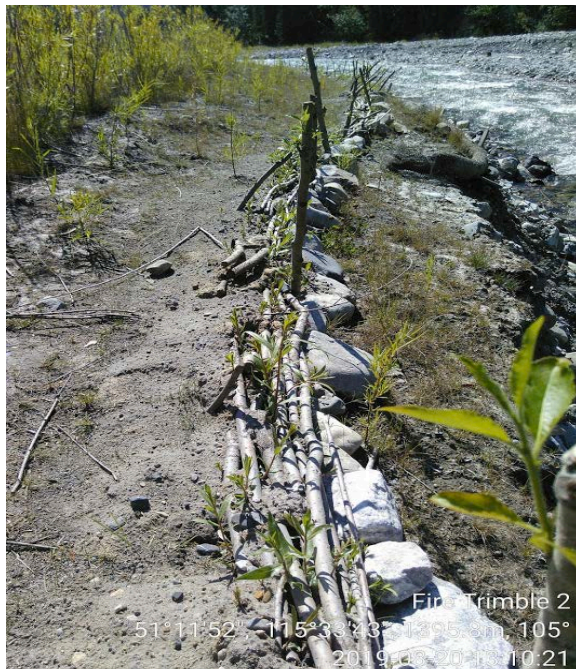
Figure 13- 40 Mile living wall- successfully sprouting

Stakes and fascines were planted according to the palisade protocol set out by Polster and Bio (2016). The palisade was planted throughout the 125M of riprap previously laid out in RHA boundaries (Fig 6). Excess stakes were opportunistically planted in ‘pockets’ of around 50 stakes at either end of the reach, as well as further upstream. Later in the season, we seeded the disturbed soil of the living wall. River beauty (*Chamaenerion latifolium*) was chosen due to its nature as a native pioneer species in riparian zones. The seed was wild-harvested from a gravel bar at nearby Cascade Ponds (Location in Appendix). Finally, we applied rooting hormone, Stim-root #2 for hardwood, diluted in water. In addition, this hand watering assured sprouting materials were kept viable during the fall season before entering dormancy.

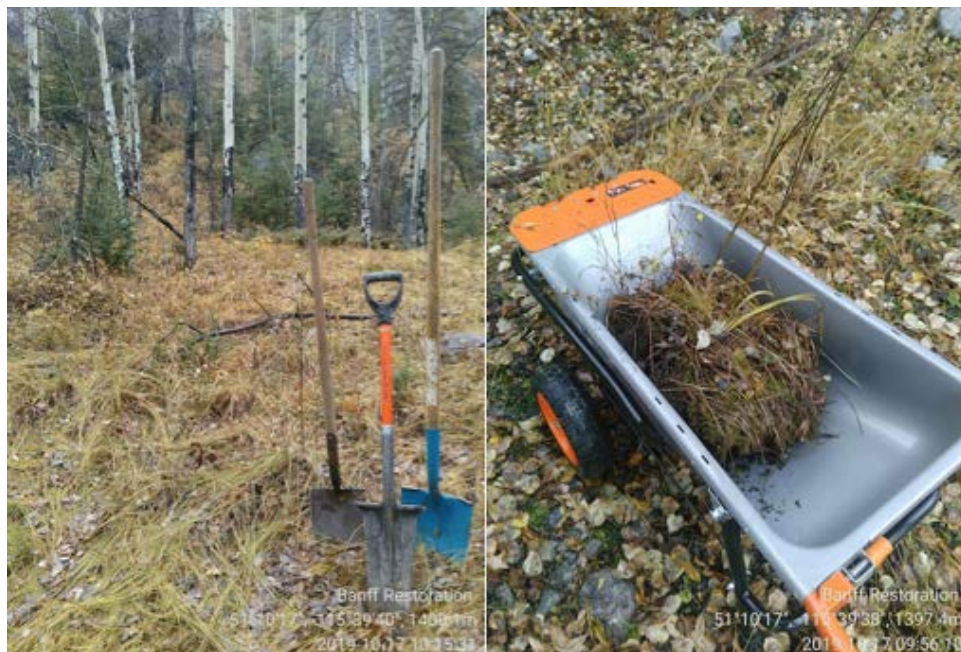
Figure 14- Harvesting Aspen guild offsite for use at 40 mile

The objective for uplands restoration was to promote succession towards characteristic species, in this case determined through ecosite assessment to be a Montane aspen-grassland mosaic. Trembling aspen (*Populus tremuloides*) was specifically chosen for this project as an early seral species growing in parklands, forest and along forest edges, often used in restoration of riparian zones by reducing soil erosion and increasing soil nutrient from decaying leaves (Wood et al., 2013). For heavily disturbed sites with little topsoil, the best conditional framework for aspen survival involves the use of transplanted saplings from local sources with fresh soil directly removed and placed from local aspen stands (Musselman et al., 2012). As a disturbance dependent species, vegetative regeneration of Aspen can be initiated through manipulations that provide hormonal stimulation, proper growth environment, and sucker protection—the three elements of the aspen regeneration triangle (Shepperd, 2001) Small seedlings of Aspen with high RSR (root to stem ratio) appear to display the greatest stem growth and leaf area under drought stress (Kulbaba, 2014). In addition, plants were collected in guilds considering that many species directly benefit from closely associated neighbours, known as facilitation or ‘nurse plants’ - a phenomena which has a practical application to the restoration of degraded environments (Padilla and Pugnaire, 2006). Aspen for the 40 mile project was collected offsite with this indication in mind (Fig 14) at an offsite location with good community composition and a relatively low proportion of invasive or disturbance species (see Appendix).

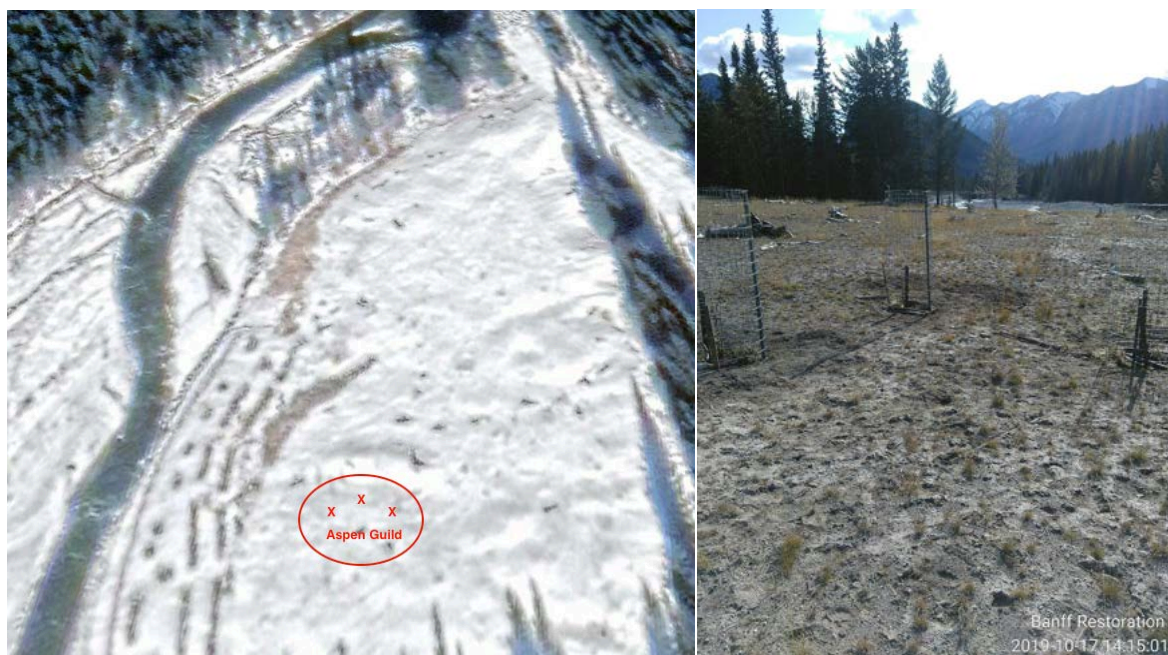
Figure 15- Location of Aspen plantings, aerial (Google Earth Pro) and terrestrial view

After harvesting the aspen guilds, we created 3 experimental planting islands in a depression within the uplands (Fig 15), digging in deeper depressions to encourage moisture collection. Soil was amended with NutriLoam planting medium according to the results of field test plots (~3cm) and topped with native ‘hay’ collected nearby to encourage moisture retention and live propagule deployment. Finally, the aspens were caged to prevent herbivory from ungulates.

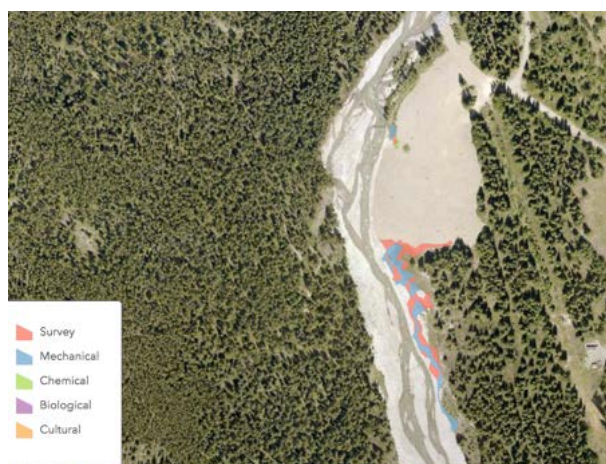
Figure 16- ArcGIS mapping of IPMP actions at 40 Mile 2019

We surveyed species using the internal Parks ArcGIS spatial database, employed mechanical and chemical control at appropriate windows, and seeded with native ruderal species Fireweed (*Chamaenerion angustifolium*) and Mountain Avens (*Dryas drummondii*) late season (Fig 16).

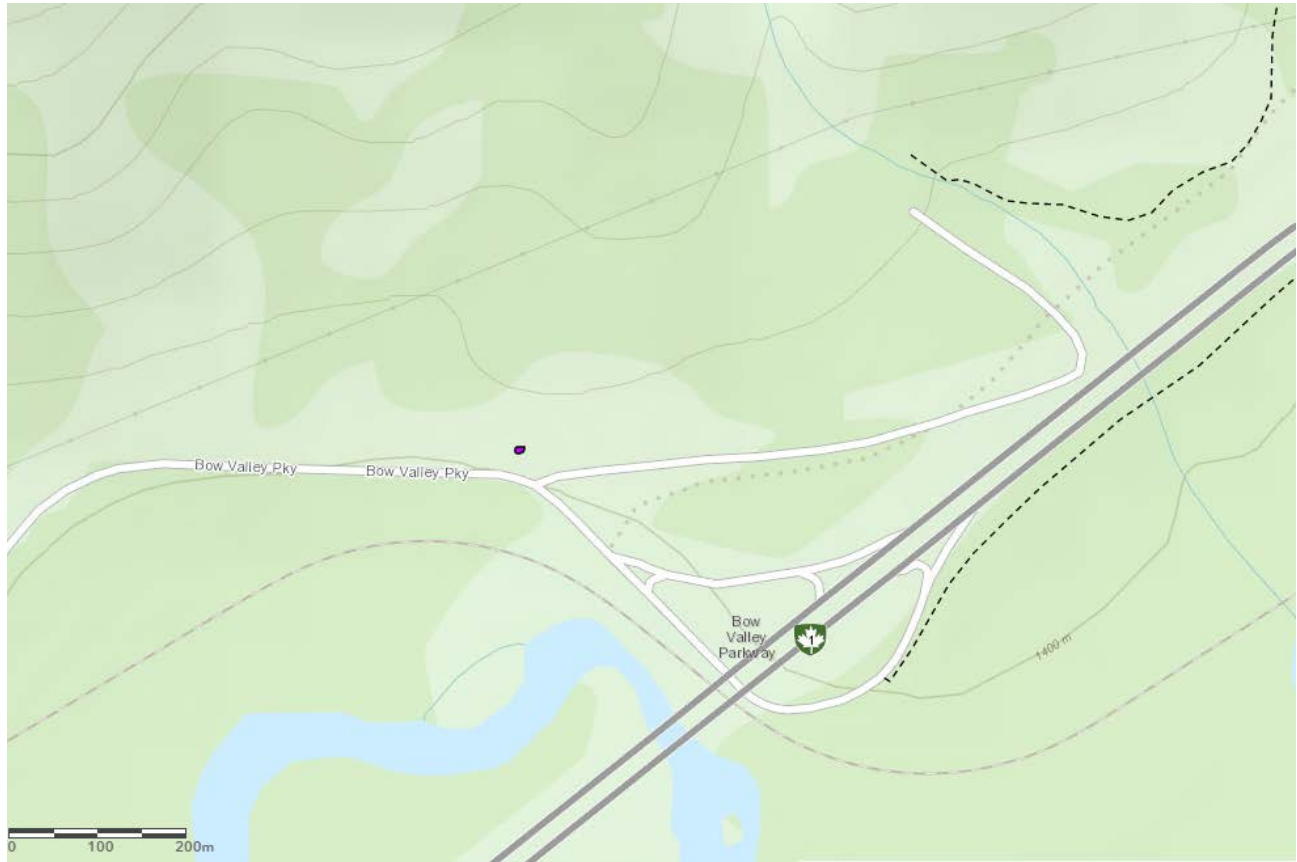
## Appendix E: Location of salvage site for aspen guild clumps

### Species List at Aspen Salvage Site

<p><u>Grasses:</u> <i>Hairy Wild Rye, Slender Wheatgrass, Smooth Brome, *Fringed Brome</i></p>	<p><u>Trees/Shrubs :</u> <i>Aspen, Wolf Willow, Buffaloberry, Salix spp, White Spruce, Larch, Bearberry, Common Juniper, Rocky Mountain Juniper, Snowberry, Prickly Rose</i></p>	<p><u>Forbs:</u> <i>Wild Strawberry, Creamy Peavine, Showy Aster, Northern Bedstraw, *Dandelion. Yarrow, American Vetch, Ragwort .</i></p>
--	--	--
