Forest Restoration in Kanaka Creek Regional Park

A restoration project to replant a 305m² site near 108 Loop,
Kanaka Creek Regional Park in Maple Ridge, British Columbia

Report prepared for ER-390: Environmental Restoration Project. Submitted March 17, 2022
to Nancy Shackelford, University of Victoria, British Columbia

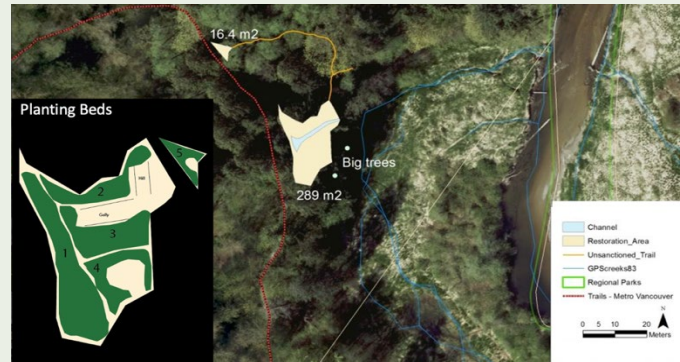
Figure 5: Creating Planting Beds

The restoration area was split into five sections for planting. The total area for the site is 305.4 m².

When considering how much soil to order, the area of the gully, the hill at the northeast corner, and the large tree stump at the southeast corner were measured. The new estimation was 198 m² of land to cover with soil for the plantings.

An average soil depth of 0.3 meters was estimated. The project would require a minimum of 60 m³ of soil to fill all five planting beds.

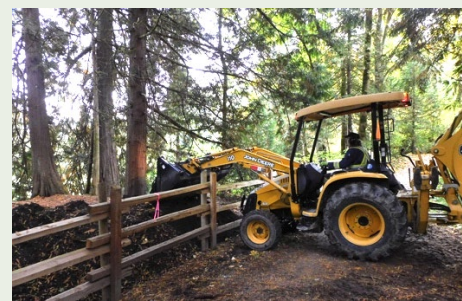
Figure 6: Soil Placement

The site location proved to be challenging for transporting materials. Using a John Deere 110 loader backhoe, Kanaka Creek Regional Park operations carried Nutrifor soil down the trail. It was lifted over the fence and dropped in large piles in the restoration site.

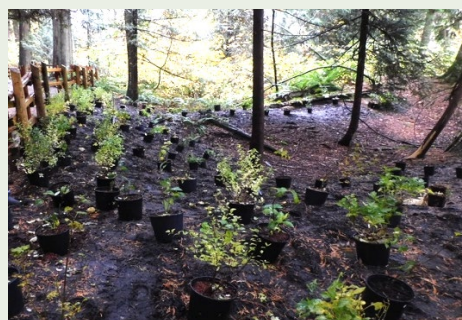
Figure 7: Plant Placement

Plants were laid out according to a planting plan (*appendix D*) that considers site features, like the hill, gully, and stump. The plan created a barrier of shrubs along the fence line, and a bowl of large-leaved avens and false lily of the valleys.

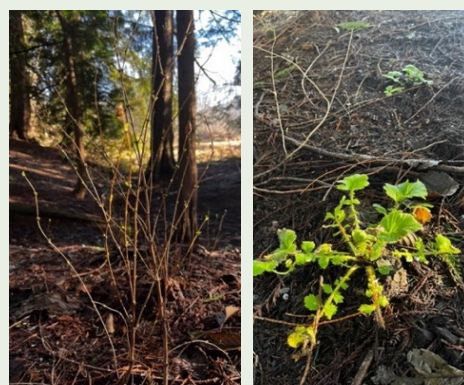
Figure 9 & 10: Post Restoration Site Visit

These photos, taken in February 2022 show leaf buds beginning to grow on the left and a large-leaved avens spreading out on the right.

After visiting the restoration site in February 2022, it appears many of the plants have survived the considerable precipitation and atmospheric river events that occurred since the restoration took place in October 2021. The ferns have transferred well, as have the avens. Red huckleberry is also starting to grow and some of the leafless shrubs are beginning to bud new leaves. As the temperatures continue to warm and the site receives more sunlight, plants should continue to grow and leaf out. This growth should support Goal 1, by limiting the visibility into the site along the fence. Continued monitoring must take place over the next year to see if all native species survived the transplant, supporting Goal 2. There also appears to be little soil run-off, which was one of the considerations during soil placement, due to the proximity of the creek below the site.
