# Invasive Species Restoration Project and Management Recommendations

for *Reynoutria japonica* at Neilson Regional Park

By Nicole Mulligan  
University of Victoria  
ER 390 Project  
Supervisor: Nancy Shackelford

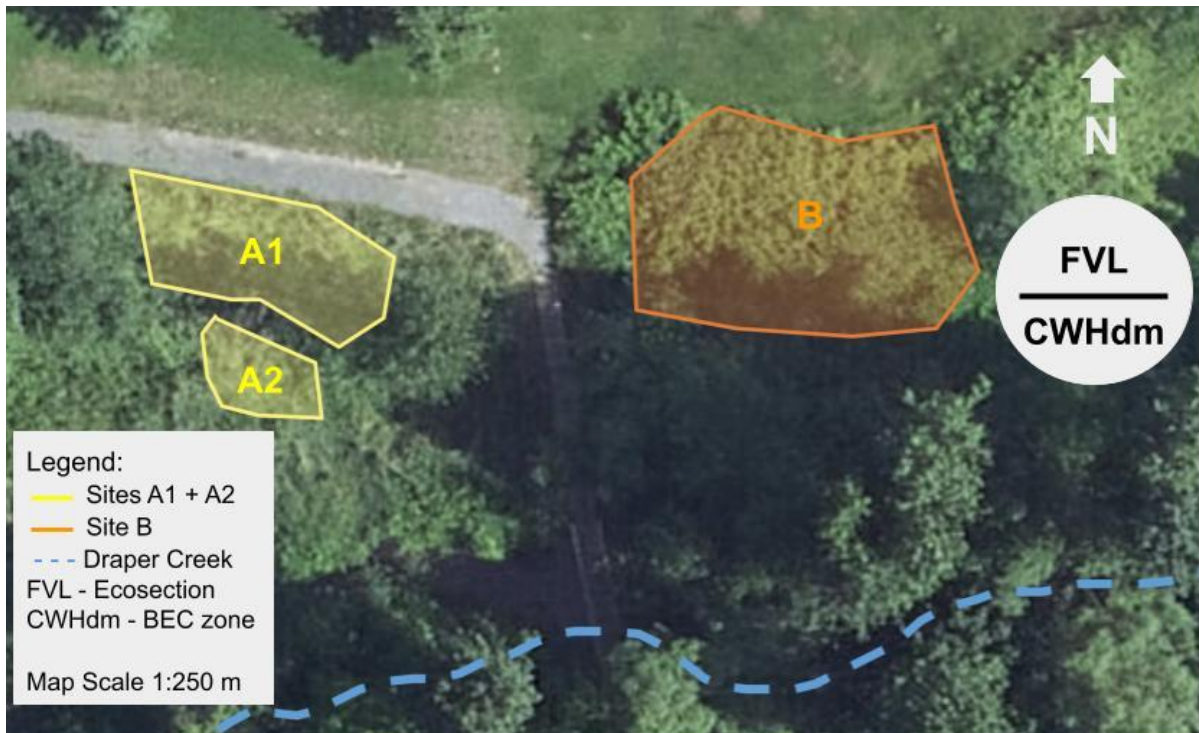
Figure 2: Shows a map of the three restoration sites at Neilson Regional Park: A1, A2, and B. The blue dotted line is Draper Creek.

The project area spans two distinct sites, site A and site B, totalling 330 m<sup>2</sup> in size (Figure 2). Both sites are on the north side of Draper Creek, near its confluence with Hatzic Lake. Site A further divides into two subsections, A1 and A2, due to their ecological disparities despite their proximity. Site A1 occupies the upper slope, while site A2 lies within a depression. With the historical and ecological context of Neilson Regional Park and Draper Creek in mind, the invasive species restoration project strives to restore the delicate balance of this vital ecosystem and foster a sustainable environment for salmon.

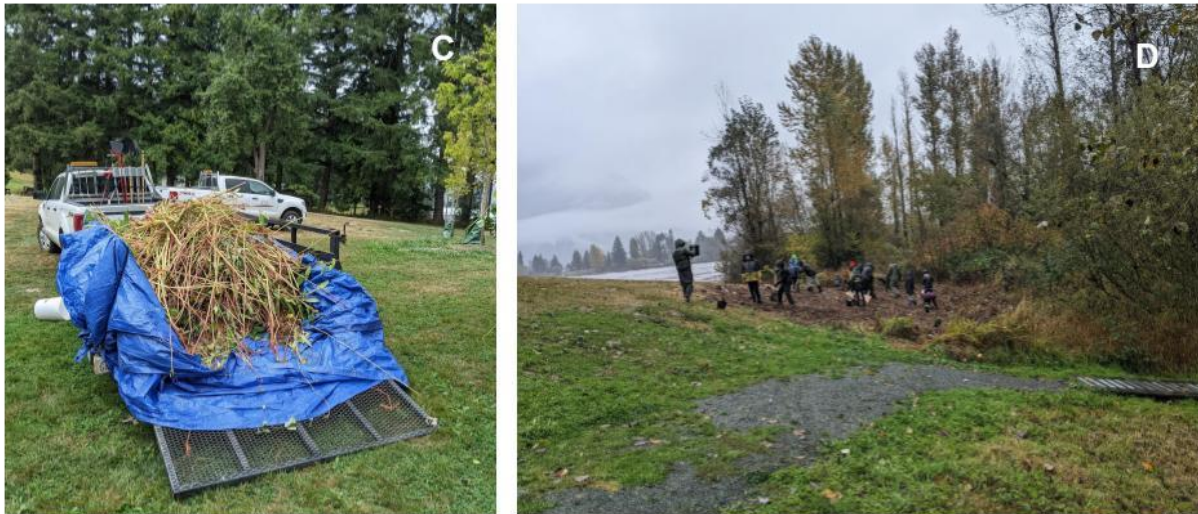
Figure 4: 4C shows all the invasive plant material that volunteers removed from the restoration sites. 4D shows student volunteers planting native species at site B.

and disposed of at a green waste facility (Figure 4C).

On November 4, 2022, 20 students from the local elementary school helped plant native species at all three sites for 50 hours (Figure 4D). Eight different native species and 42 plants were planted throughout the three sites. Students brought their own gloves and gardening spades. The students received a demonstration on how to plant the native flora by FVRD staff. The students worked in groups to loosen the dirt and dig holes with their gardening spades. Once they had holes, the depth required for the nursery plant's root system, they added mulch to the bottom of the hole, removed the native plants from their nursery pots, loosened the nursery soil and the plant's root system before placing the plant in the hole. Once the plant was in the hole, mulch and dirt from the site were used to backfill the holes, then they gently pressed the soil around the roots to ensure good soil-to-root contact. After the roots were covered, FVRD staff provided cardboard to lay around the stems of the native plants; finally, mulch was added on top, ensuring there was space left

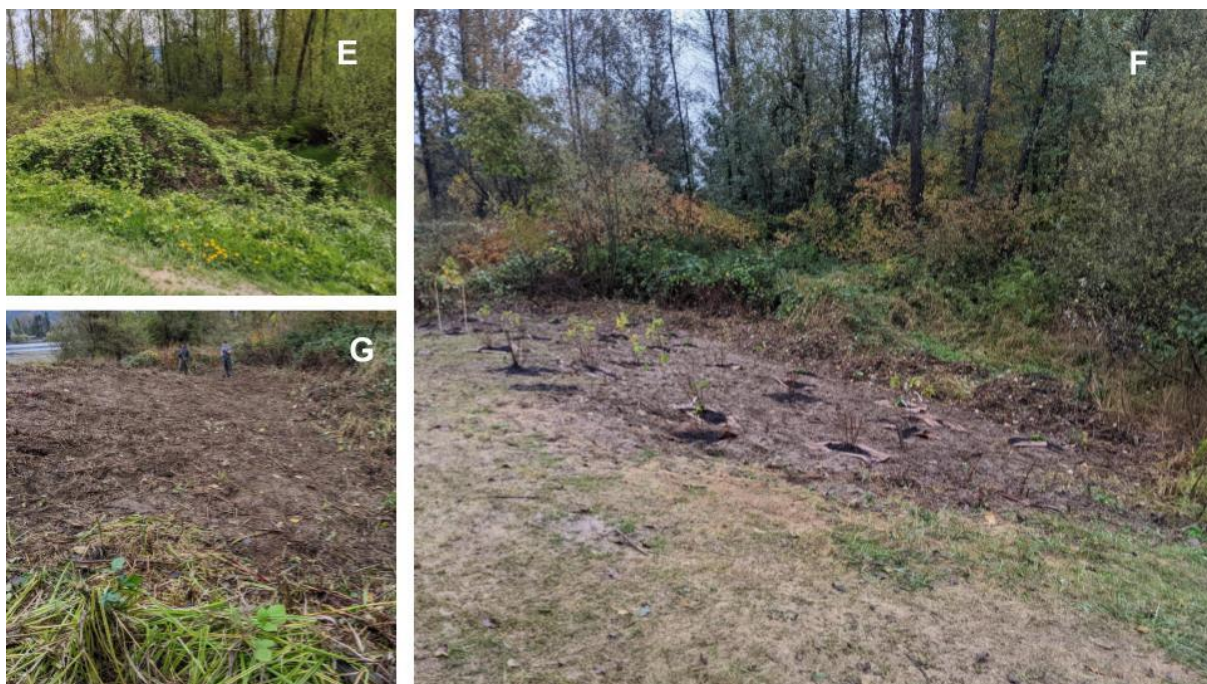
Figure 5: This figure shows site B before any restoration was done (5E), after the invasive species have been removed (5G), and after the native planting (5F).

*A. macrophyllum* got planted where the slope steepness had leveled out at site B. All 8 *Gaultheria shallon* plants were planted at the south edge of the plot to create a barrier between site B and the rest of the uncleared *R. armeniacus* along the slope. The remaining *P. capitatus*, *R. parviflorus*, and *R. spectabilis* were randomly planted on the slope for 25 plants on site B.

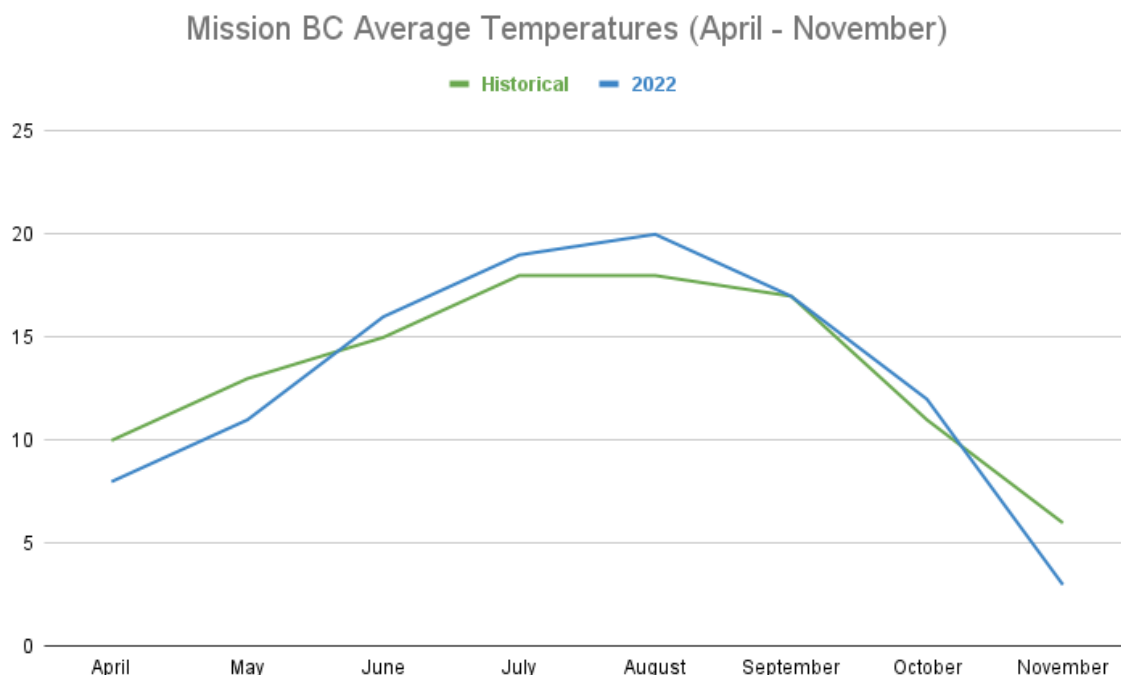
Graph 1: Mission, BC Comparing the Average Temperature from April to November in 2022 and Historical.

The project took place from April to November of 2022. The weather was abnormal for the region, adding additional challenges to the project. The Fraser Valley experienced a cold spring that continued into the start of July (Graph 1); this affected the growing season. The *I. glandulifera* located in the park usually starts flowering from late June and early July. However, in 2022 the flowering was delayed due to the cold spring. It is important for the flowers to start blooming to make it easy for volunteers to correctly identify them for removal; therefore, the volunteering event got pushed into August.

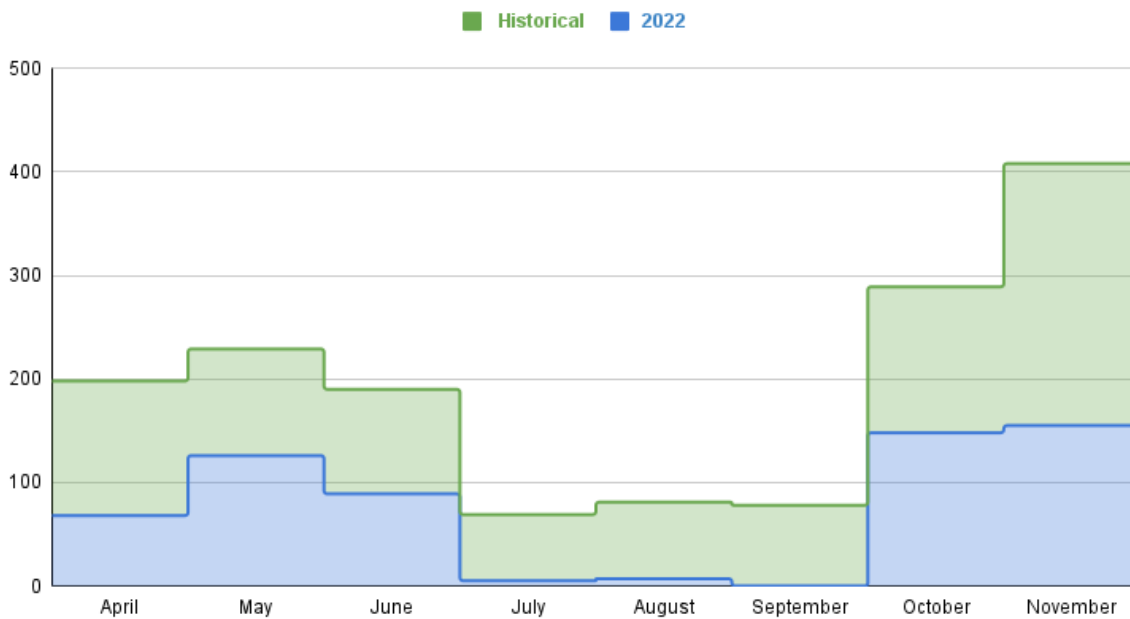
Graph 2: Mission, BC Comparing the Average Precipitation from April to November in 2022 and Historical.

The Fraser Valley region was in drought, which extended the wildfire season well into October (Graph 2), causing poor air quality. The goal of planting the native species in the fall was to eliminate the need for watering, as they would get moisture from the rainy fall days as they lay dormant until the next growing season. Alternatively, if the native species were planted in the spring, they would have required weekly watering over the spring and summer months to help them get established. High temperatures and poor air quality from wildfires burning late in the year made it unsuitable for the students to plant the native species until the air quality improved and the region was experiencing consistent precipitation. By the middle of October the weather started to cool down (weatherstats, 2023). As the effects of climate change continue to alter long-term weather patterns in all regions, steps need to be taken to adapt to these changing work conditions.

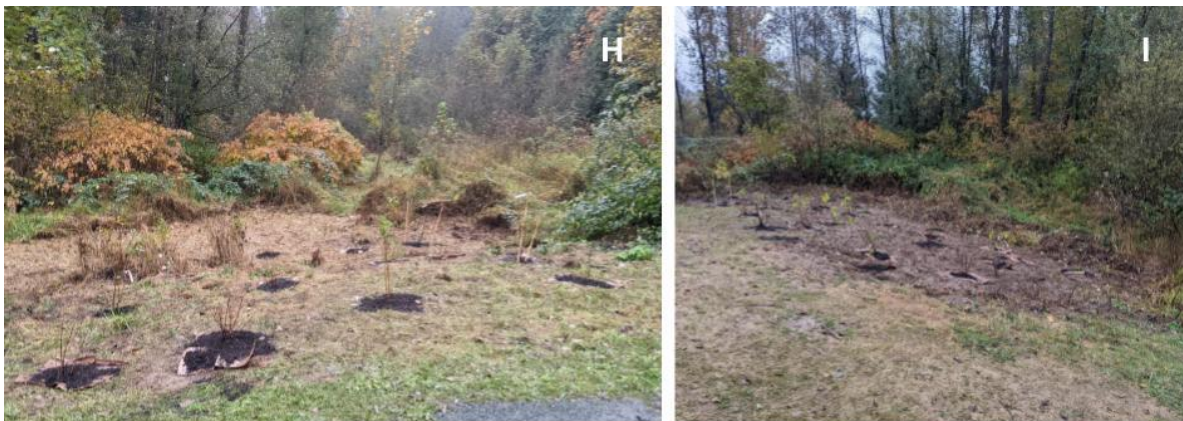
Figure 6: Shows the completed native species plantings for site A1 (6H) and site B (6I).

The native species planting at the three sites were successful (figure 6H and 6I); however, if they are left unattended, the same invasive species may come back from the plot edges out-competing the native plantings. Hence all restoration sites need a long-term management plan after the initial work. The FVRD park staff will monitor and maintain the three sites for five years. Years two to five will require the removal of invasive species that creep back into all three sites. The *P. arundinacea* at site A2 will be line-trimmed two to three times a growing season to prevent it from shading out the native species. As the years continue, the native species will become more established, allowing them to shade out the *P. arundinacea*. After five years the park staff will reevaluate the restoration site to see if additional monitoring will be required.
