# DAM CATCHMENT RESTORATION

*EROSION PREVENTION AND RESPONSE*

*April 1st, 2019*  
*Taylor Josephy*  
*ER 390*

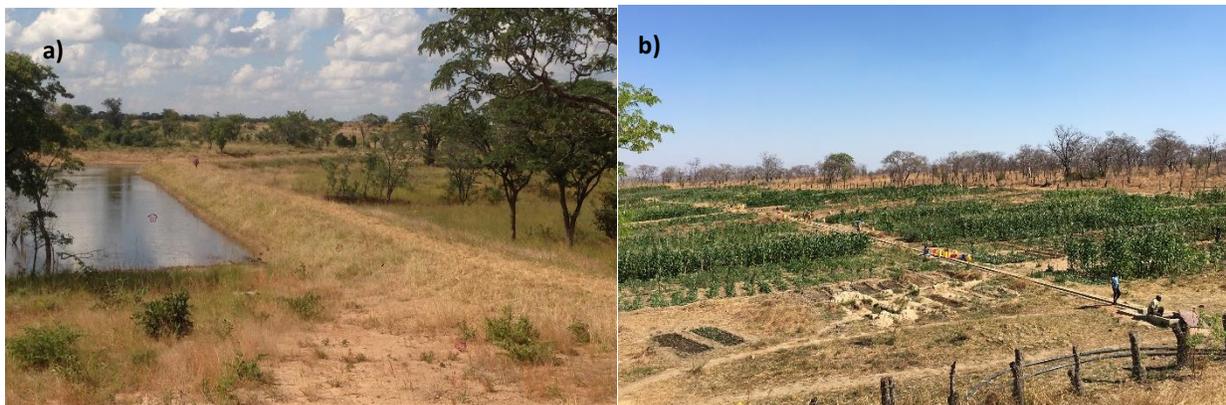
**Figure 1: a)** Siandwazi dam embankment, 140m long, 7m tall at the highest point, and roughly 3000m<sup>3</sup> in volume; **b)** Siandwazi irrigation scheme, supplied by a gravity-fed siphon system that pulls water over the embankment and runs it along canals to allow for dry season gardening

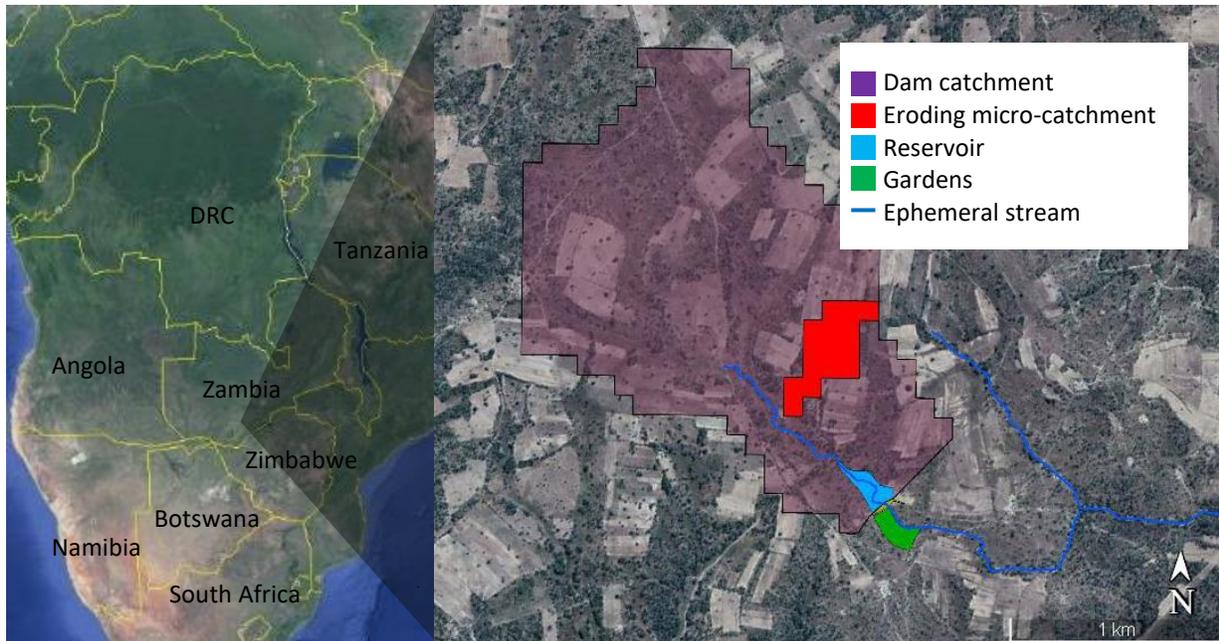
Siandwazi is located inimba District, Southern Province, Zambia. In traditional jurisdictions, it falls within the Sipatunyana Chiefdom. The dam is located at 17° 29' 43.51" S, 26° 17' 53.99" E and has a 259ha catchment (Fig. 4).

Figure 4: Siandwazi dam site and watershed, produced using Google Earth Pro

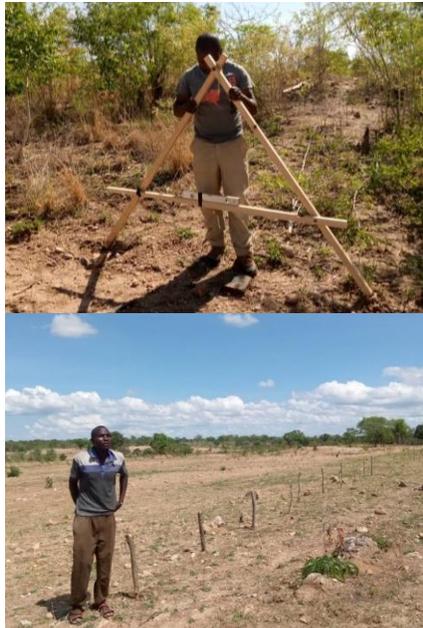
**Figure 10: a)** Maambo (Ministry of Agriculture) next to an adapted A-frame which uses a level to establish two points of equal elevation to build a contour; **b)** contour for farmers to follow while tilling

To cease erosion in the eroding micro-catchment, it was agreed that floods would be managed from their source, a field with down-slope, open-tilling. A meeting between the dam committee and the landowner took place to sensitize on the impacts of the land-use and establish how the landowner could be assisted to manage floods. The erosion was a priority concern for the landowner, and it was revealed that the tilling direction and water-concentrating bund at the edge of the field were attempts to mitigate erosion occurring in another catchment which endured the field’s run-off when tilling occurred along the other slope. Discussing potential solutions with the landowner, the Ministry of Agriculture, and the dam committee, it was agreed that the Ministry of Agriculture would help the farmer perform “contour farming” to ensure tilling occurs perpendicular to slope to catch water and split the run-off between the two catchments as would have occurred prior to the field. This was chosen over alternative conservation farming methods being promoted due to economic and labour trade-offs experienced by farmers in the region. A simple “A-frame” was constructed to establish contours in a time-effective manner and contours were pegged across the field (Fig. 10). Despite enthusiasm from the landowner, the field remained uncultivated throughout the rain season due to economic challenges derived from an early drought, thus water continued along the down-slope furrows from the year before.

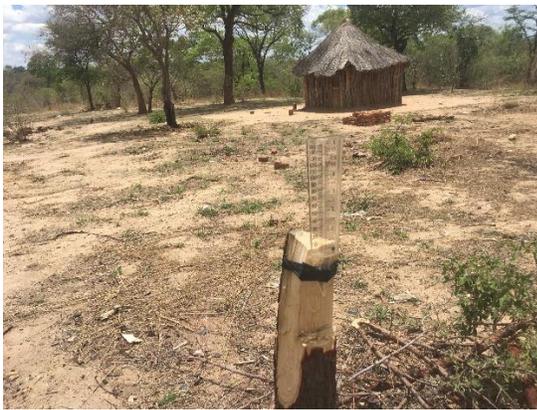
Figure 12: Rain-gauge set up near Siandwazi dam

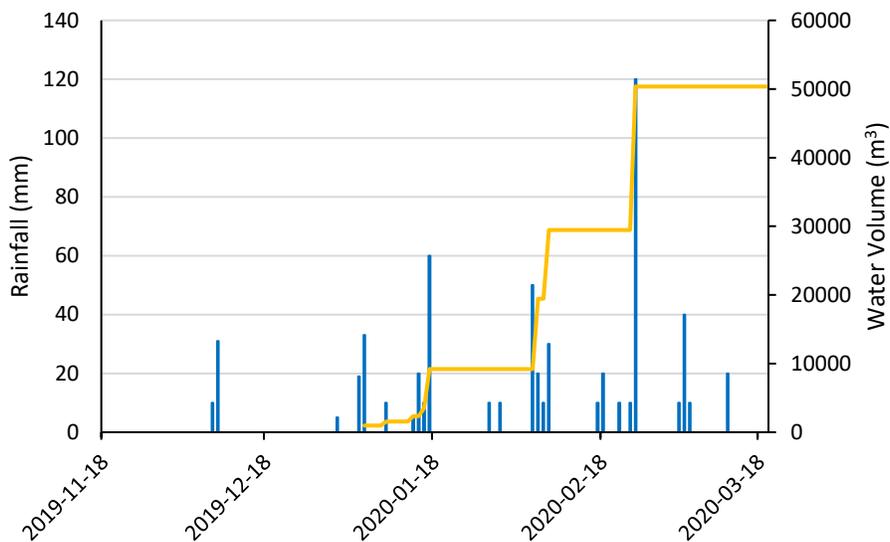
The precipitation and dam water level data are shown in Figure 17. Overall, 583mm of precipitation was recorded over 25 rainfall days. The dam filled and spilled during the season’s largest rainfall event of 120mm on February 24<sup>th</sup>. The season’s run-off coefficient was calculated to be 3.9%, while event-based coefficients were, in chronological order, 0.7%, 2.2%, 6.4%, 1.4%, 3.6%, 4.4%, 9.7%, and 5% (averaging to 4.2%).

Figure 17: Siandwazi precipitation depth (blue) and reservoir volume (orange) throughout the 2019/20 rain season

Since the contour farming in the eroding micro-catchment did not go forward and the check dam construction is still underway, there were no activities that could have contributed to increased baseflow during this rain season captured in the present data. Even if there are late rains, since the dam is full, the effect of the check dam on watershed-scale run-off will not be measurable.

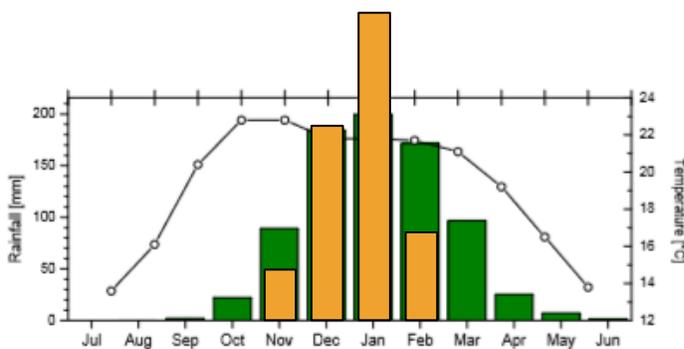
**Figure 18:** 50-year monthly average precipitation (green) and temperature (grey line) from meteorological station in Choma (Baumle et al, 2007) and Siandwazi 2019/20 precipitation (orange)

Contrarily, intensified rainfall late in the rain season increases the difficulty of controlling erosion. Figure 18 shows a comparison between Siandwazi's 2019/20 rainfall data (orange) and a nearby meteorological station's 50-year average. Although it is only one year, Siandwazi's distribution aligns with climate change observations and predictions of a shortened, intensified rain season (GRZ, 2017). The 120mm rainfall event is an example of this trend and a testament to the relative success of this project - the nearest dam to Siandwazi underwent an expensive rehabilitation with multiple cement drop-down structures on its spillway and even these were damaged in the same flood event. Without the restoration on the spillway, it is possible that the Siandwazi dam could have failed.
