Riparian Restoration and Erosion Stabilization of a Road Crossing near Richmond Lake Recreation Site

Prepared by Alisha Skelton

University of Victoria
Restoration of Natural Systems Program
ER 390 Final Project
December 4, 2020

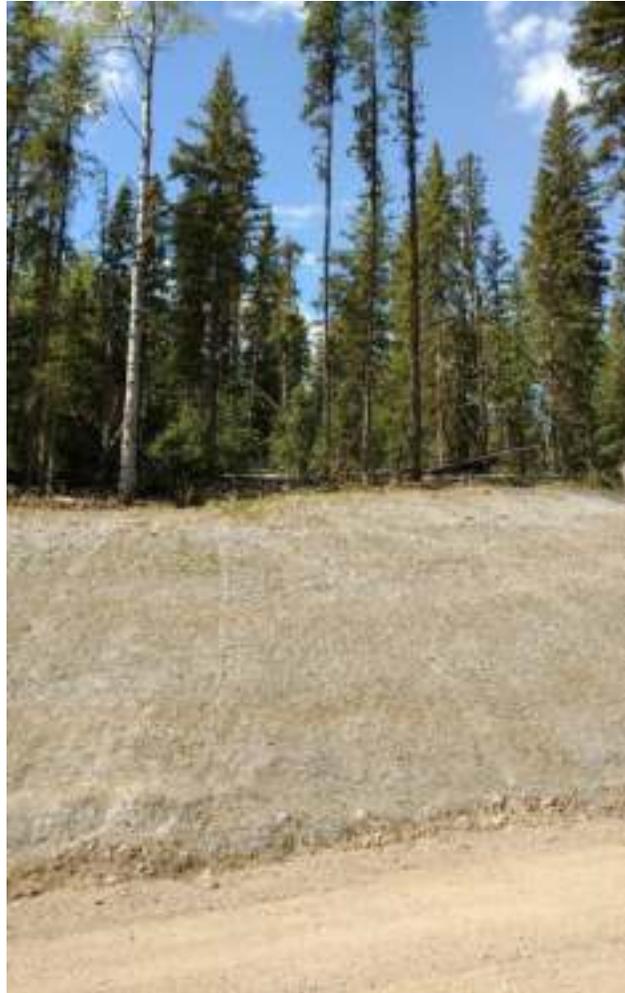
Polygon 1, the upper hillslope, has been significantly disturbed by road construction activities and falls within the site series SBSdk/05 (Sxw - Spirea – Feathermoss) (MoFR & MoE, 2010). The remaining forested area is an undulating landscape of mature stand of lodgepole pine and old growth hybrid spruce with paper birch and trembling aspen (Table 1). The soils in polygon 1 are very fine, easily erodible silt and sand with almost no topsoil or vegetation as a result of road construction activities. There is some seepage present, but the soils are mostly well drained (Appendix D).

Figure 6- Polygon 1 (2018)

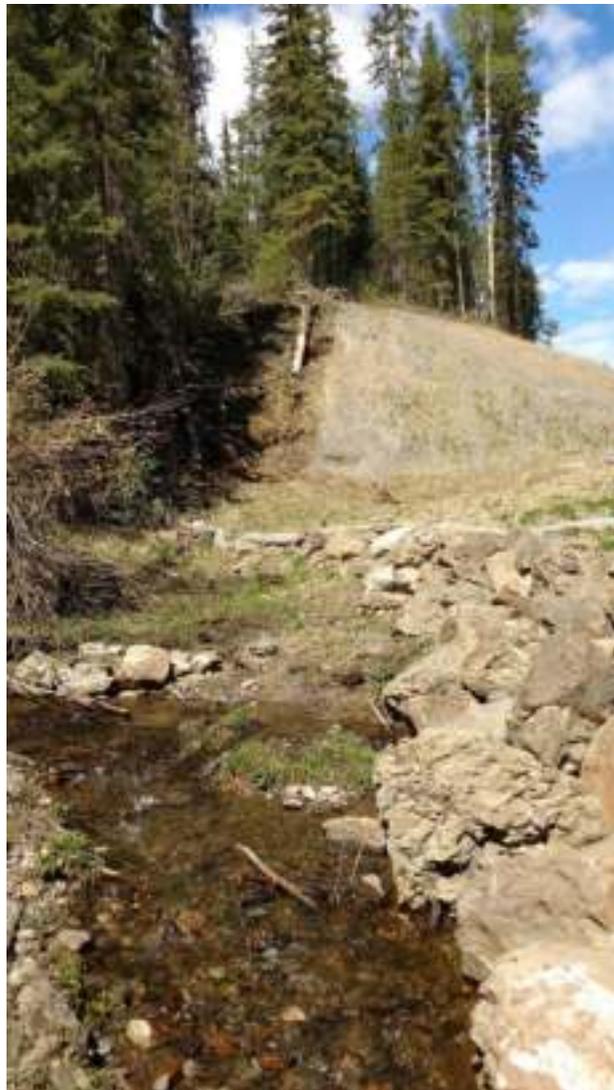
The second polygon is within the small stream wetland and riparian area of the right-of-way. This polygon is in the SBSdk/10 (Sb - Soft-leaved sedge - Sphagnum (forested swamps)) site series (MoFR & MoE, 2010). This area has been impacted by road construction, but also by sedimentation caused by erosion and runoff of the soil on the upper hillslope area during heavy rain events. This polygon is wet most of the year and the water table is near the surface resulting in saturated silty-clay soils with obvious mottling (Table 2) (Appendix E).

Figure 7- Polygon 2 (2018)

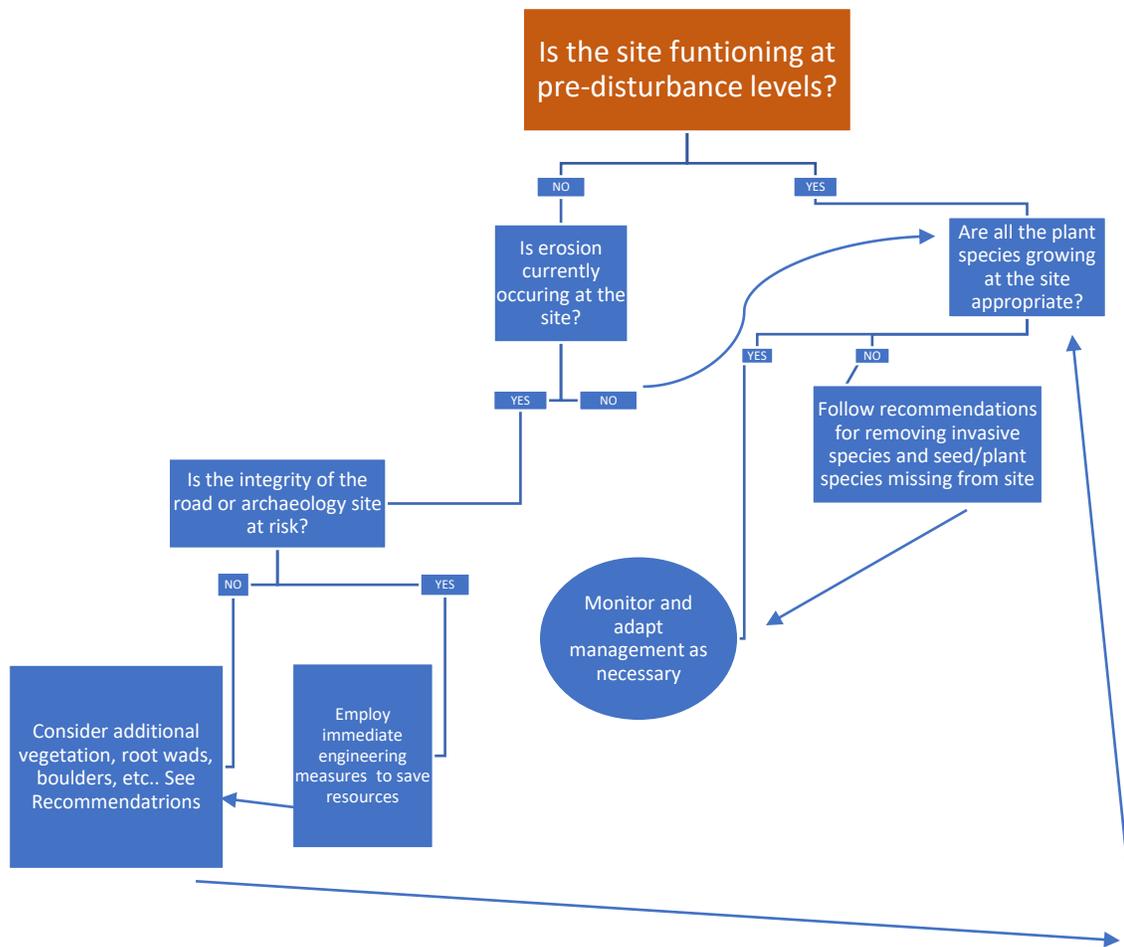
Figure 14- Management Response Decision Tree for Further Work

The above decision tree (Fig. 15) is meant as an aid for land managers and road licensees when considering whether the restoration site requires additional works. Some of the recommendations, such as brushing and road maintenance, are covered in a Professional Monitoring Plan developed by FLNRORD for every high-risk engineering project (R Phillips, personal communication, 2020). As an additional measure not normally completed for engineering works, I have requested ongoing targeted effectiveness monitoring be undertaken through the FREP program by staff at the Nadina District, beginning in 2021. I will communicate results of whitebark pine planting to the Bulkley Valley Research Centre and the research staff at Skeena FLNRORD so that they can continue to track the site and contribute to
